NATIONAL TRANSPORTATION SAFETY BOARD

**ADDENDUM NUMBER 14 TO THE STRUCTURES GROUP CHAIRMAN'S
FACTUAL REPORT**

DCA02MA001

Title:
 MSN513 LHS and RHS test program for rear main fittings
 Lug Test#2 and #3

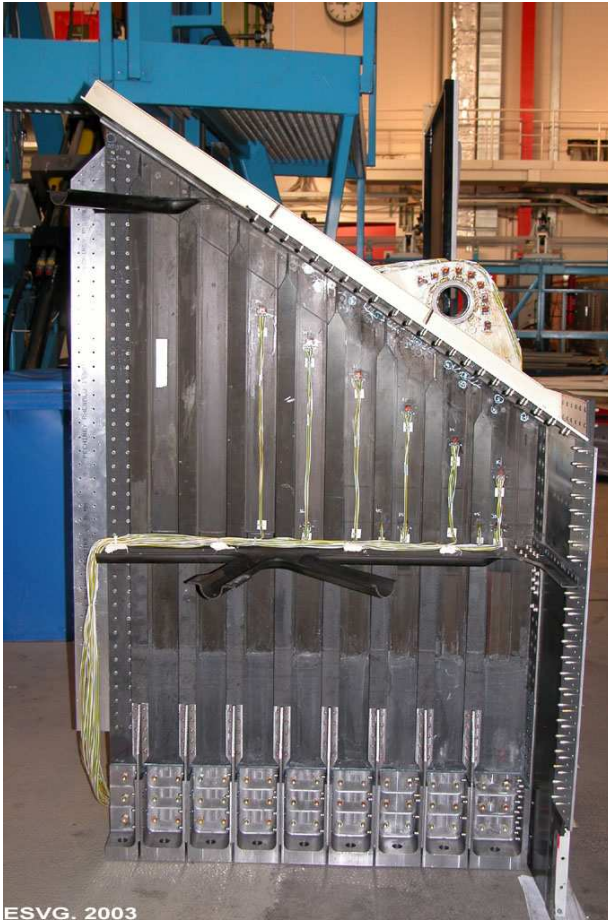
Figure 3.3 LHS Lug Test#2 [inside]

The test component is shown in figure 3.1 to 3.5 with the assembled parts.

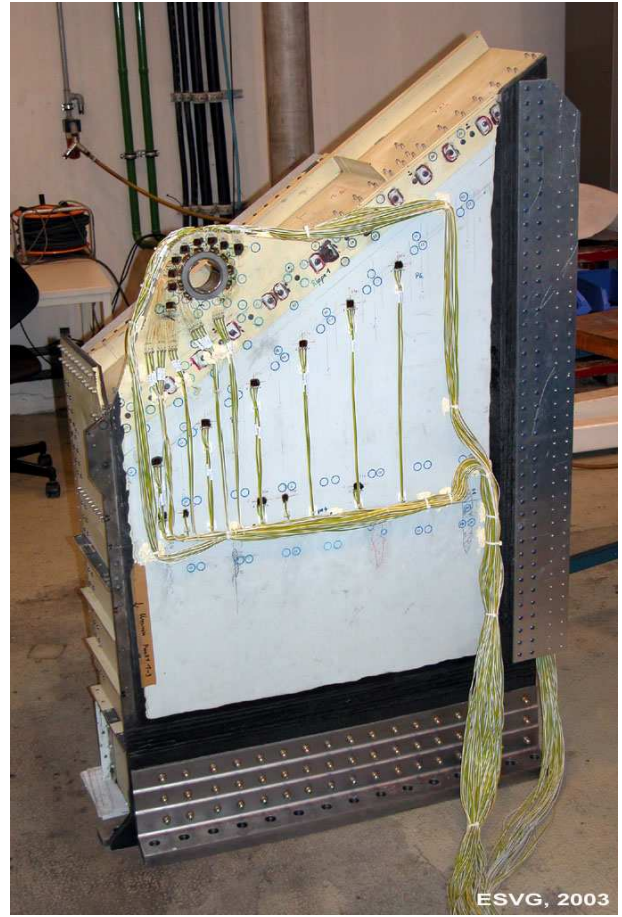
Figure 3.4 LHS Lug Test#2 [outside]

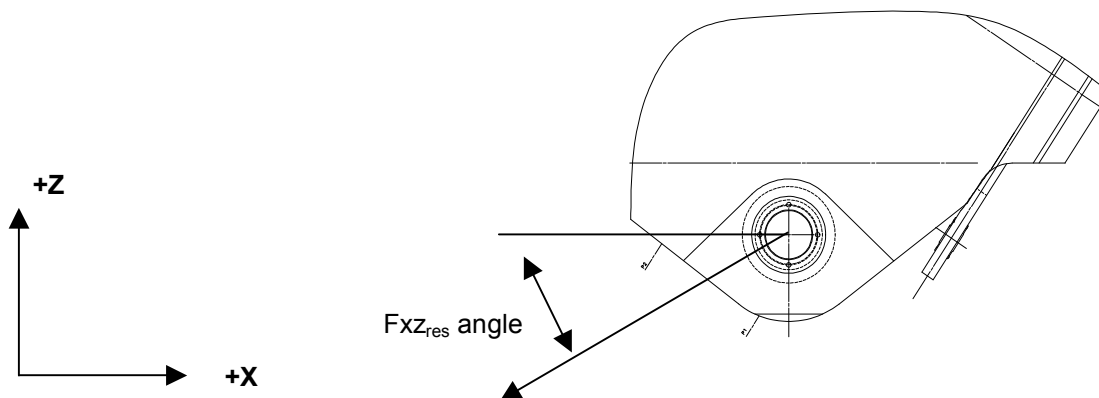
The following load sets (preliminary) are the target condition for 100% applied forces F_x , F_y and F_z in combination with the pre-adjusted bolt rotation R_x .

MSN 420							
Load case		F_x	F_y	F_z	F_{res}	Rx bolt rotation*)	Angle xz plane
No.		[N]	[N]	[N]	[N]	[°]	[°]
1	BI17_UL	-255794	-28990	-636556	686640	0.3	68
2	W375-MOD	-400000	-42000 ¹⁾	-864000	953000	0.45	65
