CW636

Id No: 11/8/96-11

Tag No: Z-4023 Green

Spanwise Beam 3- Web segment,
Near lower chord, RBL 98.6

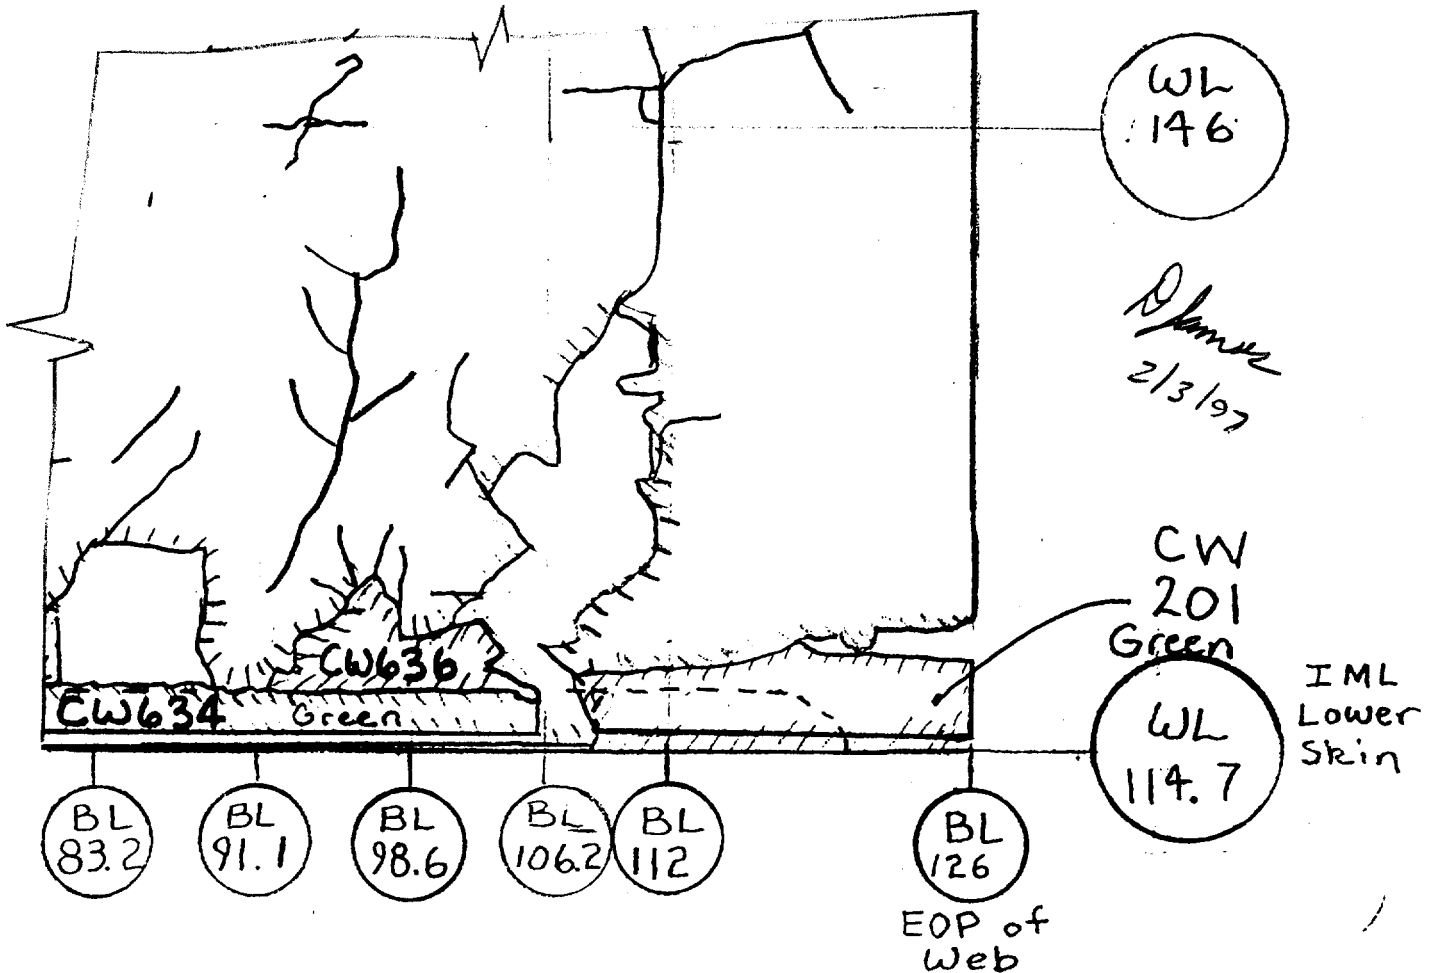
Part is extensively distorted and sooted. Segment is also shows signs of salt water corrosion. A more accurate description of part is difficult due to distortion of part. See attached map for probable undistorted size and shape.
