LOG # LF37 ^{SR/5} ^{RR 10-7-96} ^{A-5}

DEBRIS FIELD # 3 red
(near)

Portions of STA 800 Lower lobe Frame.

STA 800
FRAME SEGMENTS

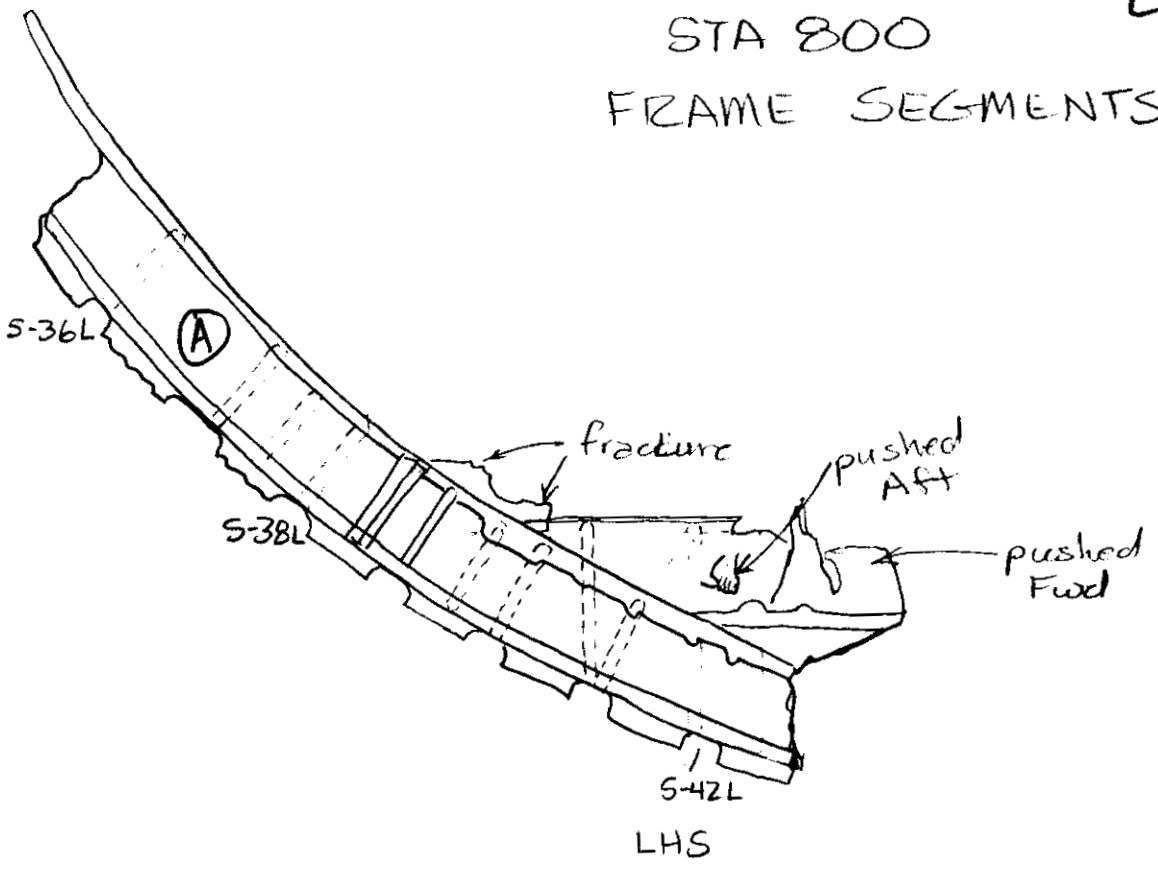
VIEW LOOKING FWD

Segment (A)

Red Tag # A619

Segment from S-35L to S-43L. Retains original contour. Two shear tie flanges are broken free, all others intact.

One aft direction puncture in deep web portion above S-42L.

There is no evidence of fire damage or sooting.
