## GREEN DEBRIS FIELD

LOG# L	F-41 P-3
TARGET#	
COORD: LAT _	5
LONG	?
_

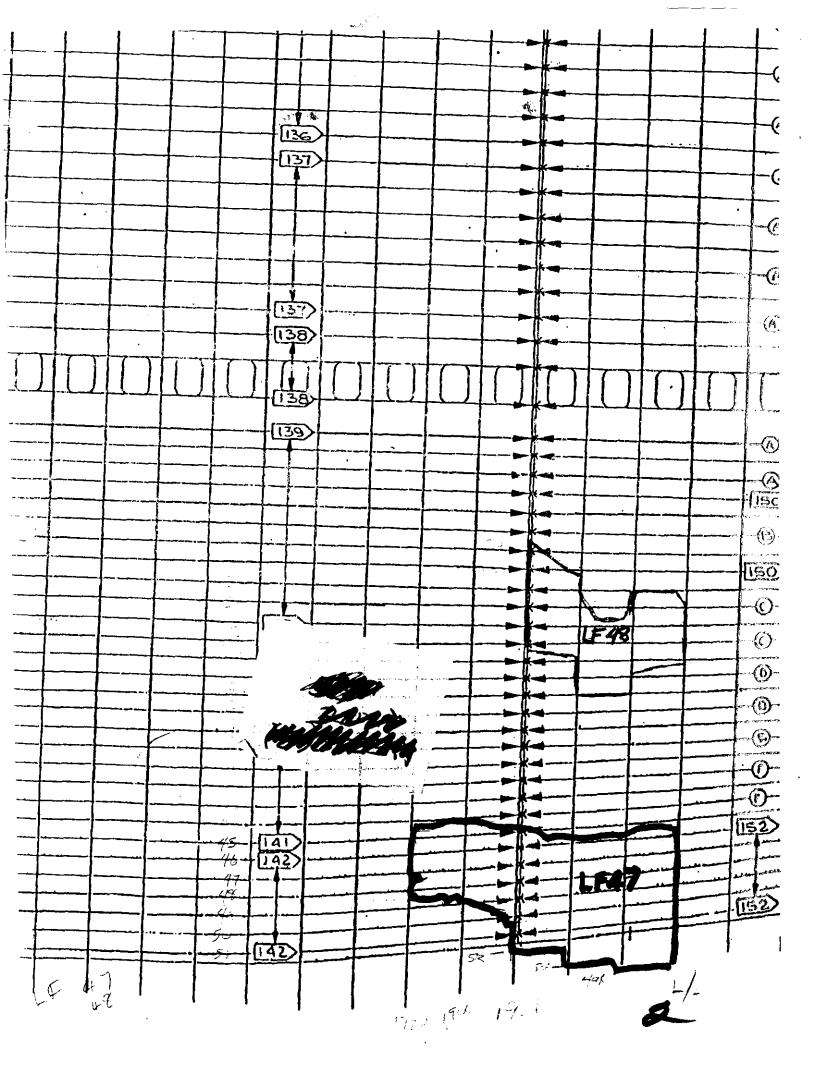
DEBRIS FIELD GREEN

THIS SECTION ENCOMPASSES AN AREA WHICH INCLUDES STATION 1920 BACK TO STA. 2020. AND INCLUDES A JAGGERED PATTERN OF TORN SKIN AND BROKEN STRINGERS FROM STRINGERS 44LITO 49 RIGHT. BEGINNING AT STA 1920 THE TEAR BEGINS AT STR 44L AND RUNS DOWN TO STR 48L. THE TEAR CONTINUES THROUGH STRS 49L AND 50L TO STATION 1960, THEN DOWN UNDER THE FUSELAGE TO STR 49R WHERE IT RUNS TO STA 2020 AND CONTINUES UP TO STR 45L. A JAGGERED PATTERN RUNNING BETWEEN STRS 44L \$45L THEN CONTINUES FORWARD TO STATION 1920.

MOST STATION FORMERS ARE MISSING. STR 51L, 50L \$49L. ARE BROKEN OUTWARD. THE COMPLETE SECTION 15 CRUMPLED AND BROKEN FROM IMPACT.

THERE IS NO EVIDENCE OF FIRE OR HEAT DAMAGE.
