Los# _Lf	- 49 190,4
TARGET #	
COORD: LAT	<u>?</u>
LONG	5
DEBRIS FIELD	3

THE SECTION IS APPROX 44 IN. HIGH AND 76 IN. 1800 WIDE AND RUNS FROM STATION 2484 BACK TO STA. 2552.4, ENCOMPASSING STRINGERS 44 UP-WARD TO STR. 25.

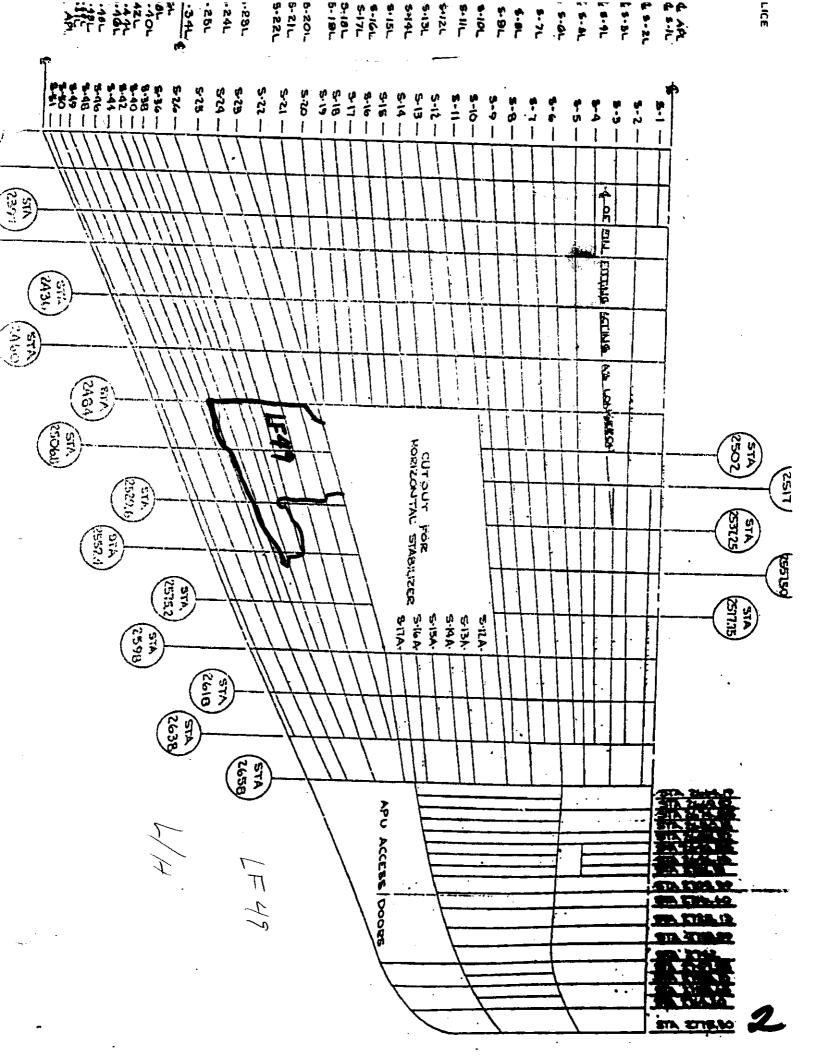
THE SECTION IS LOCATED DIRECTLY UNDER THE CUTOUT FOR THE HORIZONTAL STABILIZER WHICH
BEGINS AT STA. 2484, AT THE TOP, IT RUNS
TO STA 2529 ALONG STR 23 THEN TORN TO
STR 26. THE TEAR THEN RUNS ALONG STR 25
TO STA 2552.4 AND CONTINUES TO STR 42.

Strs. 24 AND 25 ARE CRUSHED, STR 26 15 MISSING FROM STA 2506 TO 2529, STR 38 is Broken.

THE SECTION SHOWS NO SIGN OF FIRE OR SMOKE DAMAGE.
