Nose Gear Doors

Log Number LG6
Debris Field Red, Yellow
Target Number Red: A070, A152, A209, A755; Yellow: B2075
Coordinates:
Latitude _____
Longitude _____

NOSE LANDING GEAR DOORS

BOEING 747

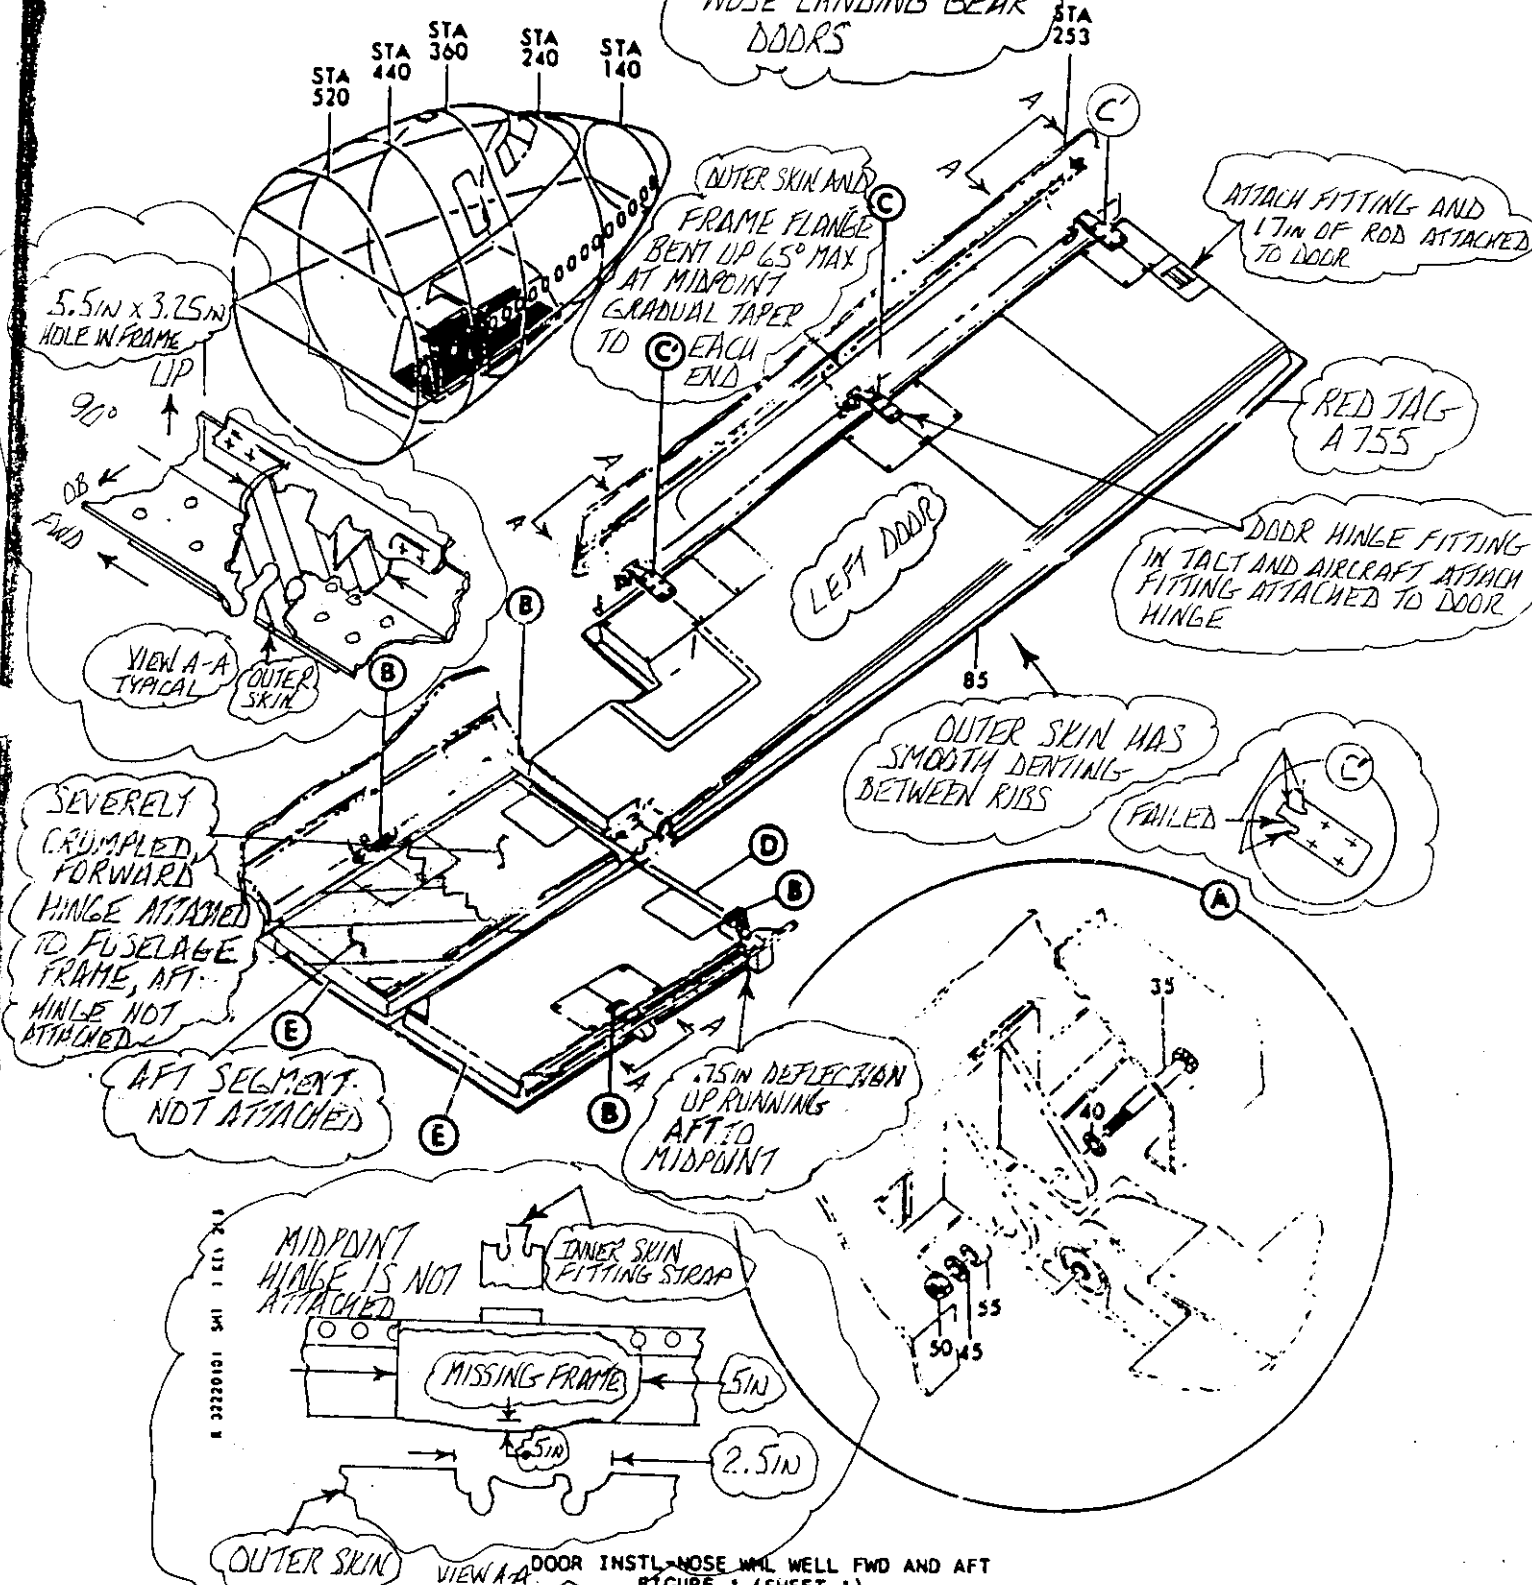
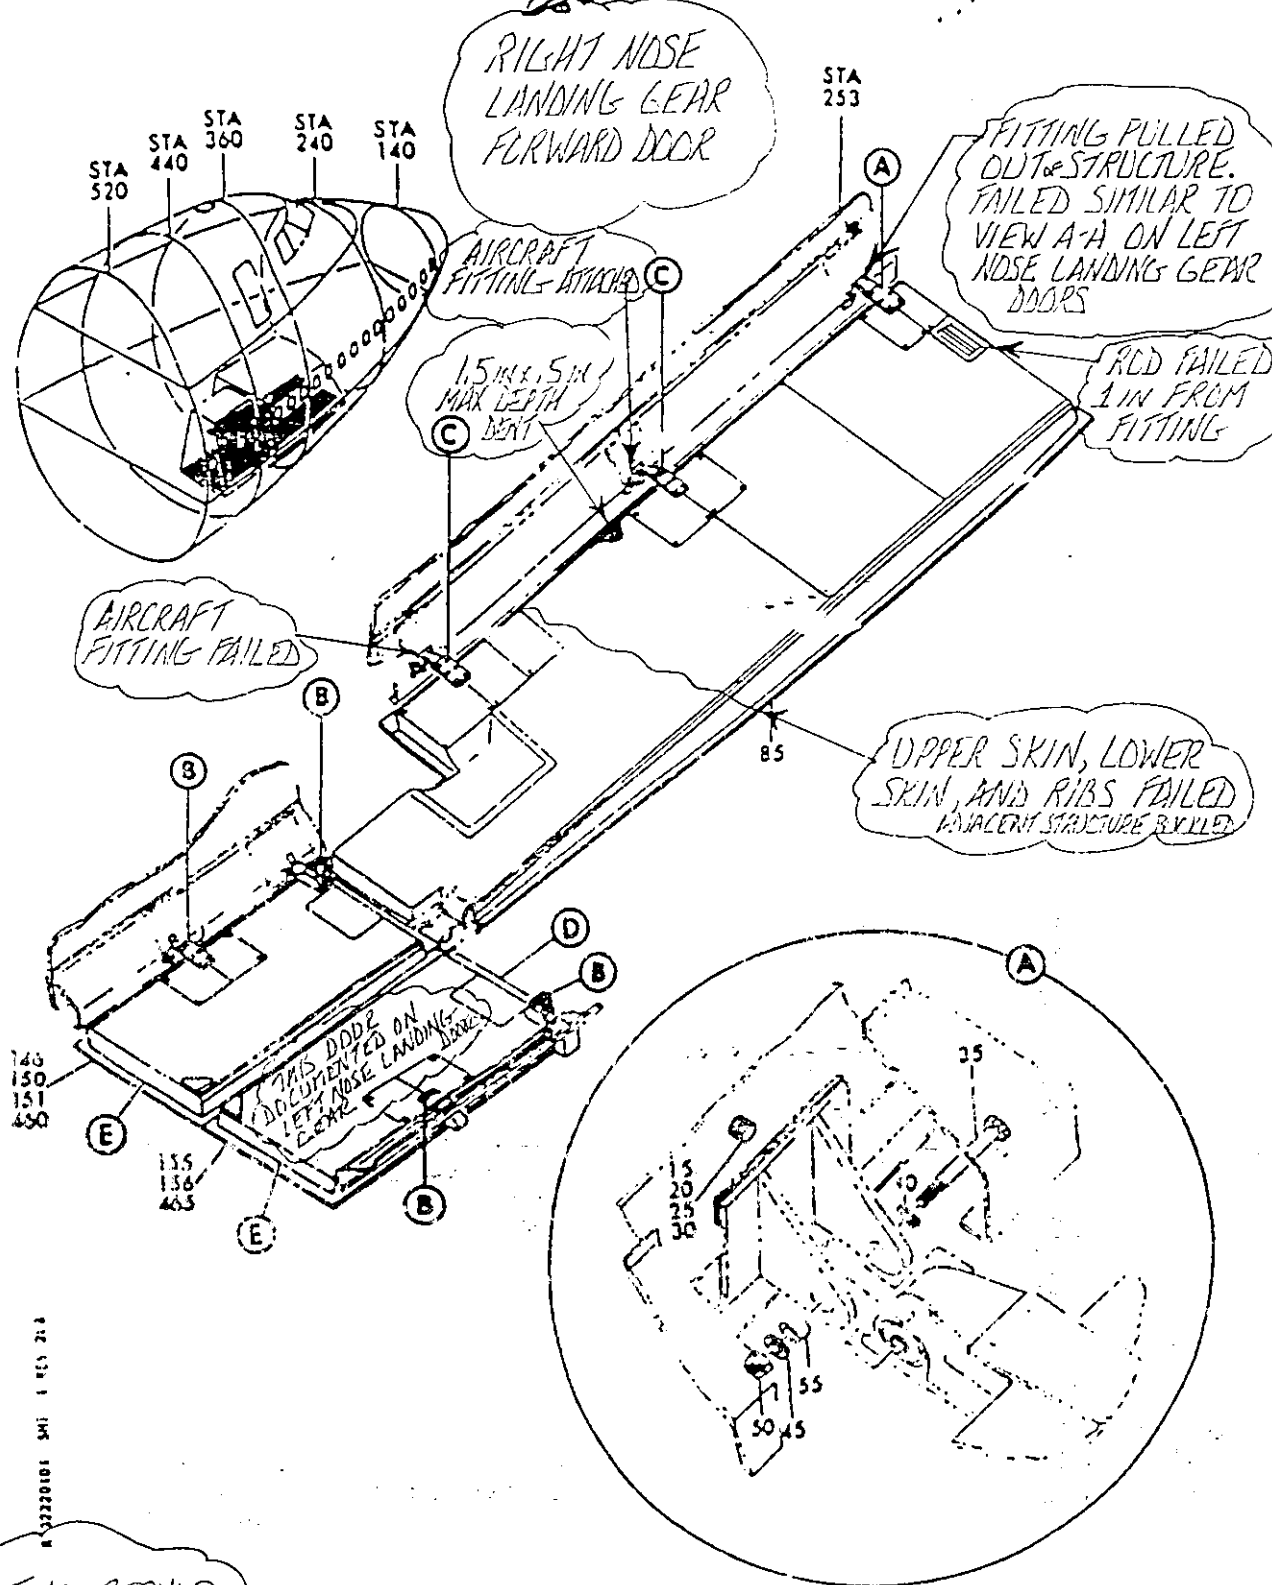
DOOR INSTL-NOSE WHL WELL FWD AND AFT
FIGURE 1 (SHEET 1)

Left Forward Door (A755)

Forward and aft hinges pulled out of door structure.
Middle hinge is attached to fuselage hinge fitting.
Outer skin has smooth denting between ribs.
Structure has minor surfaces abrasions. No visible indication of soot.

Left Aft Door (Yellow, B2075)

This door is severely crumpled.
Forward hinge is attached to fuselage frame.
Aft hinge not attached to door assembly.
Aft segment of door is not attached. Aft segment of door is not identified.

Right Forward Door (forward segment A209, aft segment A152)

Forward and Aft segments are separated. Inner skin, outer skin, and internal structure failed approximately sixty-two inches aft.
Forward hinge tore out of door structure.
Middle and aft hinge locations have fuselage hinge fittings attached.
Rod failed one inch from door fitting.
Structure has minor surface abrasions. No visible indications of soot.

Right Aft Door (A070)

Outboard edge bent upward .75 inch at leading edge running aft to middle hinge location.
Forward hinge attached but failed.
Rod assembly attached.
Two cannon plugs attached with wires sheared.

Structure has minor surface abrasions. No visible indications of soot.
