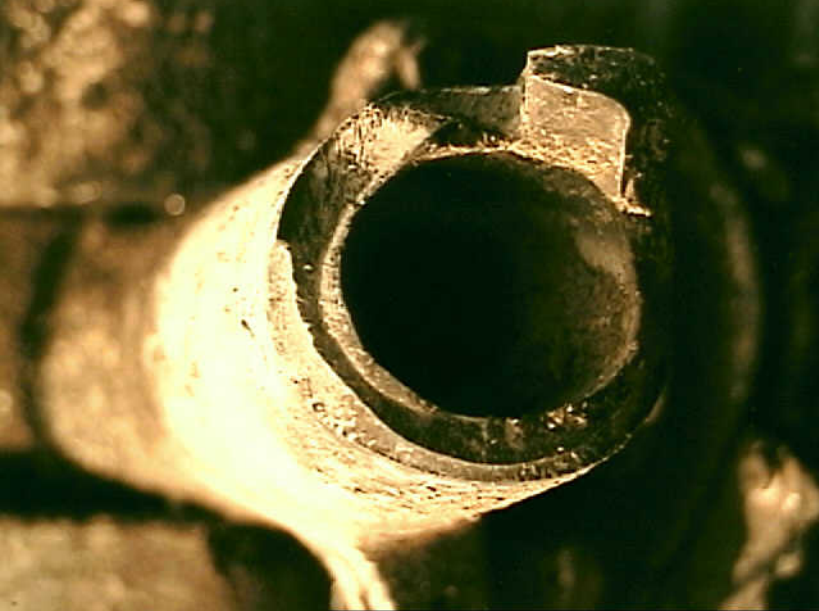
Structures 7 - Photo 12. Close-up view of the fixed brace fracture face
