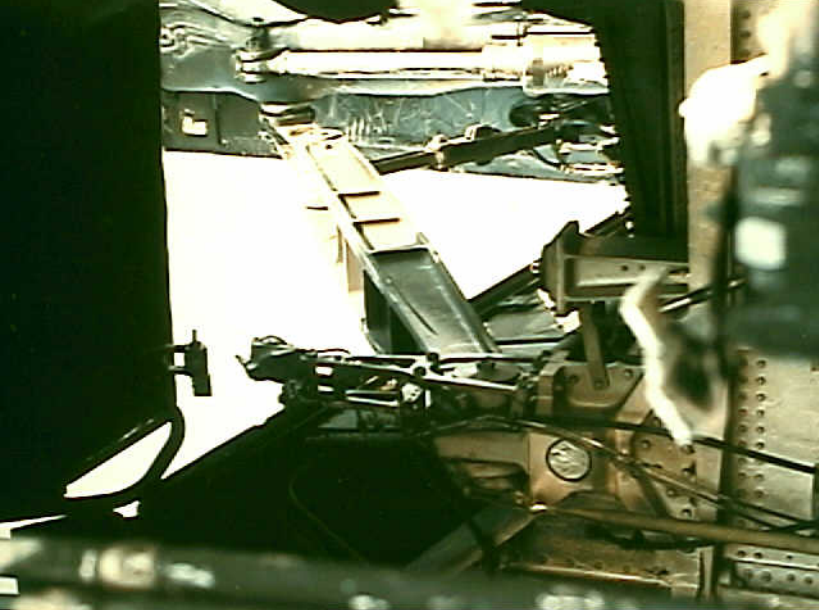
Structures 7 - Photo 18. View of the intact left landing gear pillow block and trapezoidal panel
