Log Nbr: R-1

DEBRIS FIELD BLUE

TAG Nbr: E2032

RUDDER

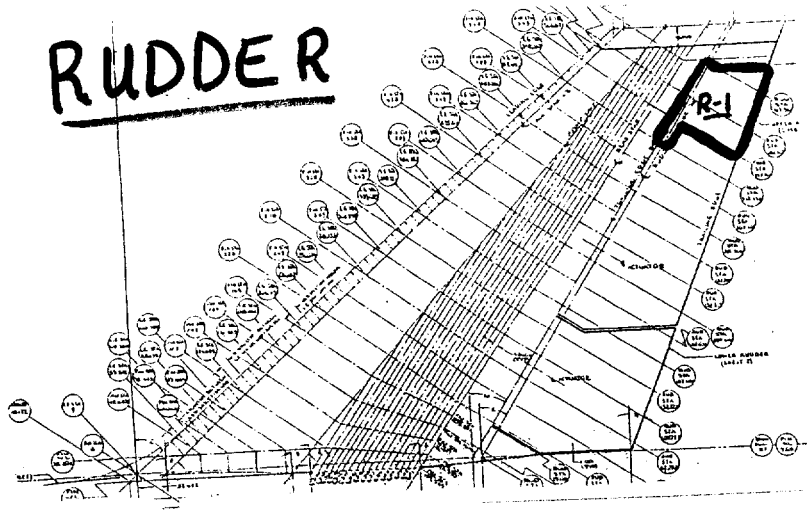
R-1 IS A SECTION OF UPPER RUDDER FROM RUDDER STA. 332 AND ABOVE, LEADING EDGE TO TRAILING EDGE, MEASURING 6' X 7' APPROX. THE BEAM WEB THAT SUPPORTS THE HINGE IS TORN AND TWISTED BELOW THE HINGE POINT, STA 382, THE HINGE HAS THE CONNECTION BOLT STILL ATTACHED. ALL COUNTERWEIGHTS MISSING AND SUPPORTING STRUCTURE DAMAGED. LOWER RIGHT SIDE TRAILING EDGE WEDGE HAS A 15" X 3" (APPROX.) SECTION OF SKIN MISSING. OUTER SKINS HAVE SOME PUNCTURES AND MINOR SURFACE ABRASIONS. LEADING EDGE SEAL SHROUD BELOW HINGE HAS IMPACT DAMAGE. LEADING EDGE AT STATION 332 MATES WITH R-2.

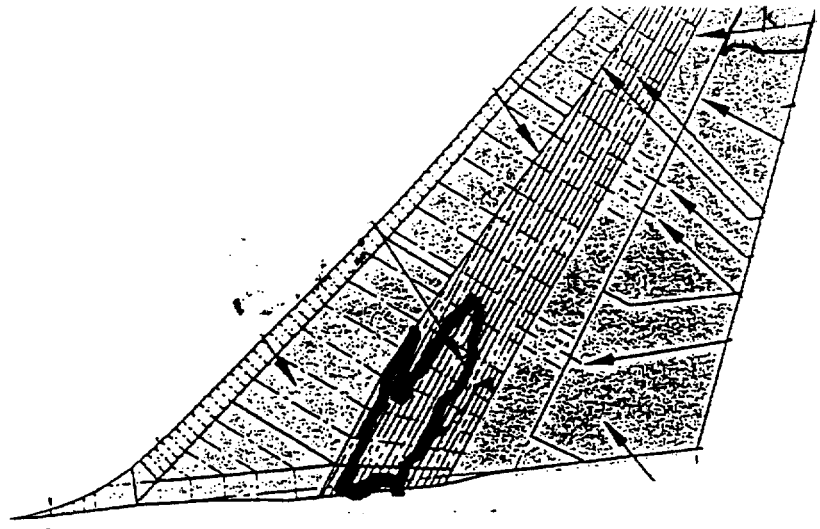
BLUE TAG E 2032

Floating Piece

R I - upper Rudder section MEASURES
Approximately 6' x 7'

ENcompasses Rudder Station 417.50 STA 387.365 &
STA 357.401

~~Trailing Edge~~ Beam is Torn & Twisted below STA 382
Hinge point that has a Bolt still attached
~~Condition of outer surface on Lft & Rht side
in fair condition~~

ALL COUNTERWEIGHTS MISSING AND SUPPORTING STRUCTURE DAMAGED
