RH UPPER SKIN SEGMENT - WS1260 to
WS1290, S-7 to S-12

RW39

Lot No: 1-24-97-6

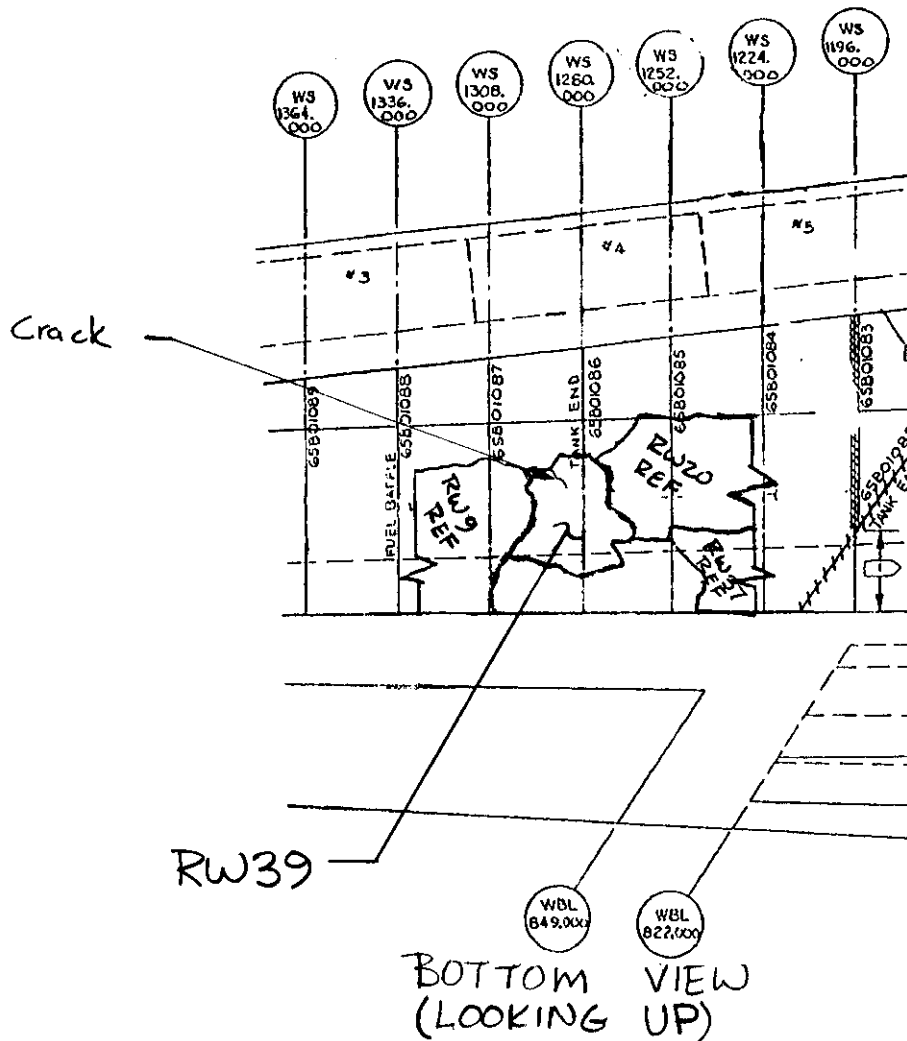
This segment of upper skin extends from approx WS1260 to WS1290 and encompasses S-7 to S-12

Part is relatively flat with some slight out of contour bends
Seoting was not detected on any surface.

Fracture surfaces show signs of salt water corrosion.

Fuel tank primer was gone from fwd inbd portion of segment.

A four inch crack was observed on the fwd outb area.

No pre-existing damage was observed.

Segment edges had areas with delamination fractures.
