**NATIONAL TRANSPORTATION SAFETY BOARD**  
Office of Railroad, Pipeline, and Hazardous Materials Investigations  
Washington, D.C. 20594

## Survival Factors

### Factual Report of the Investigation<sup>1</sup>

Location: Minneapolis, Minnesota  
Date: August 2, 2017  
Time (approximate): 10:22 a.m. CDT<sup>2</sup>  
Event Description: Natural gas explosion at an educational facility  
Accident site: North Campus of the Minnehaha Academy,  
3100 West River Road, Minneapolis, Minnesota  
NTSB Accident Number: DCA17MP007

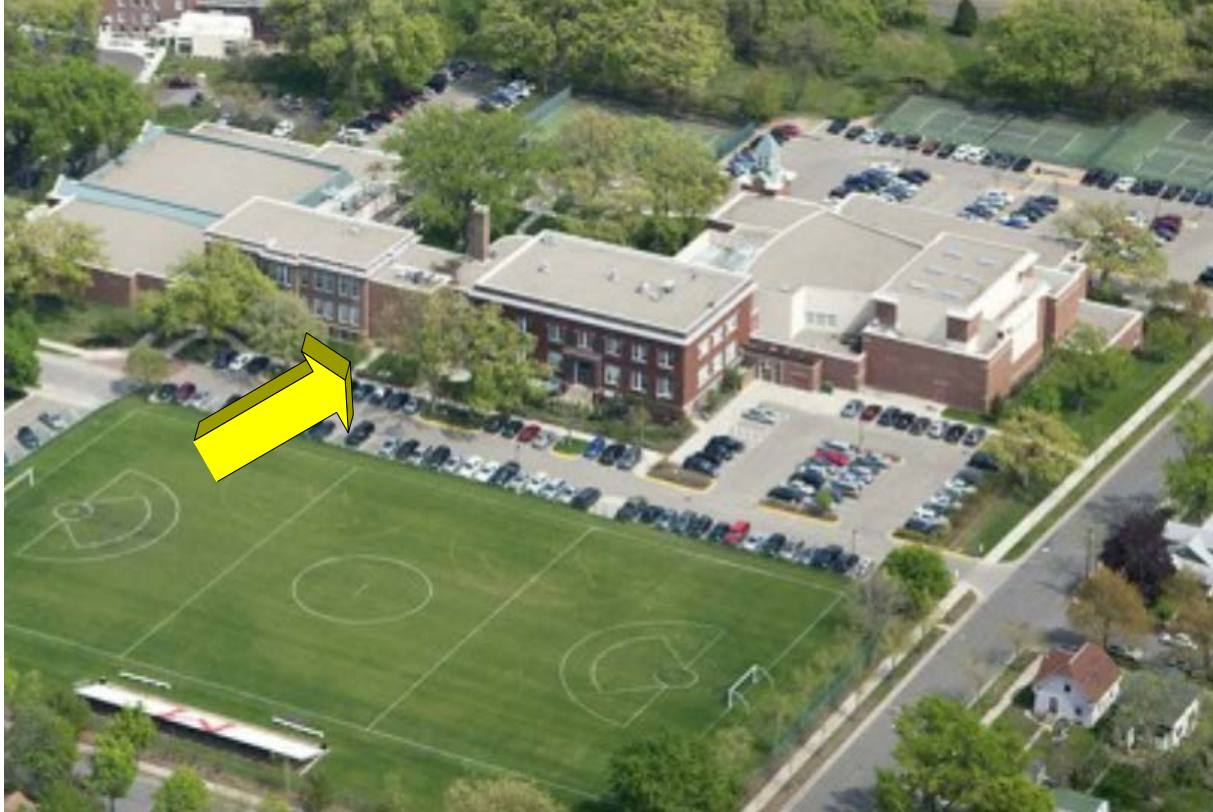
Figure 1. Aerial view, prior to the accident, of the North Campus of the Minnehaha Academy; yellow arrow indicates the area of the explosion. (Photo courtesy of minnehahaacademy.net)

508 Text: Aerial view of Minnehaha Academy, prior to the accident, which shows the campus (red brick buildings, athletic fields, and vehicles parked in the nearby parking lots); a yellow arrow indicates area of explosion.

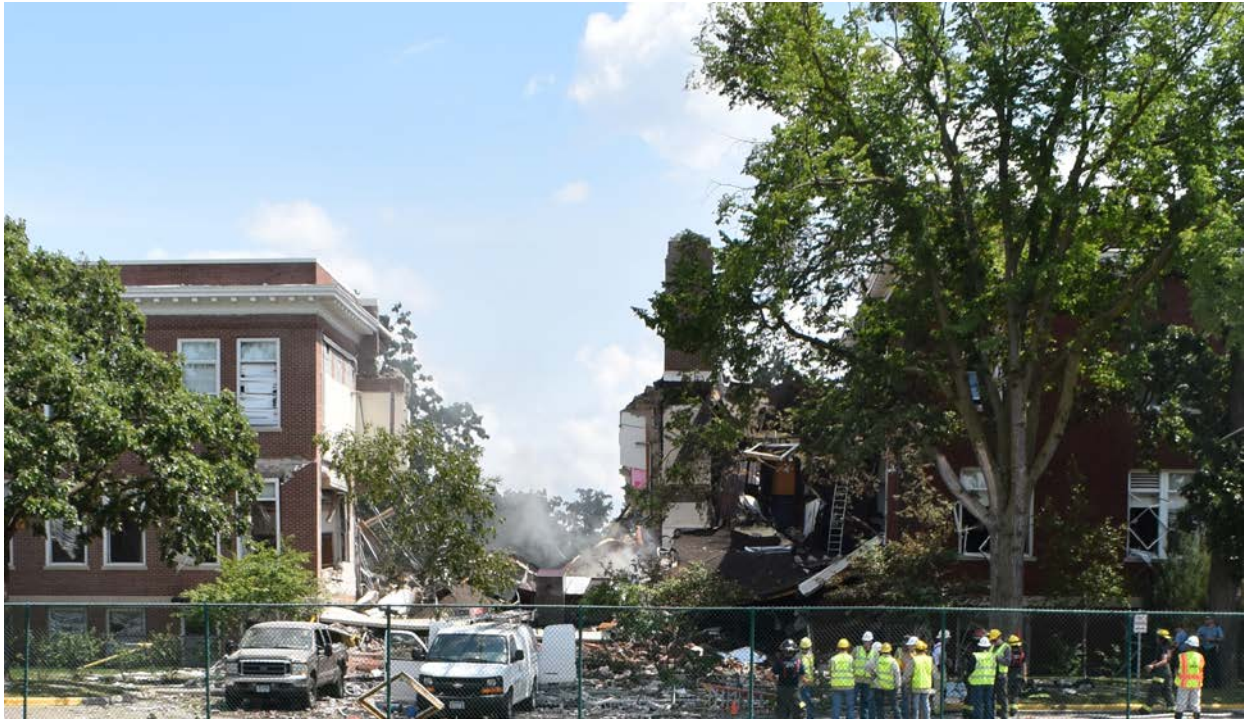
Figure 2. Photo of the accident site taken after the building explosion with several gas company personnel and emergency responders on-scene. Source: Minneapolis Fire Department.

508 Text: Photo shows the destroyed building with debris scattered over the area in front of the structure, with several gas company personnel and emergency responders on-scene.

The ‘center section’ structure was completely destroyed by the explosion. The two floors above the basement of the ‘center section’ structure collapsed, with the debris dropping into the void of the basement, which ignited and burned as a result of the explosion. The (integrally attached) structures adjacent to the ‘center section’ structure, consisting of the southern one-third segment of the North building, and the north end of the South building, each sustained extensive damage as a result of the explosion, in which the structural shell of each building remained standing. The explosion resulted in material of the structure, and some of its contents, to have been forcibly expelled in an outward direction from the structure, which resulted in a debris field in front of the structure.

A pre-recovery examination of the debris field evidence supported that the explosion appeared to have occurred in the basement of the ‘center section’ structure of the building.<sup>4</sup>
