NATIONAL TRANSPORTATION SAFETY BOARD

Survival Factors Specialist's Factual Report

DCA15MA029

Operator: Sage Aviation LLC.
Location: Gaithersburg, Maryland
Date: December 8, 2014
Time: 1041 EST
Airplane: Embraer EMB-500 Phenom 100, N100EQ

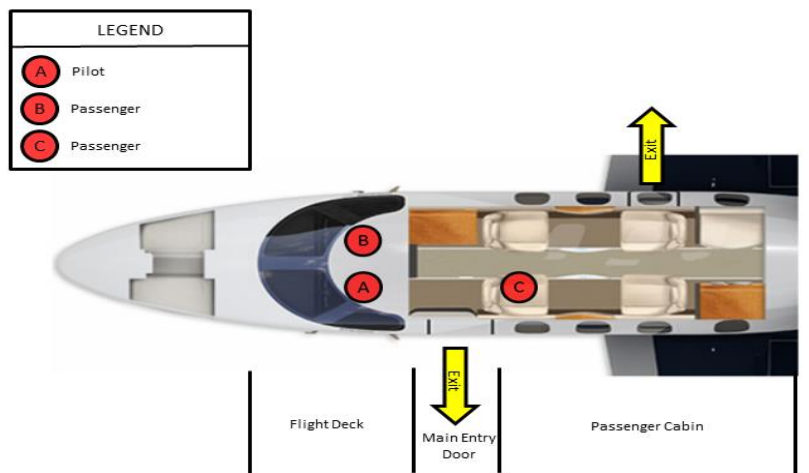
The pilot was seated in the left cockpit seat and the passengers were seated in the right cockpit seat and the aft facing left side cabin seat (figure 1). The cockpit portion of the airplane wreckage came to rest inverted, with extreme impact damage, and the interior cabin fuselage was heavily damaged by fire (photograph 1).

Figure 1- Occupant seat location.

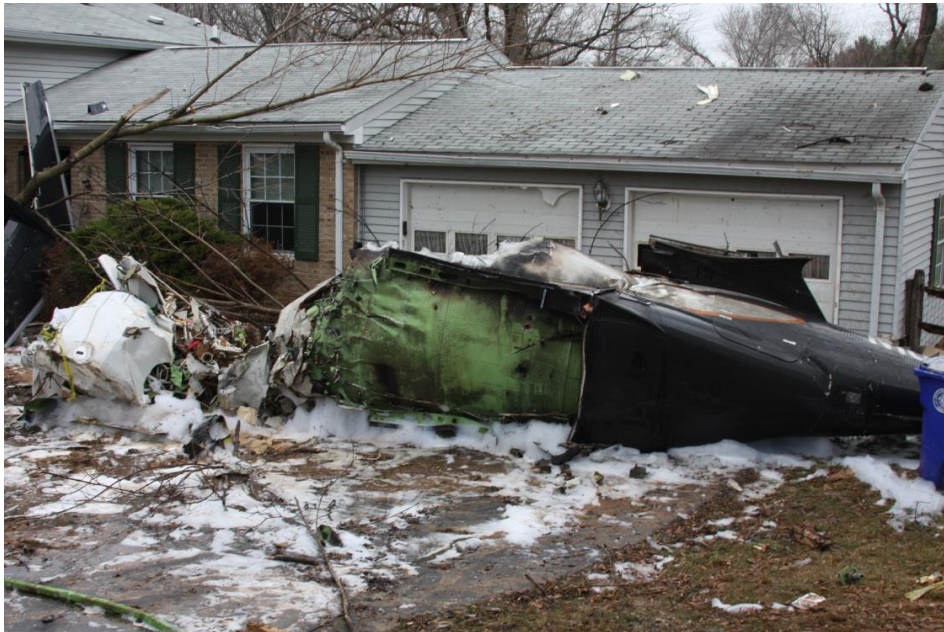
Photograph 1- Location of the fuselage.

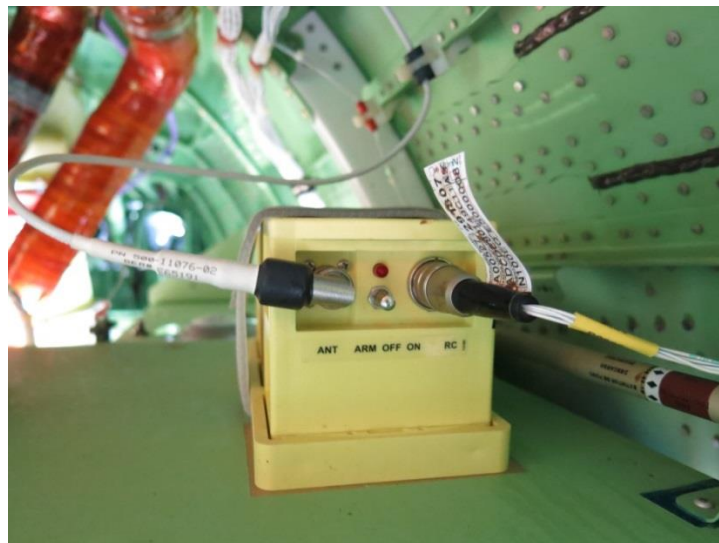
The ELT was identified as a Kannad 406AF (Photograph 2). The NTSB Structures Chairman noted the ELT was still operating and found the ELT with the switch in the 'ARM' position. The ELT was secured to a side wall inside the cargo compartment with a Velcro strap. The antenna and cockpit remote switch cables were still securely affixed, connected, and secured with Velcro. The following information was obtained from the ELT:

Photograph 2- Secured ELT inside the cargo compartment.
