Comair, Inc.
Lexington, KY
August 27, 2006
DCA06MA064

**NATIONAL TRANSPORTATION SAFETY BOARD
WASHINGTON, D.C.**

ATTACHMENT 1

PHOTOGRAPHS

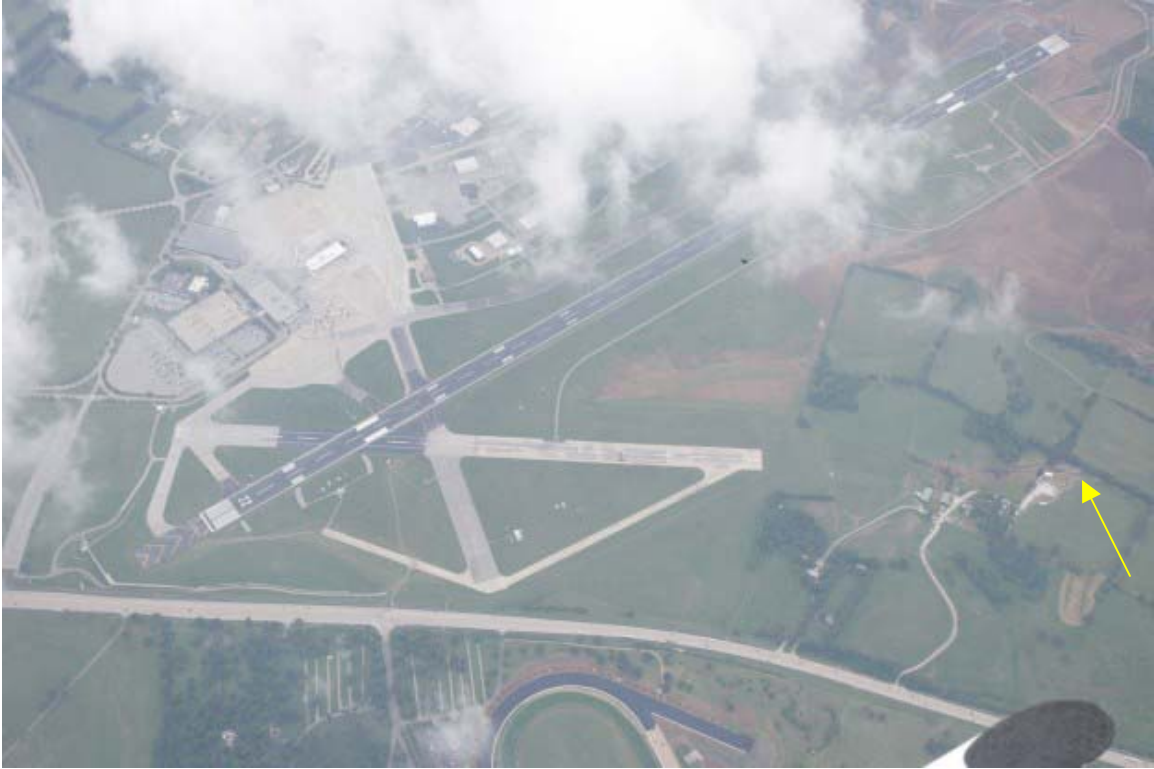
Photo 1. High altitude photograph of LEX and the crash site (Courtesy: Lexington PD)

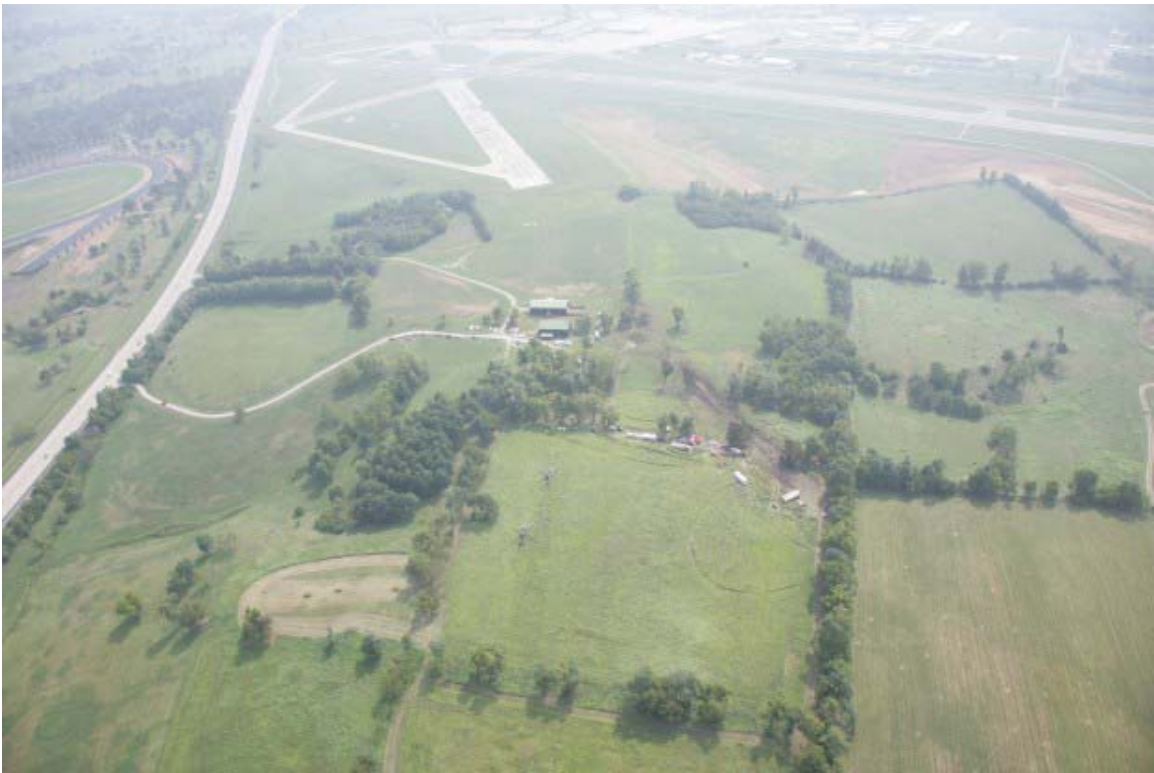
Photo 2. Aerial photograph of runway 8/26 and the crash site (Courtesy: Lexington PD)

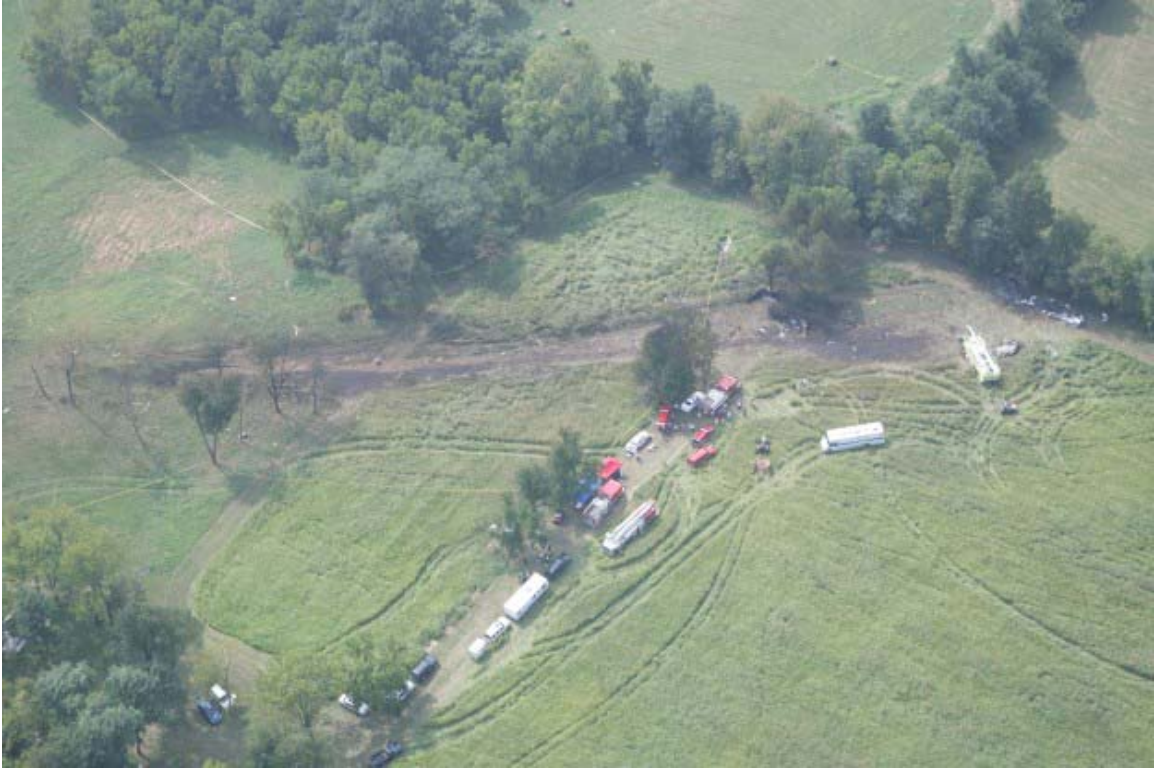
Photo 3. Aerial photograph of the crash site (Courtesy: Lexington PD)

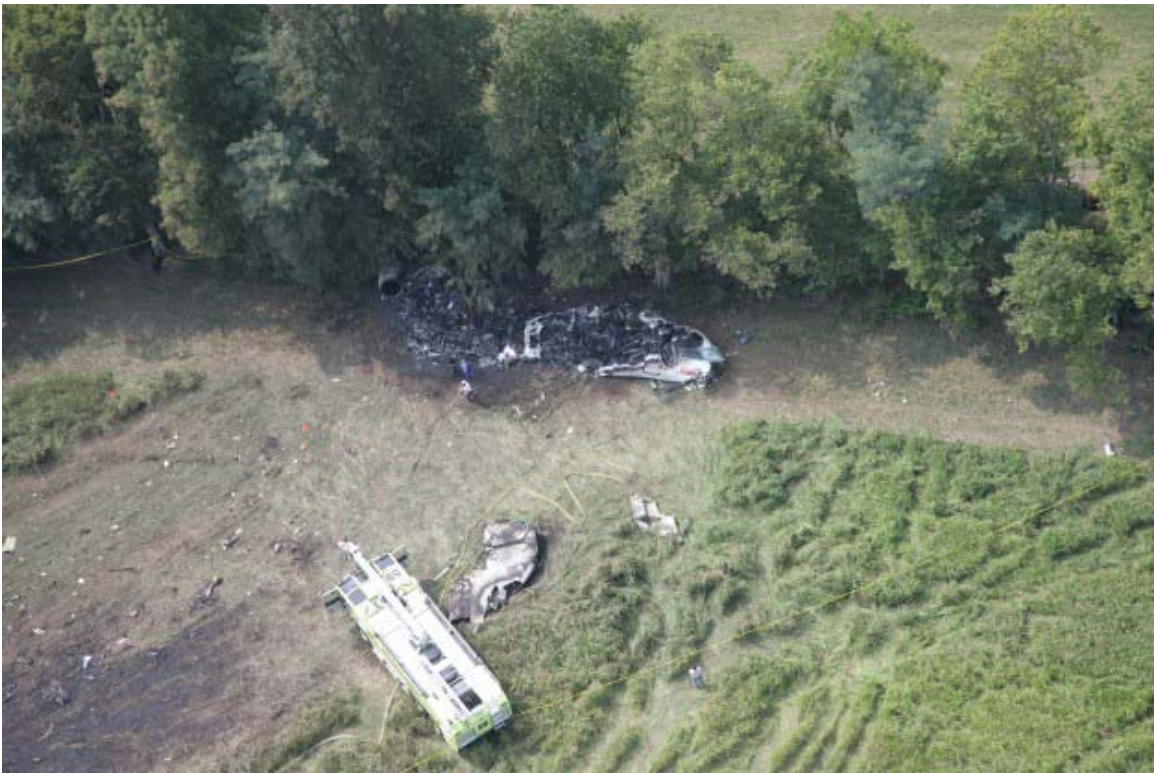
Photo 4. Aerial photograph of the crash site (Courtesy: Lexington PD)

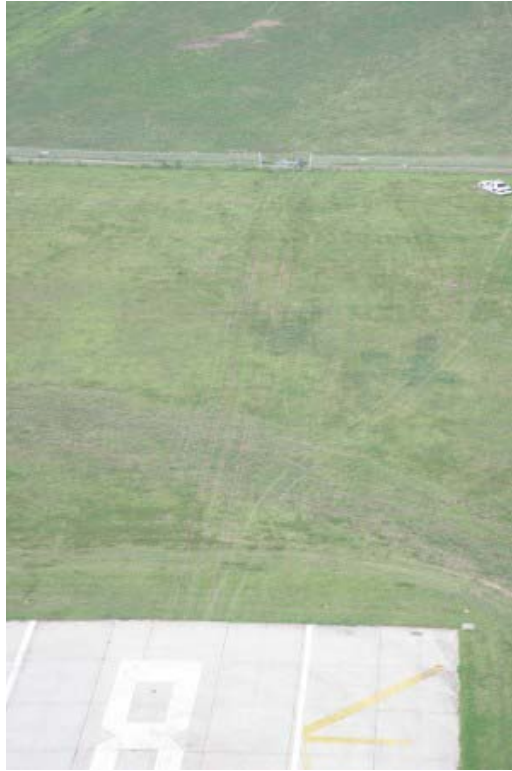
Photo 5. Aerial photo of the end of runway 26 and the damaged airport perimeter fence
(Courtesy: Lexington PD)

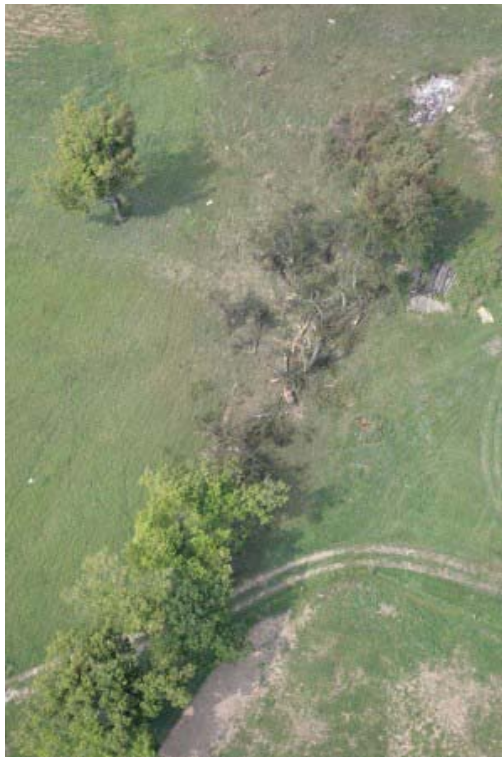
Photo 6. Area of initial tree strikes beyond airport perimeter fence
(Courtesy: Lexington PD)

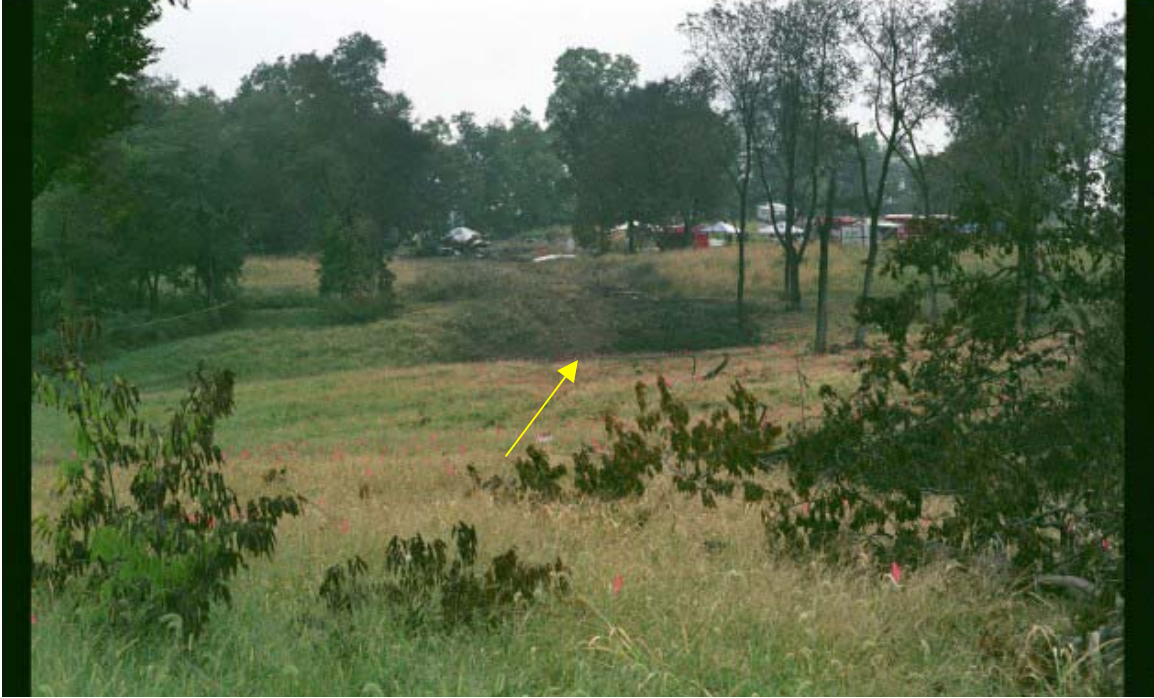
Photo 7. Area of initial impact with the ground (Courtesy: Lexington PD)

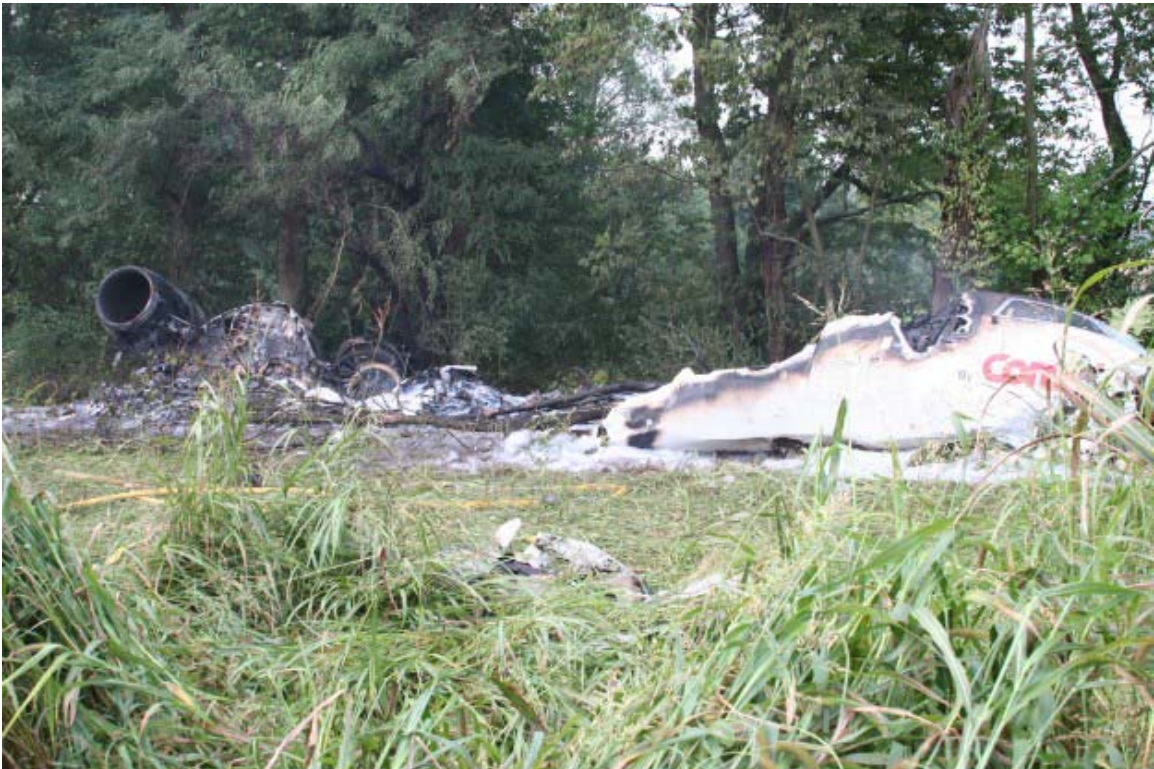
Photo 8. Main wreckage of N431CA (Courtesy: Lexington PD)

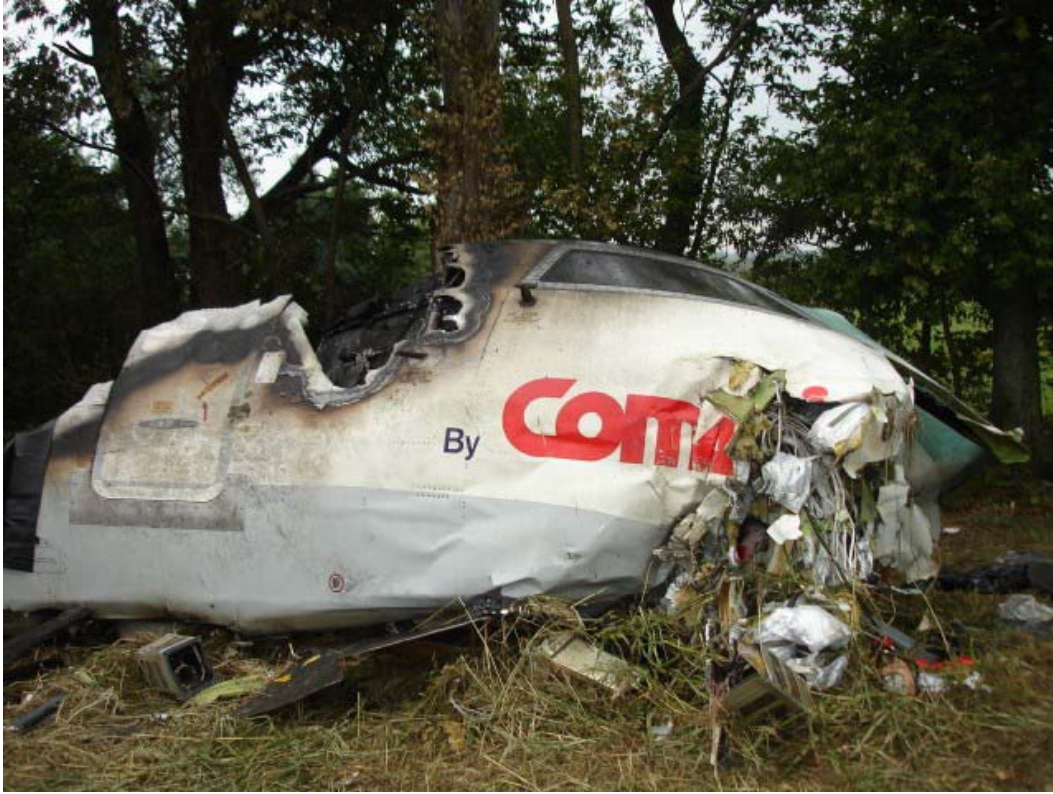
Photo 9. Service door and right side of the cockpit

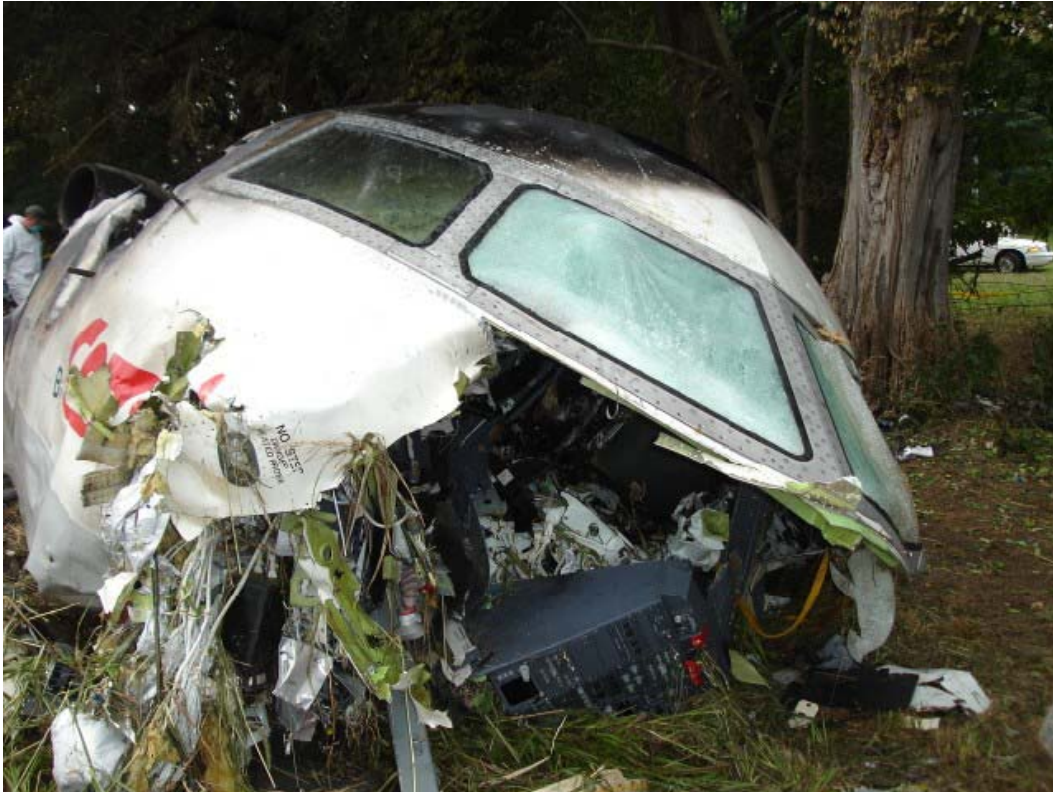
Photo 10. Cockpit damage

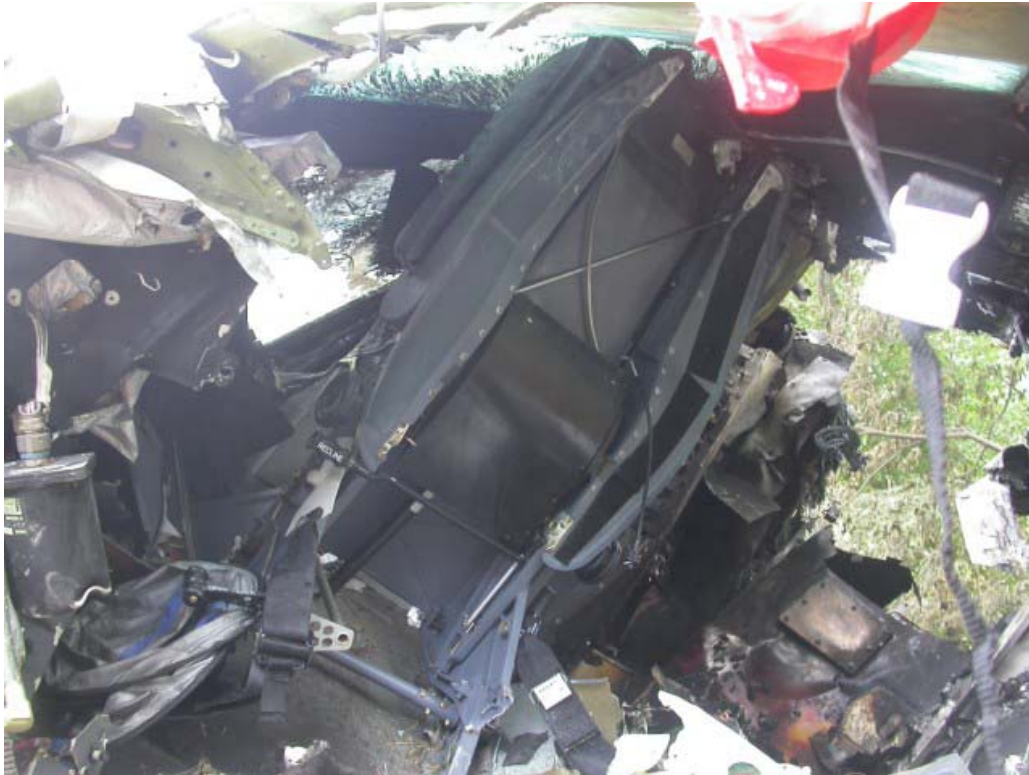
Photo 11. Portion of first officer's seat still attached to the cockpit floor structure

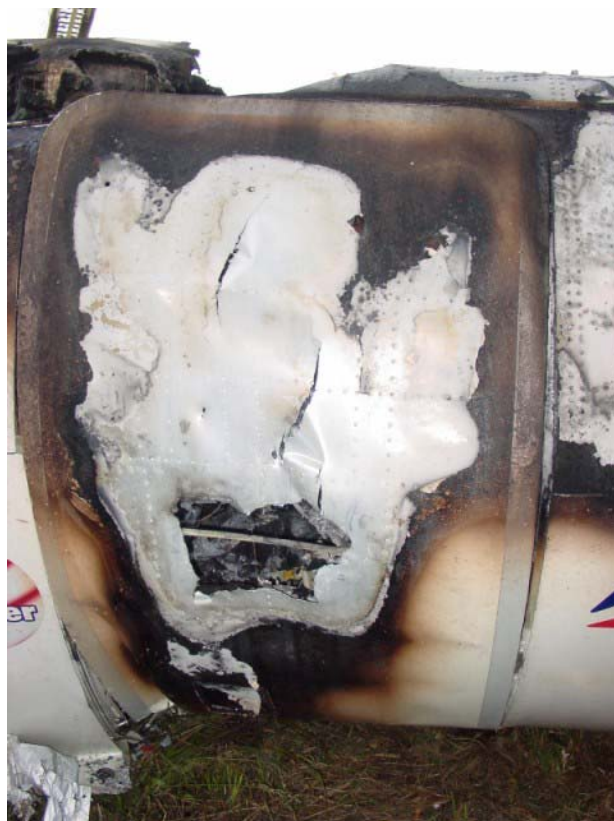
Photo 12. Main cabin door

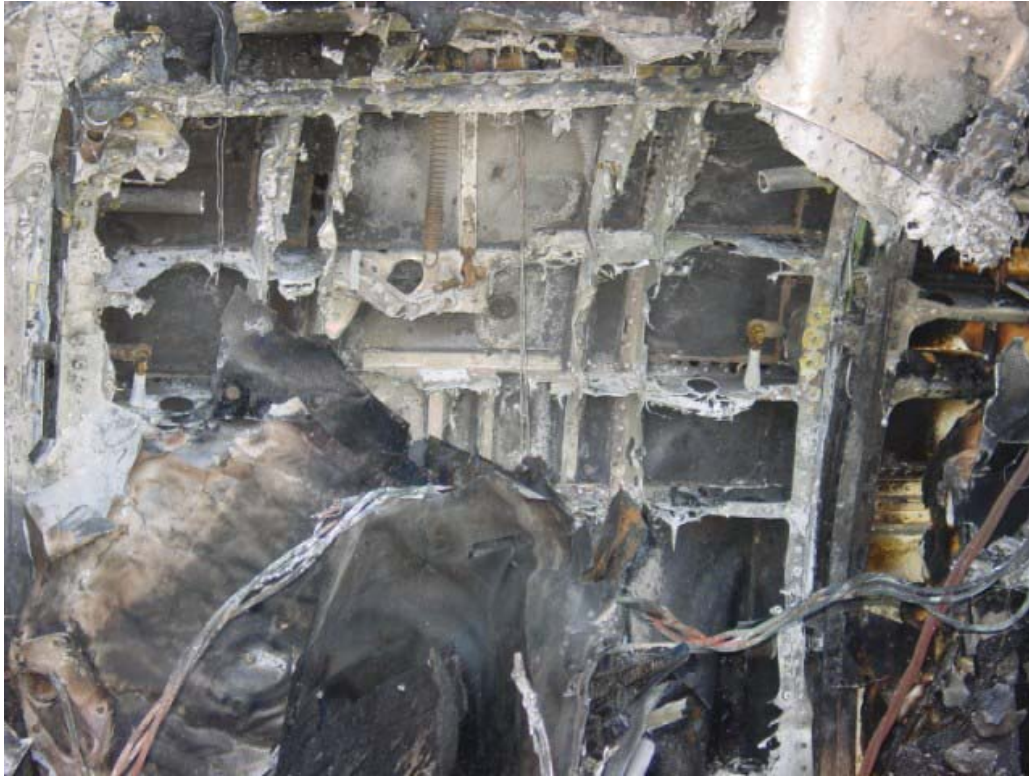
Photo 13. Interior of the main cabin door

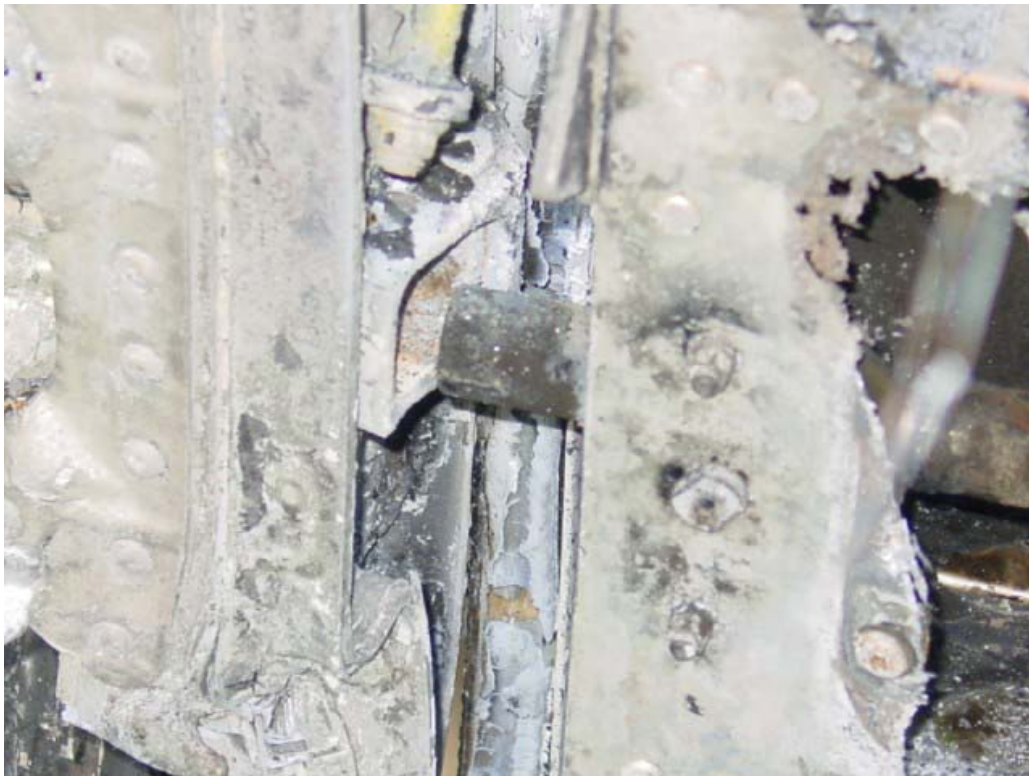
Photo 14. One of the main cabin door's extended aft lock pins

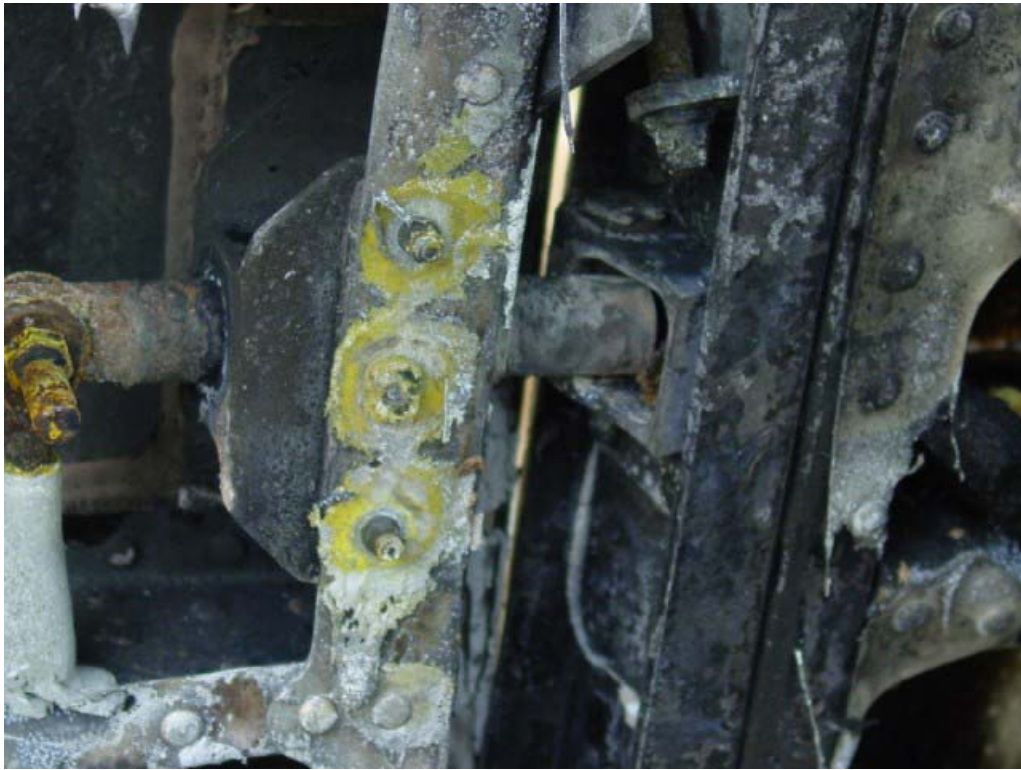
Photo 15. One of the main cabin door's extended forward lock pins

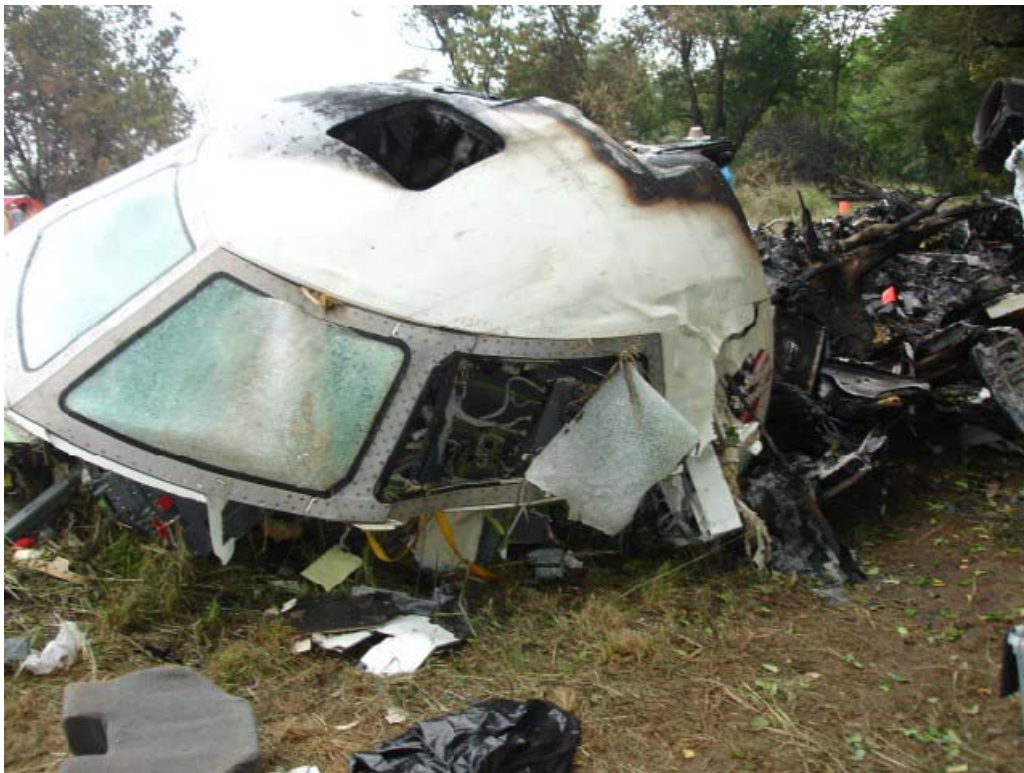
Photo 16. Cockpit damage and left side of the fuselage
(note: main cabin door has been removed)

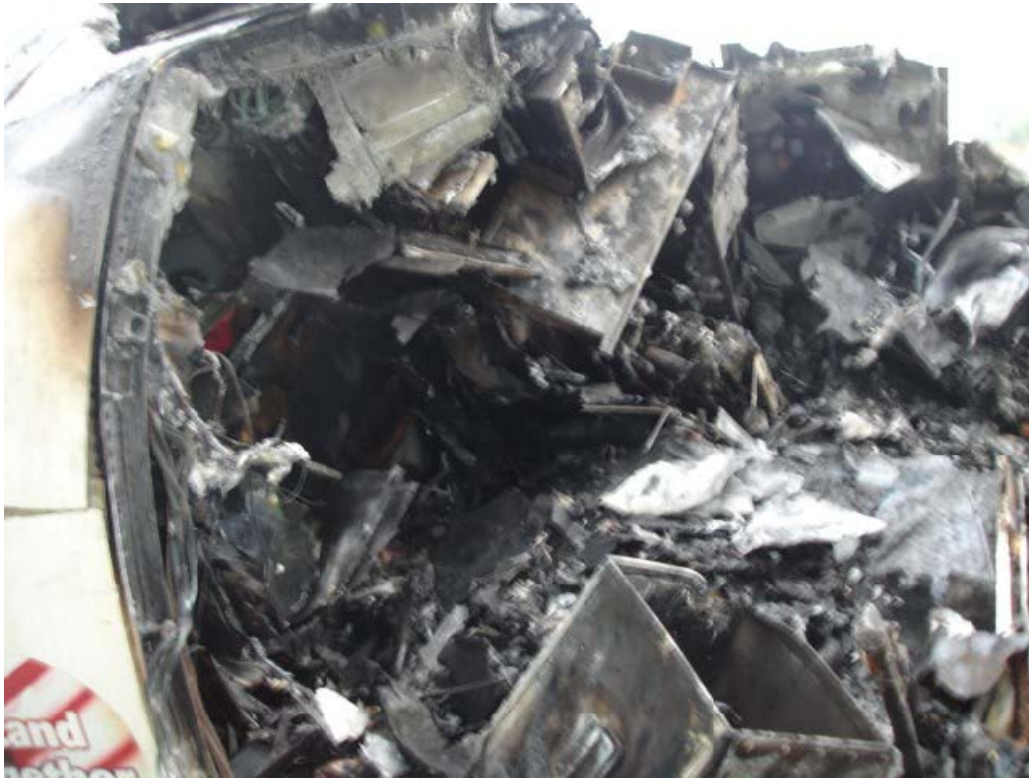
Photo 17. View of the forward galley area (taken from main cabin door)

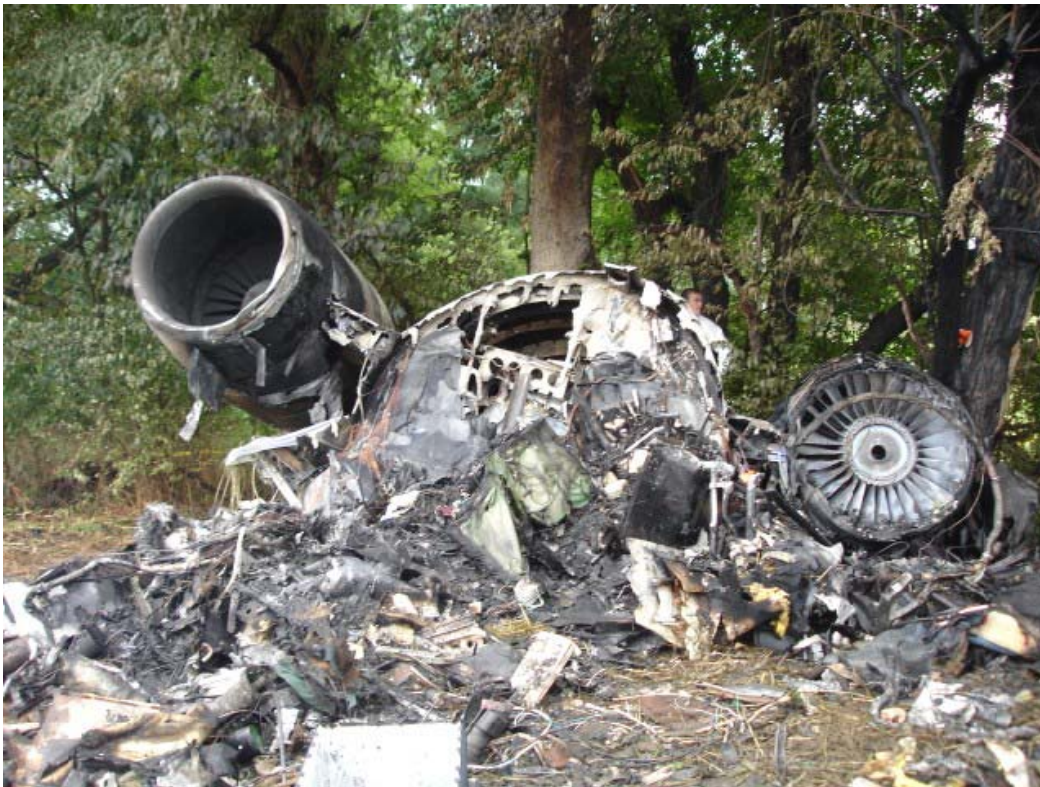
Photo 18. Aft section of cabin fuselage

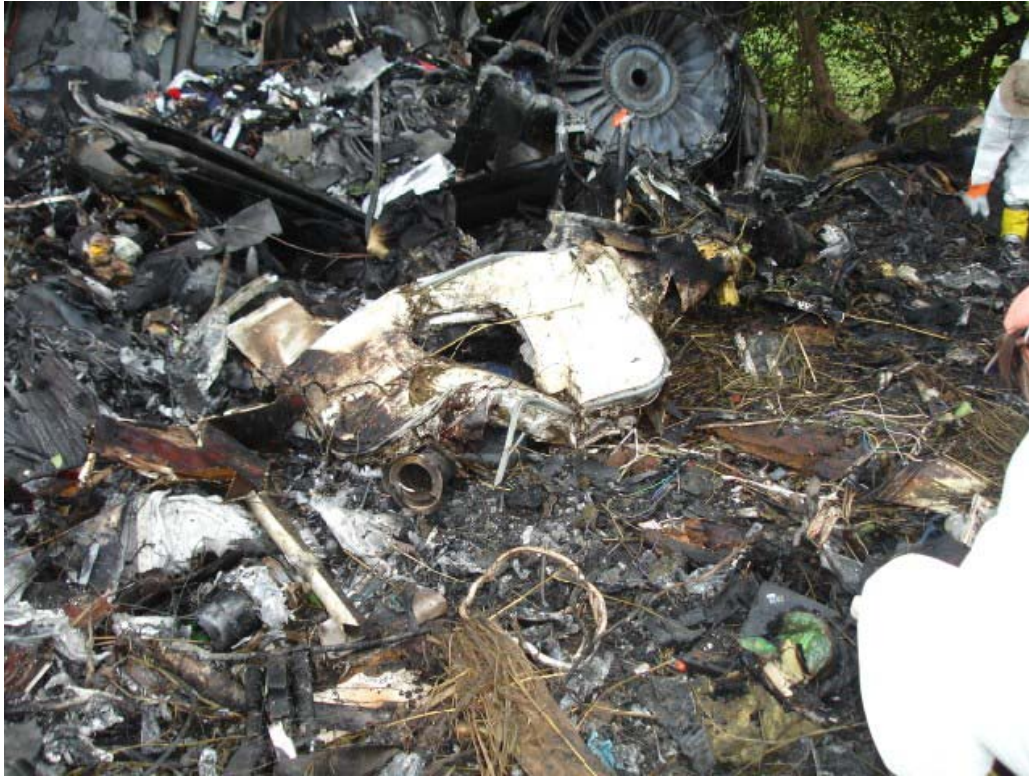
Photo 19. The left-side overwing exit

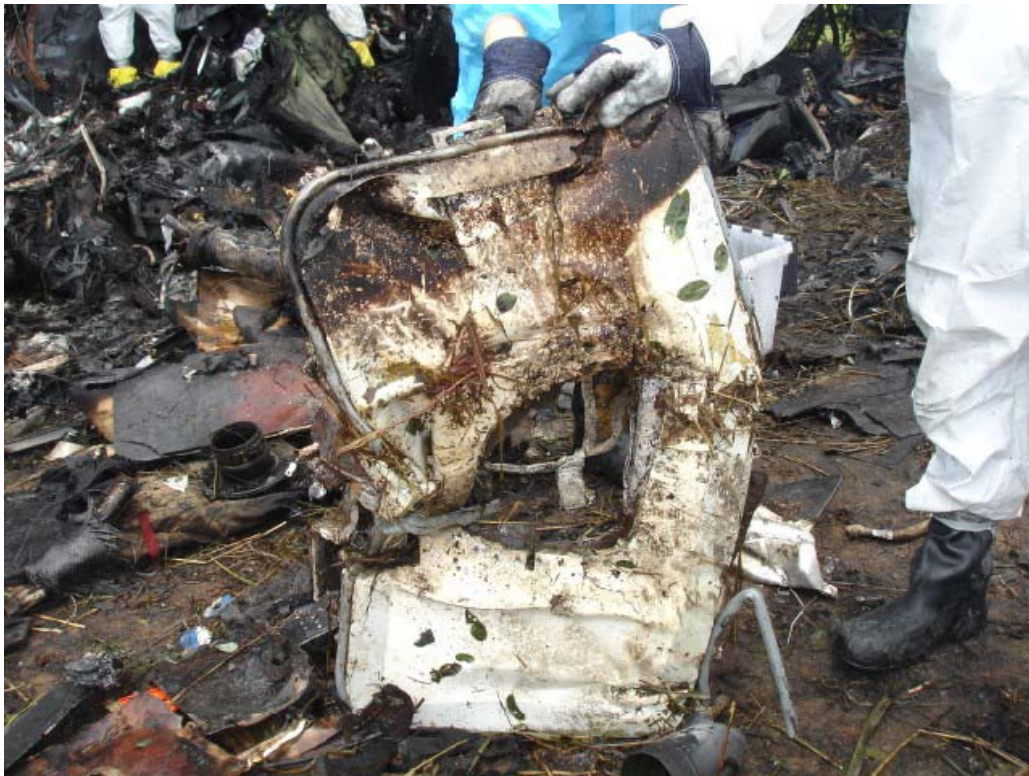
Photo 20. The exterior of the left-side overwing exit

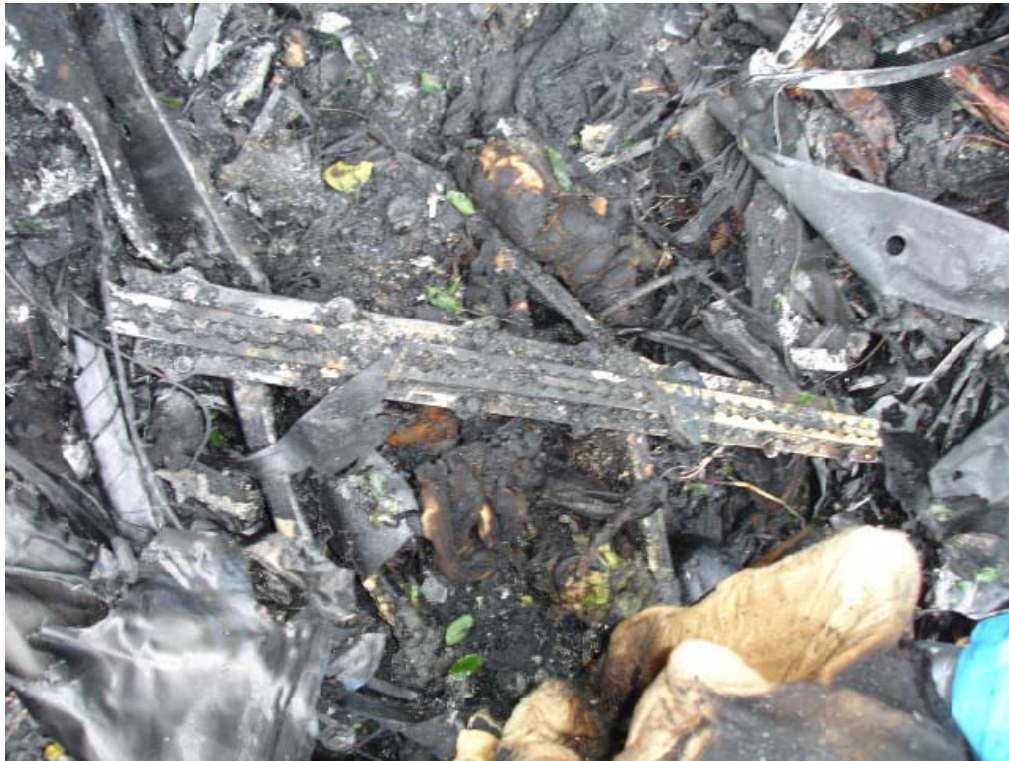
Photo 21. A section of fractured floor track

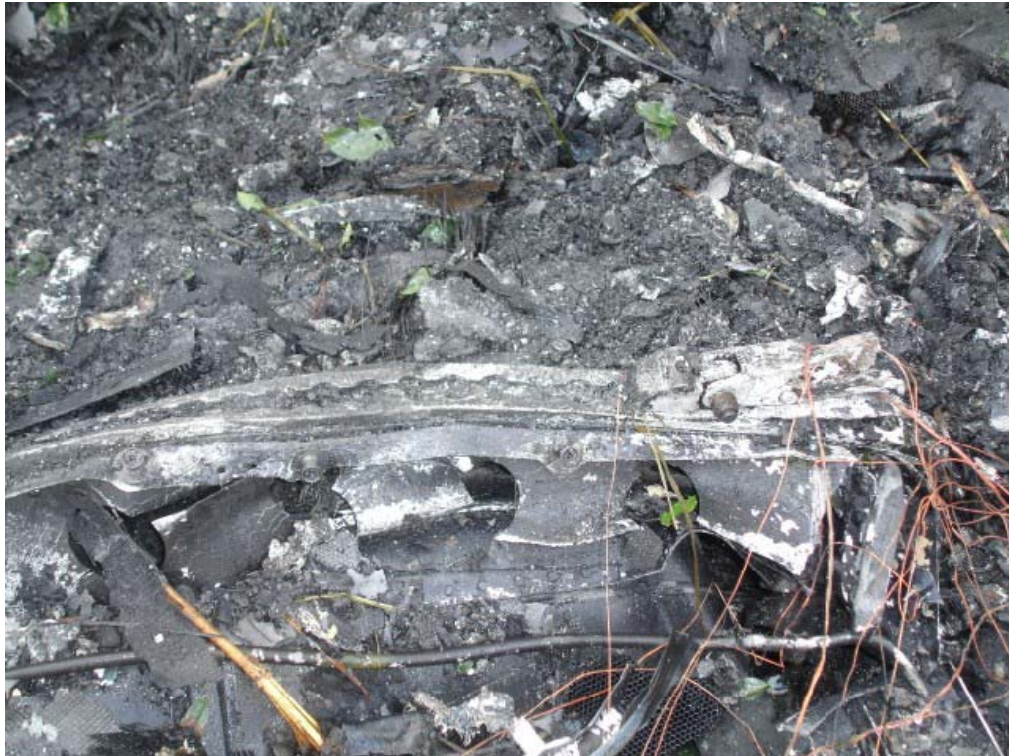
Photo 22. A section of floor track with a fractured aft seat attachment fitting

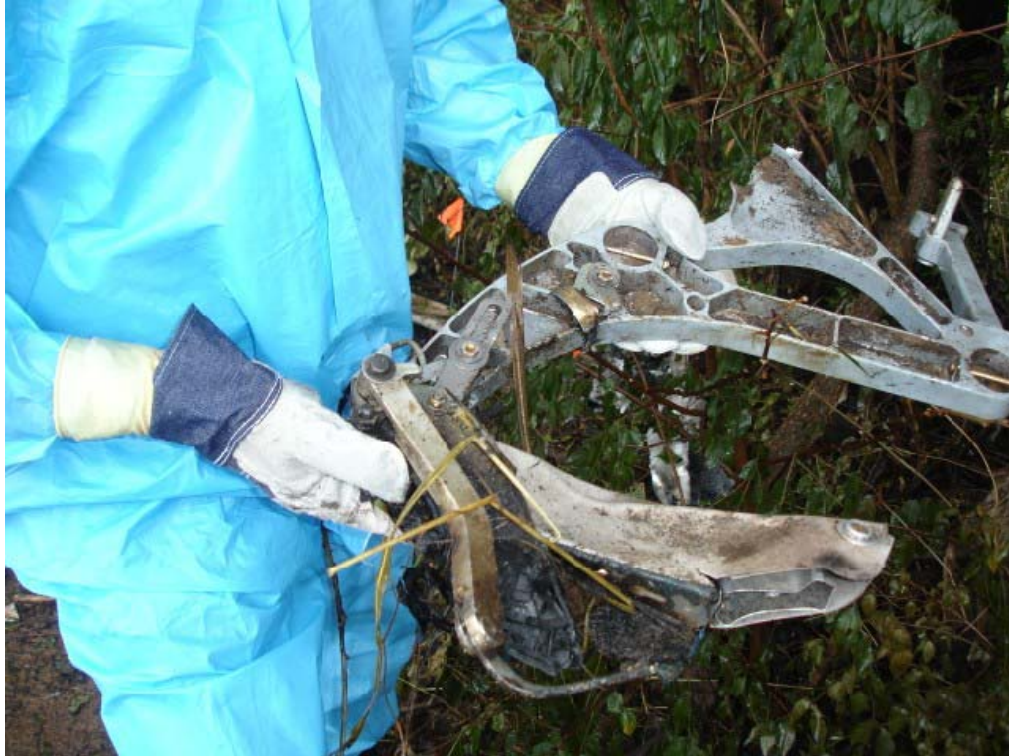
Photo 23. A seat armrest and fractured seat leg

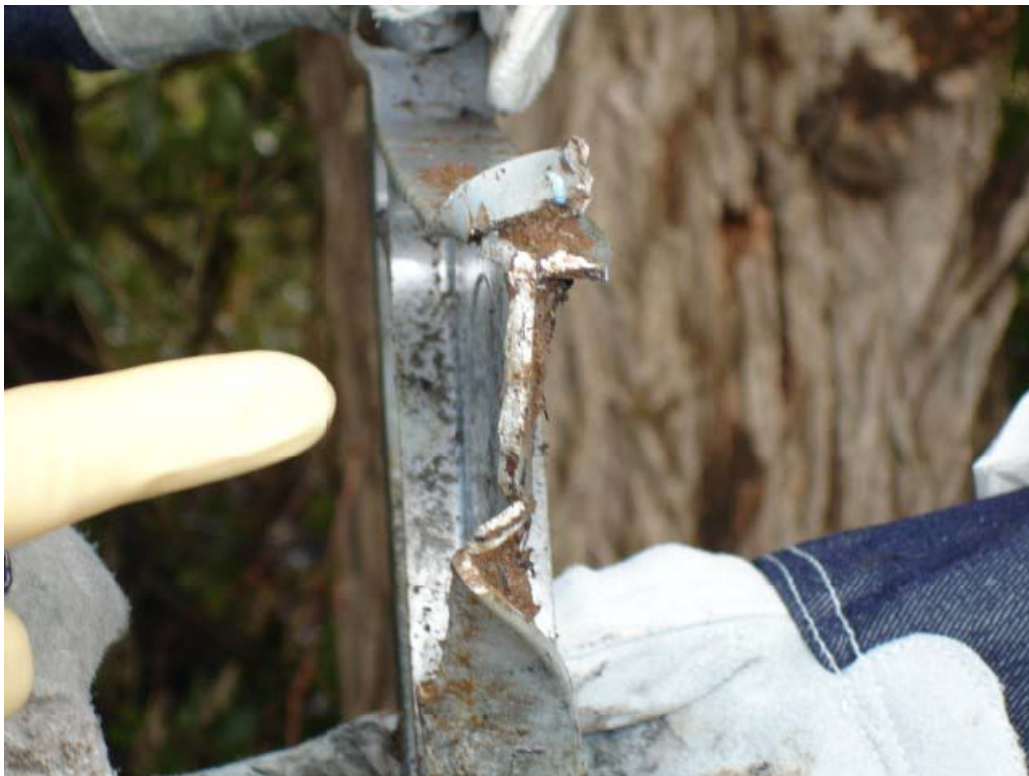
Photo 24. The fracture surface of the seat leg seen in photo 23

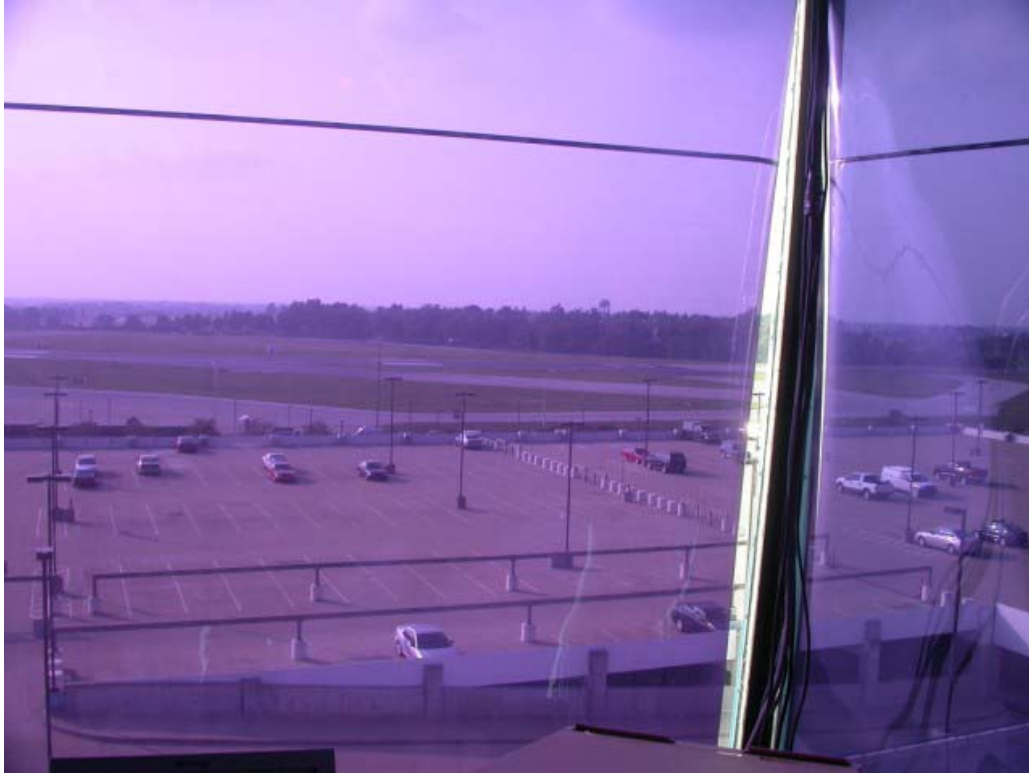
Photo 25. View from the ATCT of the runway 8/26 intersection with old T/Ws A and A5

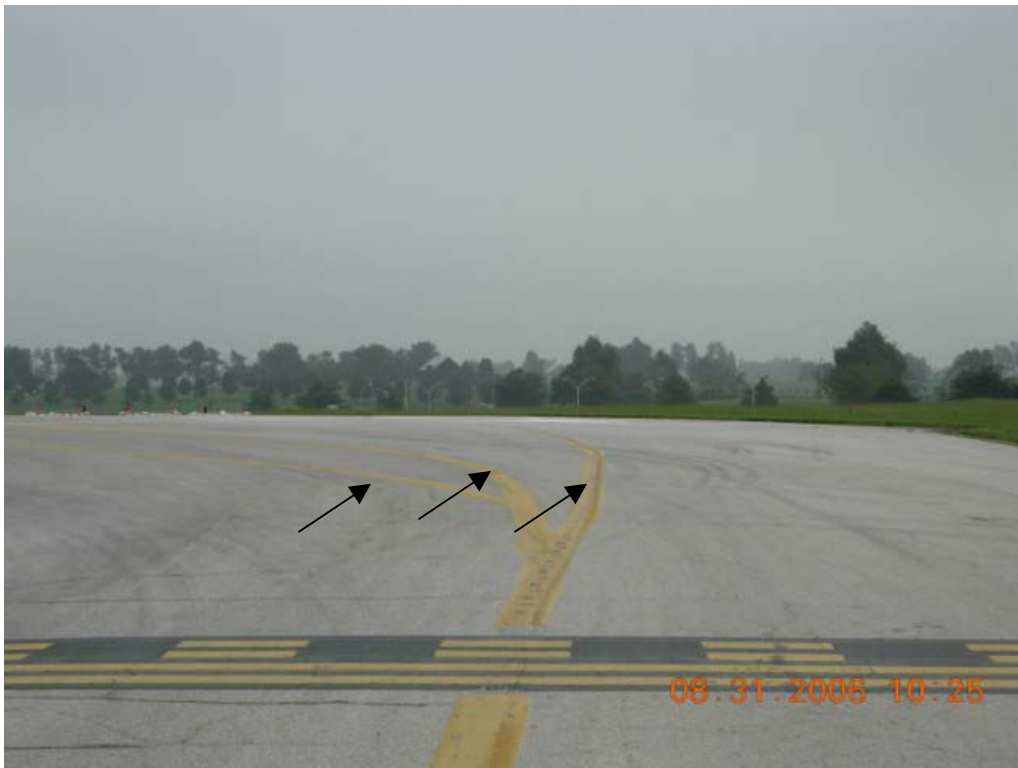
Photo 26. View from T/W A of the hold short position for runway 26

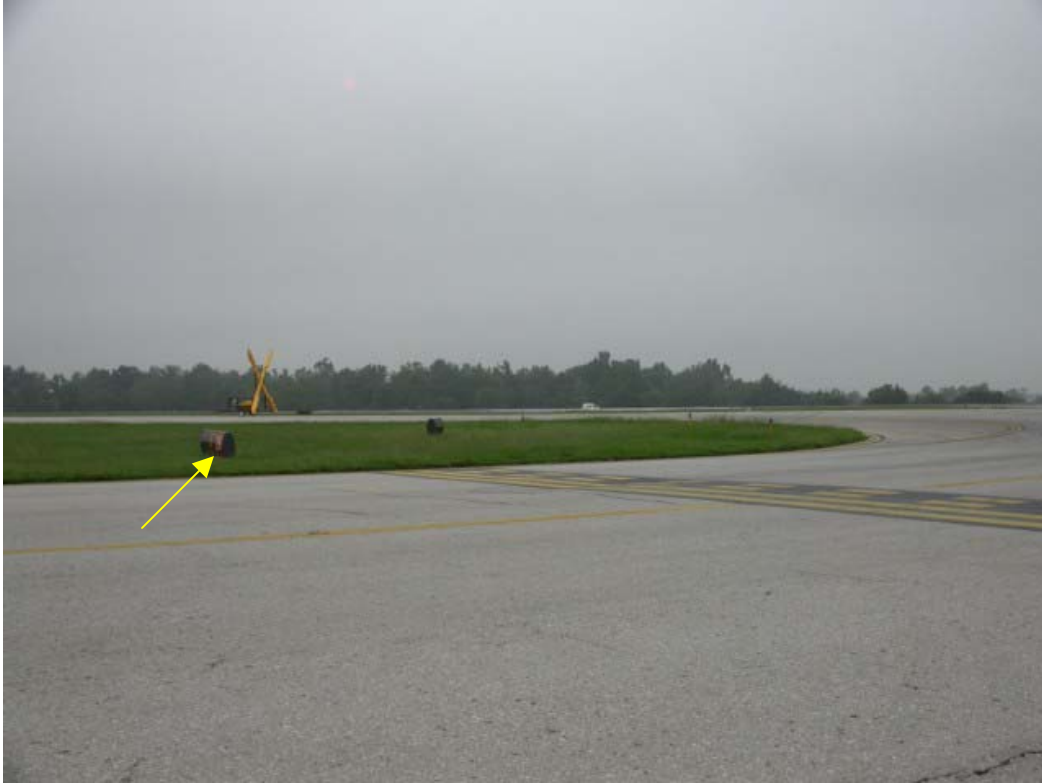
Photo 27. Location of T/W A holding position sign for runway 26

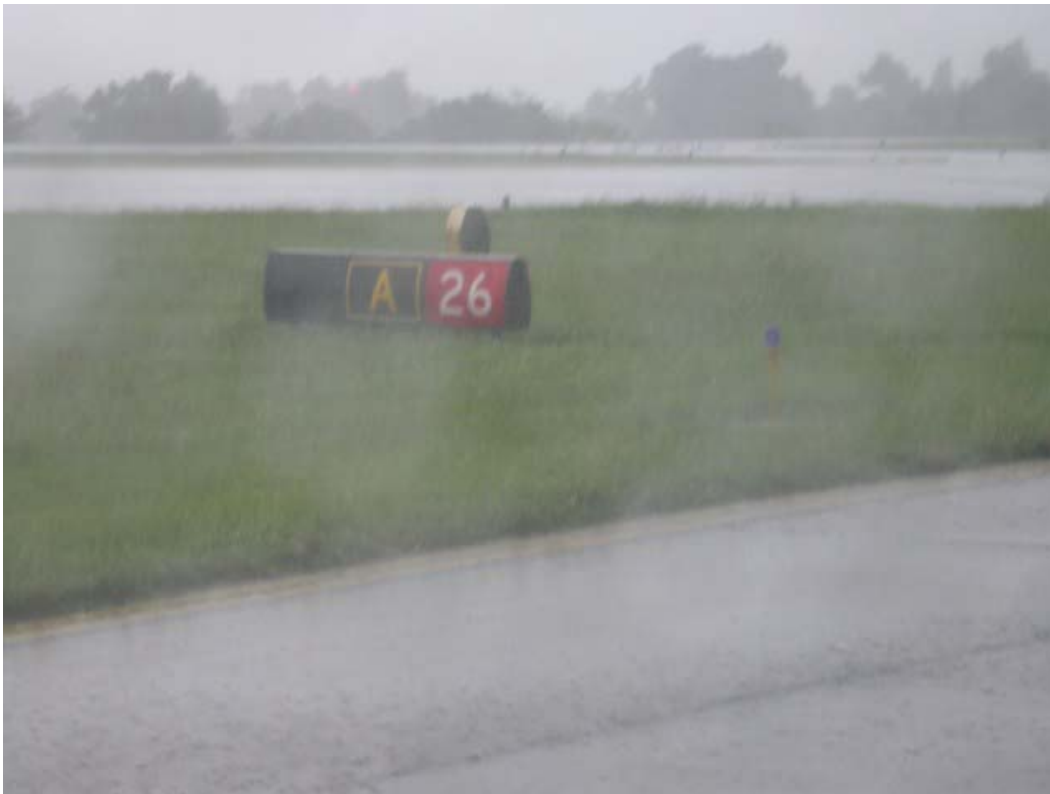
Photo 28. T/W A holding position sign for runway 26

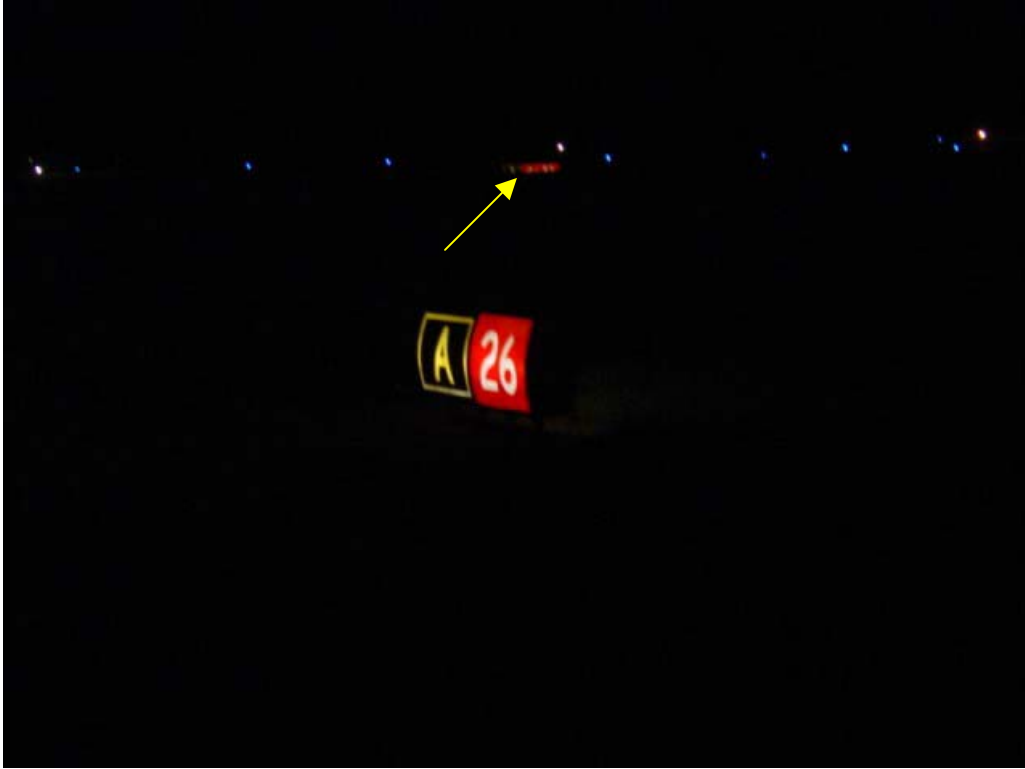
Photo 29. T/W A holding position sign for runway 26 as viewed from a 15-passenger van during the night taxi examination (Note: in the distance is the T/W A holding position sign for runway 22)
