Comair, Inc.
Lexington, KY
August 27, 2006
DCA06MA064

**NATIONAL TRANSPORTATION SAFETY BOARD
WASHINGTON, D.C.**

ATTACHMENT 1

PHOTOGRAPHS

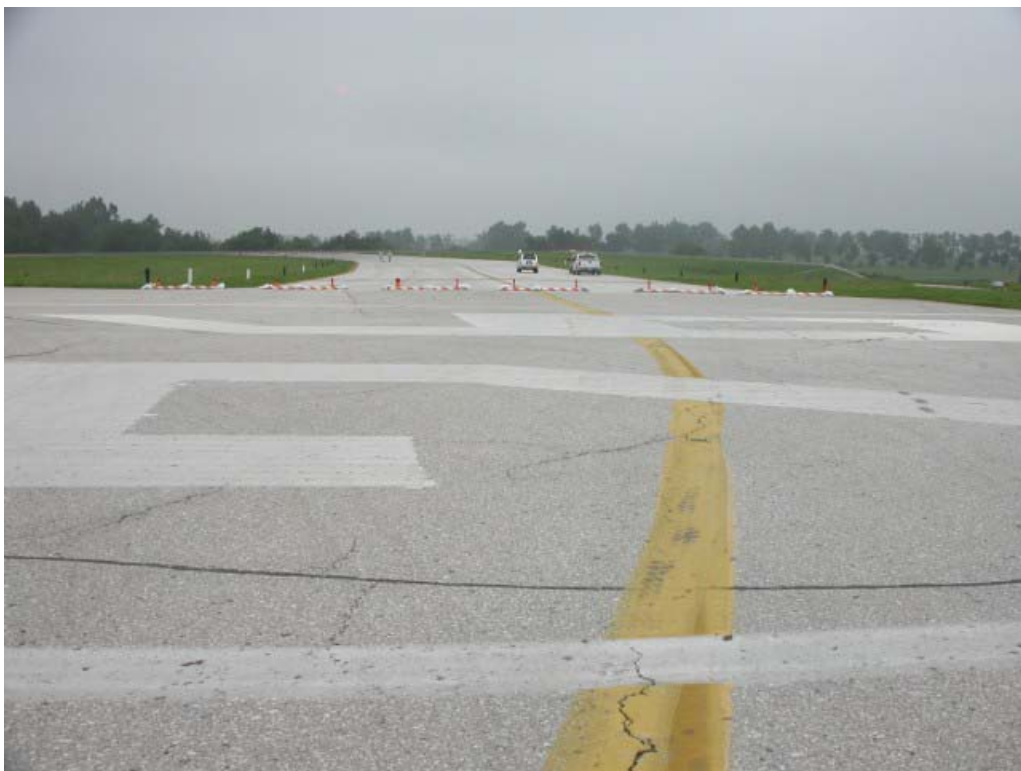
Photo 30. Old T/W A with lead-in line and low-profile lighted barricades

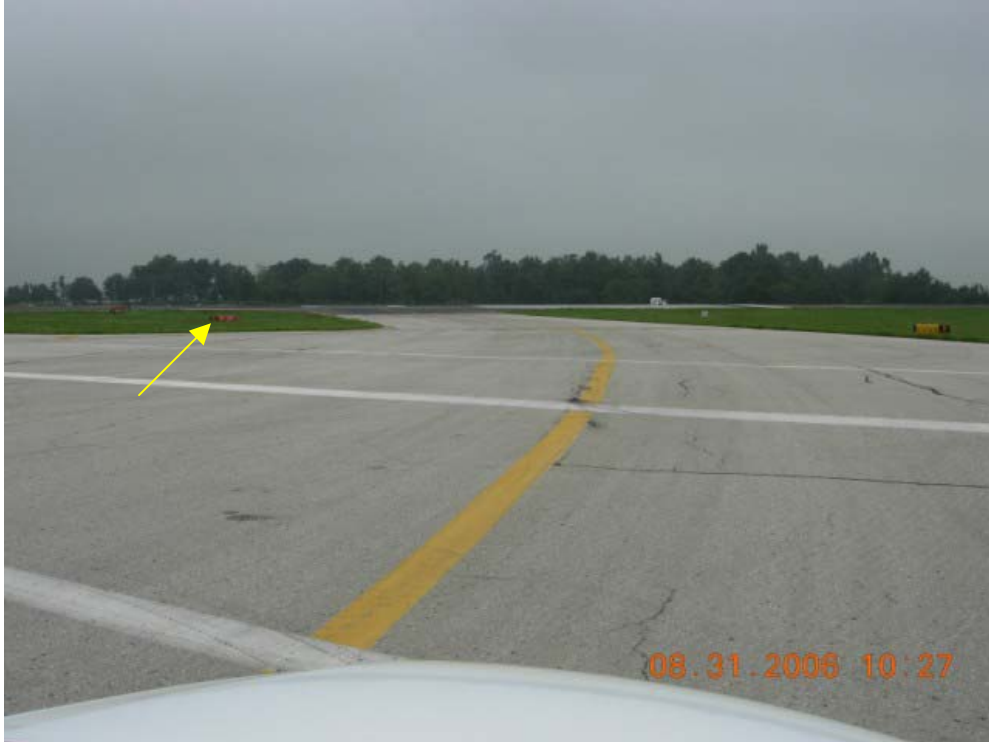
Photo 31. T/W A and T/W A holding position sign for runway 22 as viewed from the taxiway lead-in line prior to crossing runway 26

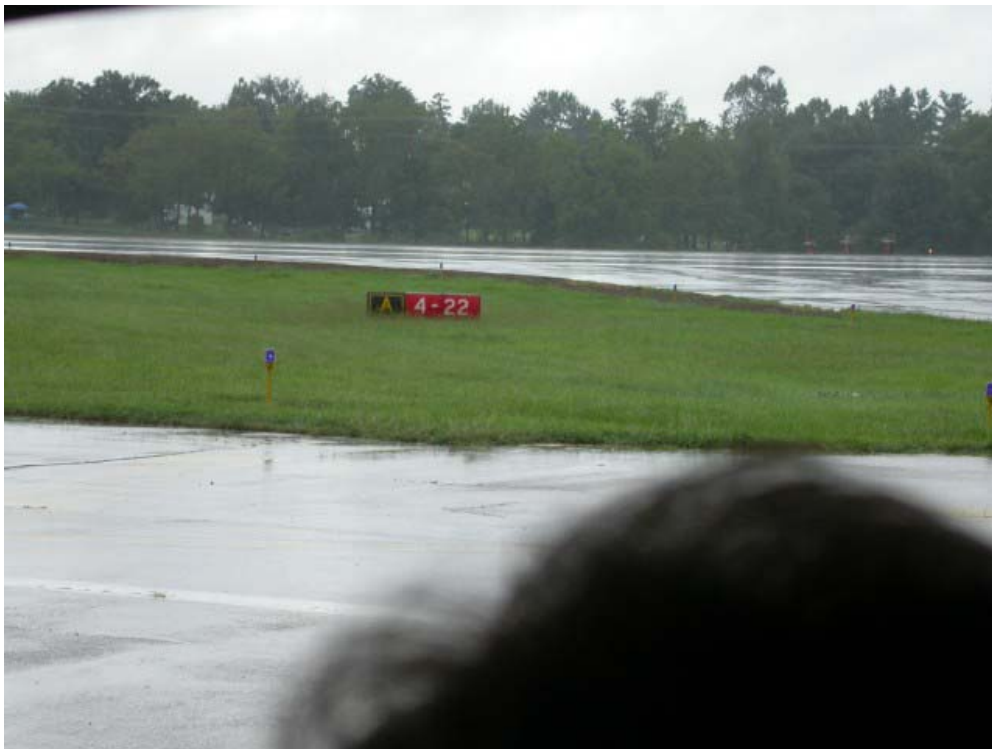
Photo 32. T/W A holding position sign for runway 22 as viewed from the centerline of runway 26

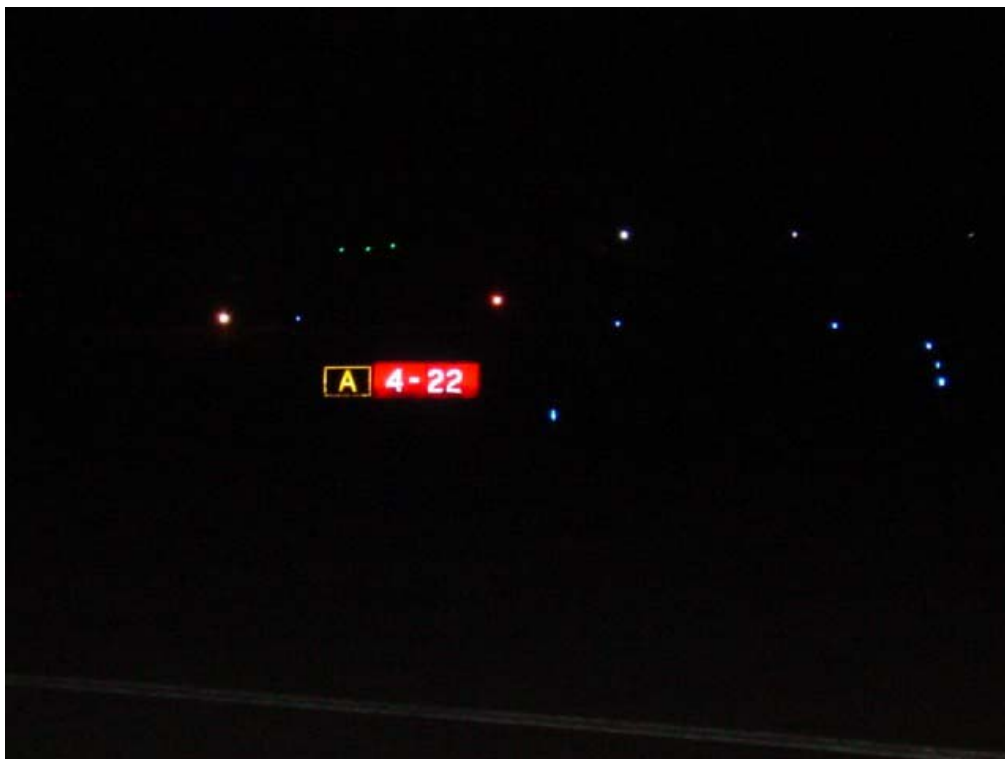
Photo 33. T/W A holding position sign for runway 22 as viewed from a 15-passenger van on the runway 26 centerline during the night taxi examination

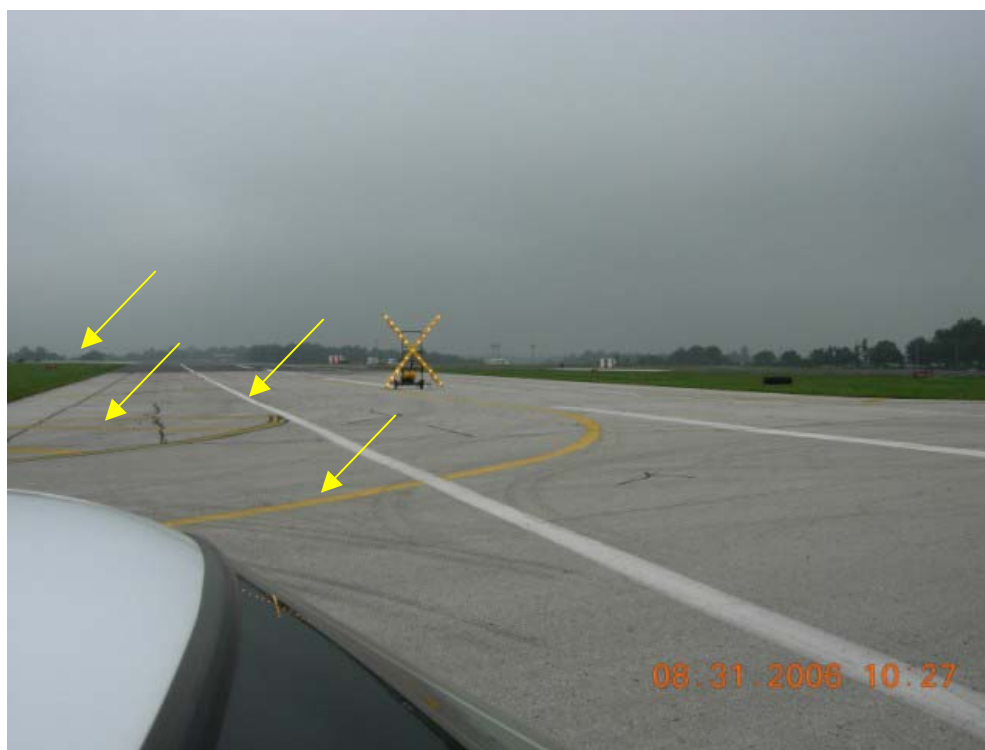
Photo 34. Runway 26 with the runway 4/22 intersection sign, lead-off line, white edge line, and yellow shoulder markings

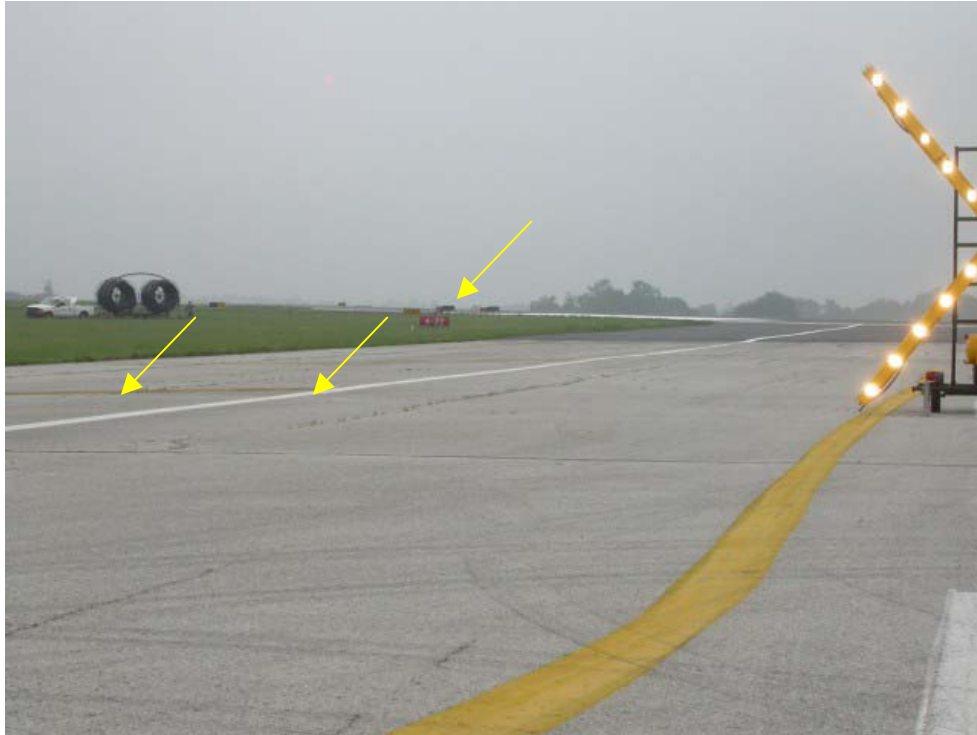
Photo 35. Runway 26 with the runway 4/22 intersection sign, lead-off line, white edge line, and yellow shoulder markings

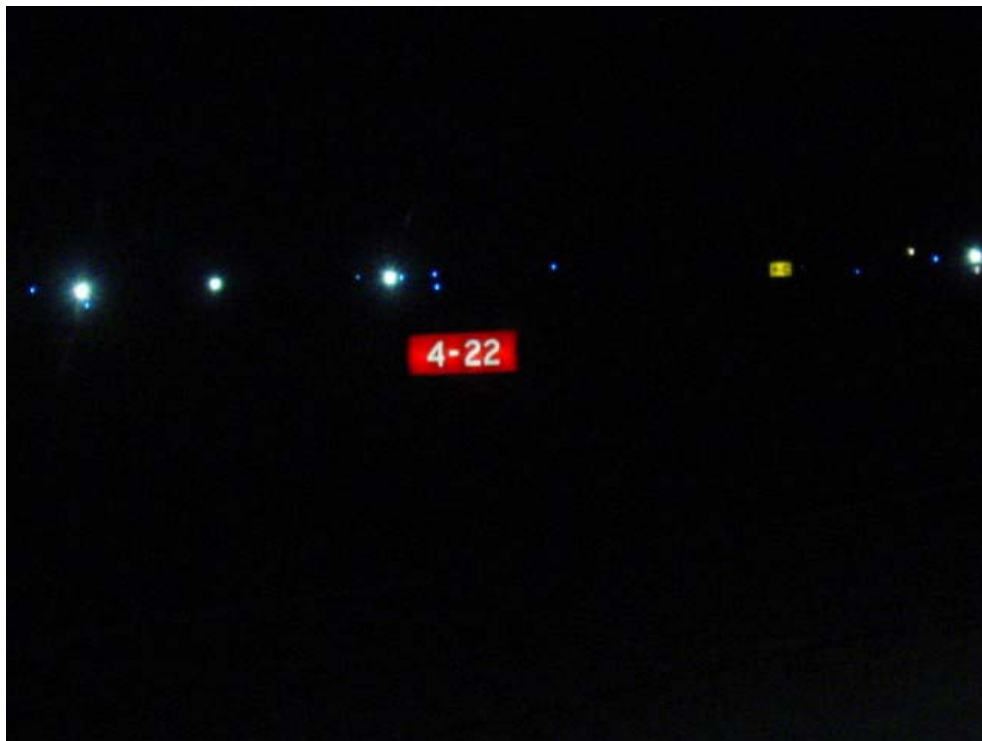
Photo 36. Runway 4/22 intersection sign as viewed from a 15-passenger van on the runway 26 centerline during the night taxi examination
