Carson Helicopter Services
Weaverville, California
August 5, 2008
LAX08PA259

National Transportation Safety Board
Washington, D.C.

Attachment 3

Carson N61NH Sister Ship
and
Cabin Interior Photographs

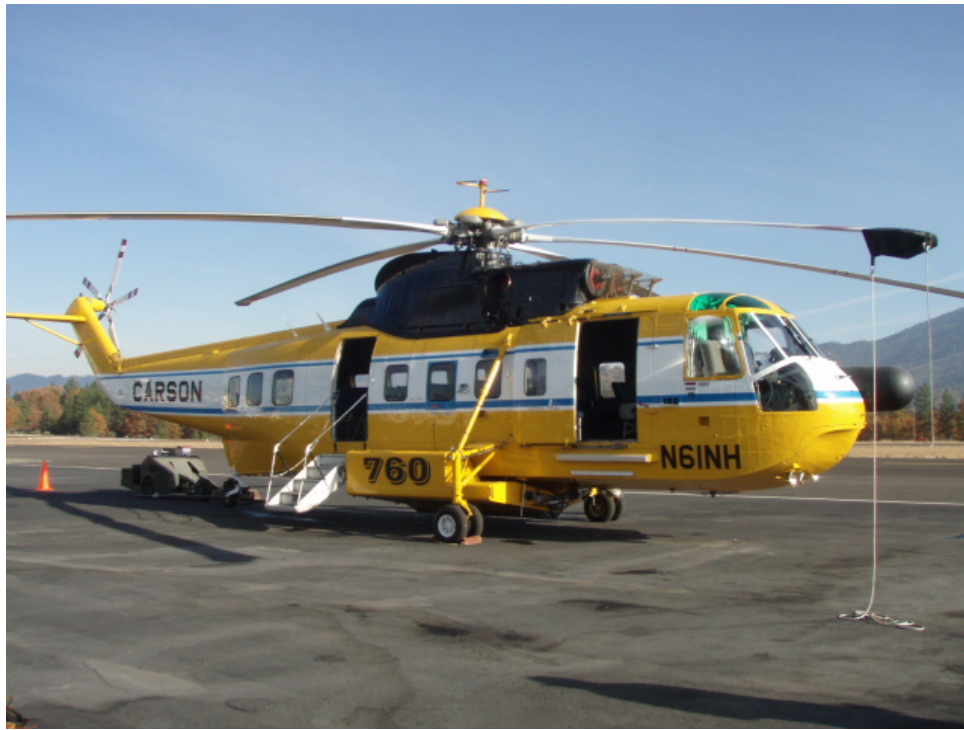
1. View of N61NH a sister ship to the accident helicopter.

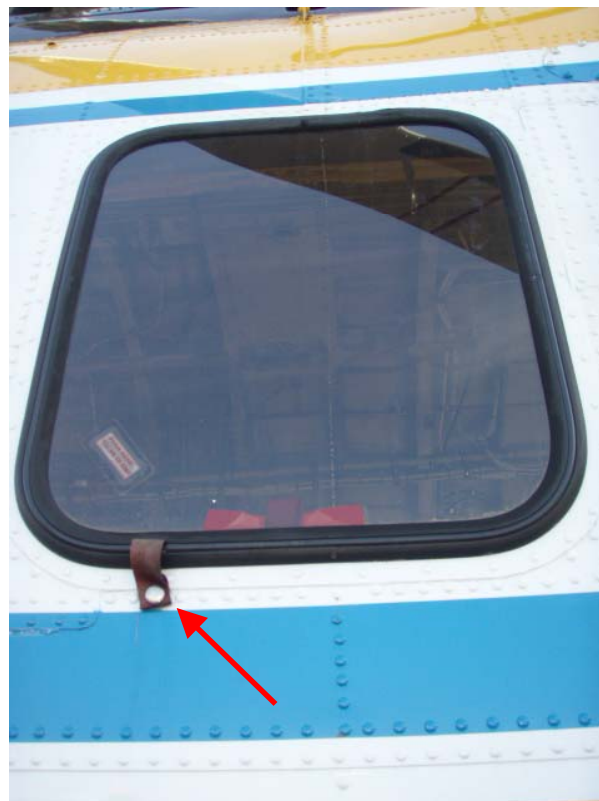
2. View of a window seal from N61NH.

Note: The red arrow points to the pull snap attached to the seal that releases the window when pulled.

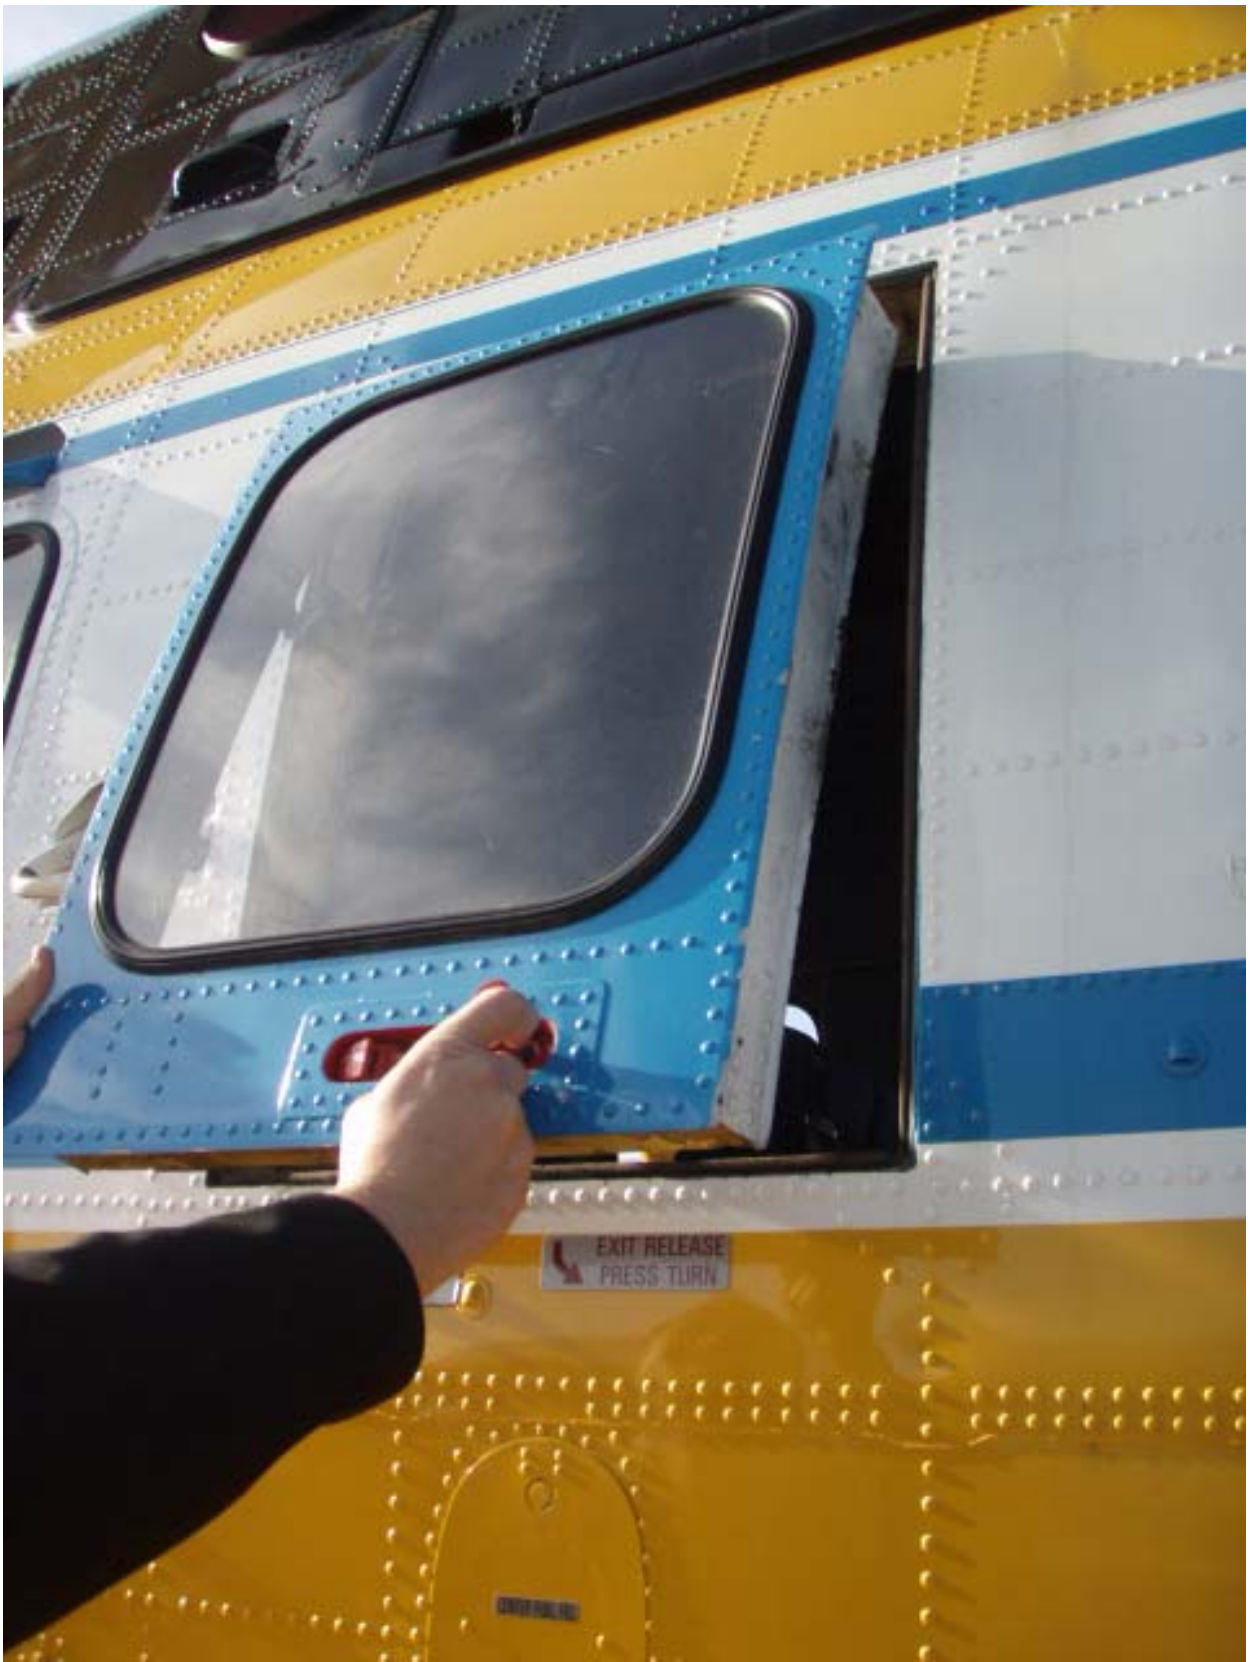
3. View of an emergency exit hatch being removed from N61NH.

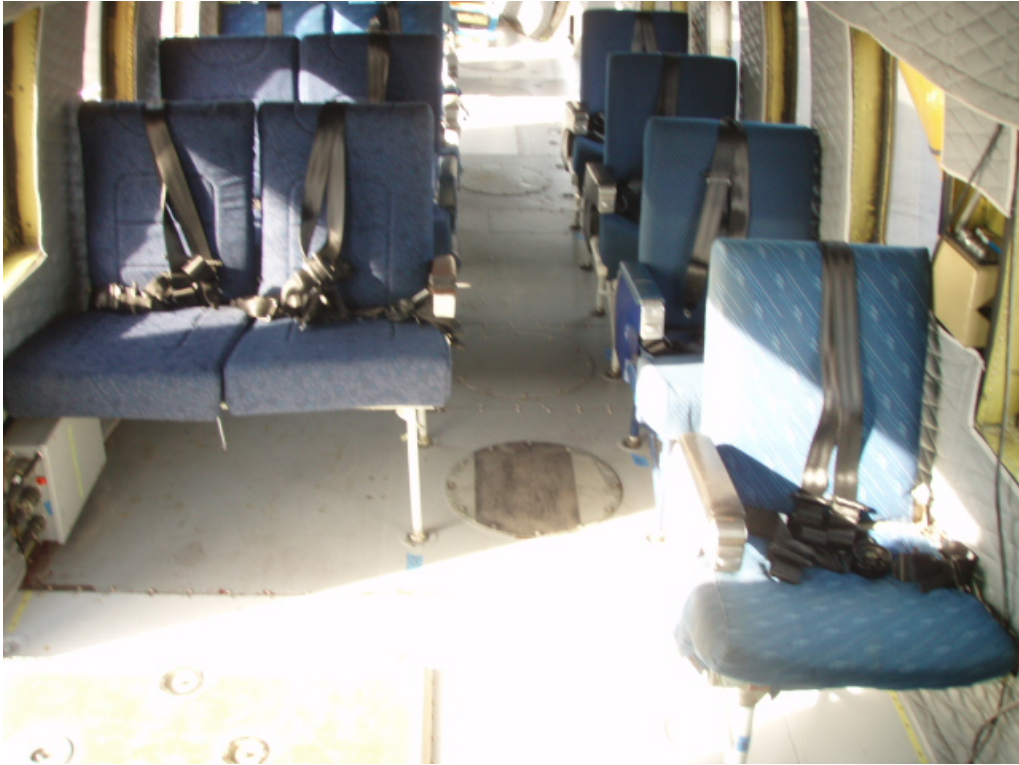
4. View looking aft of the N61NH's cabin interior.

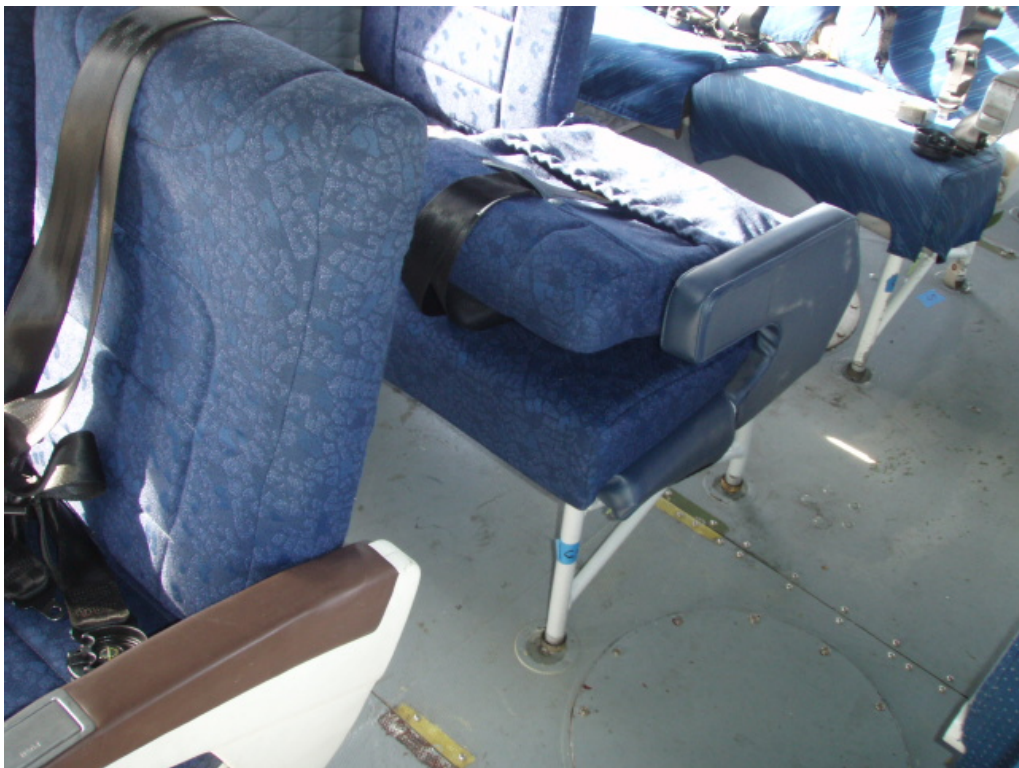
5. View of the inboard double seat back folded forward.
Note: There was no mechanical stop to retain the seatback in the upright position.

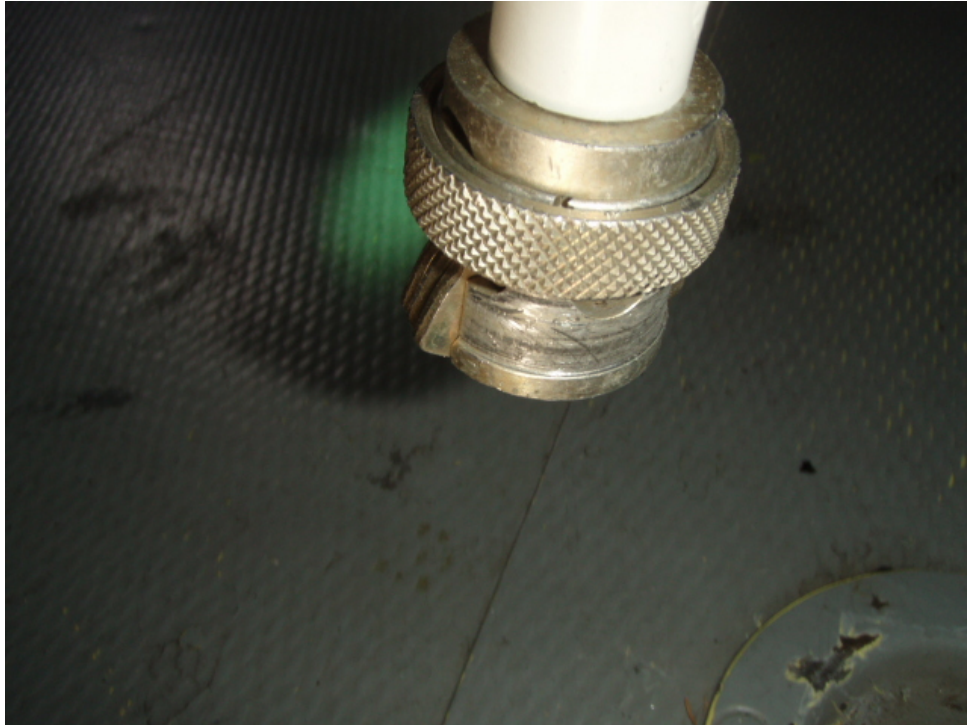
6. View of a single stud hold down fitting installed on the inboard seat legs of the Burns 650 and Aerosmith H25-1 S61N cabin seats.

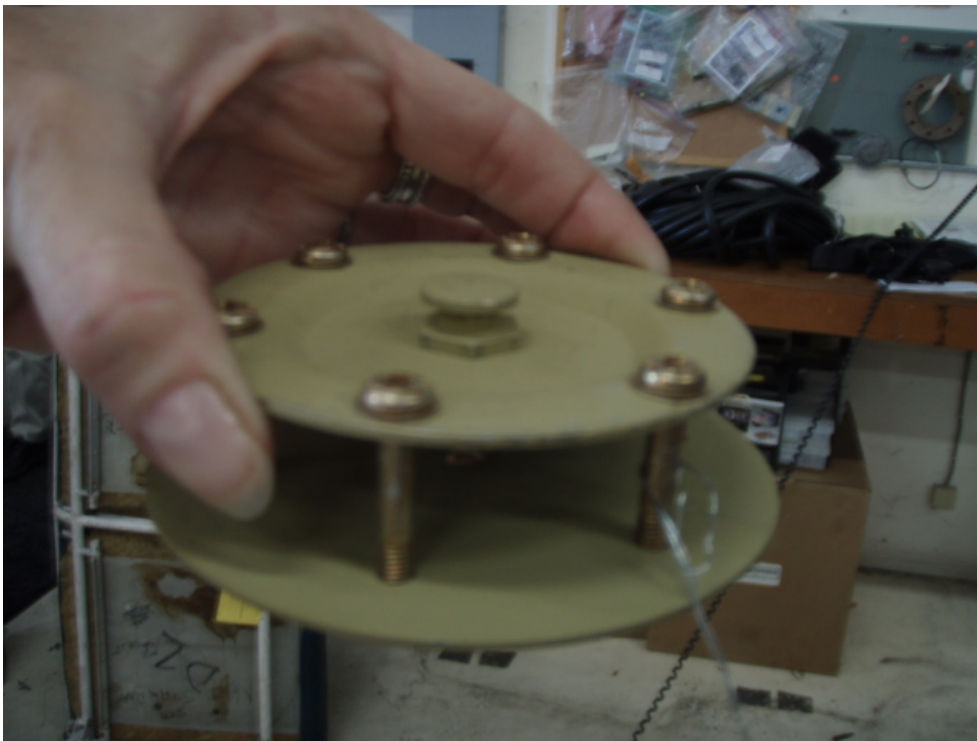
7. View of a pan fitting (normally installed in the floor of a S-61N helicopter.)
Note: The single stud hold down fitting attaches to the pan fitting to secure the cabin seat to the floor.

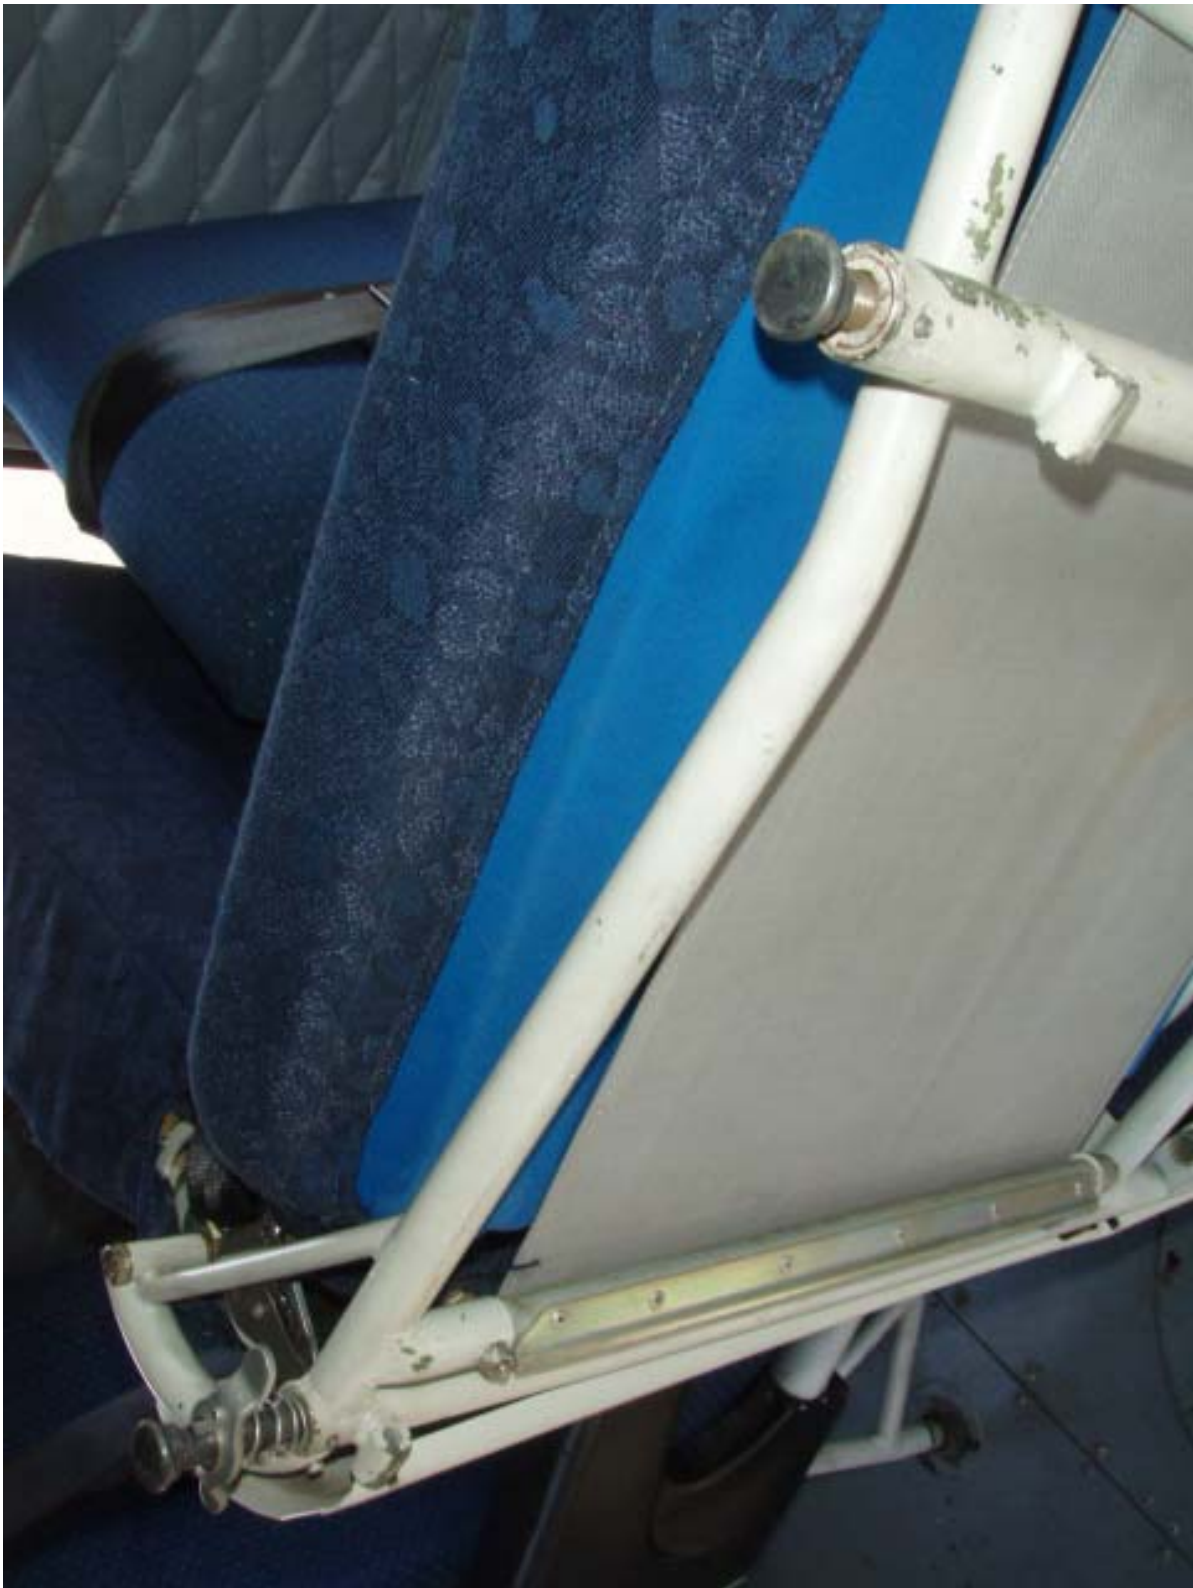
8. View of the bottom of a seat showing the forward and aft (spring loaded locking) single pin hold down fittings that attach the seat to the side of the cabin.

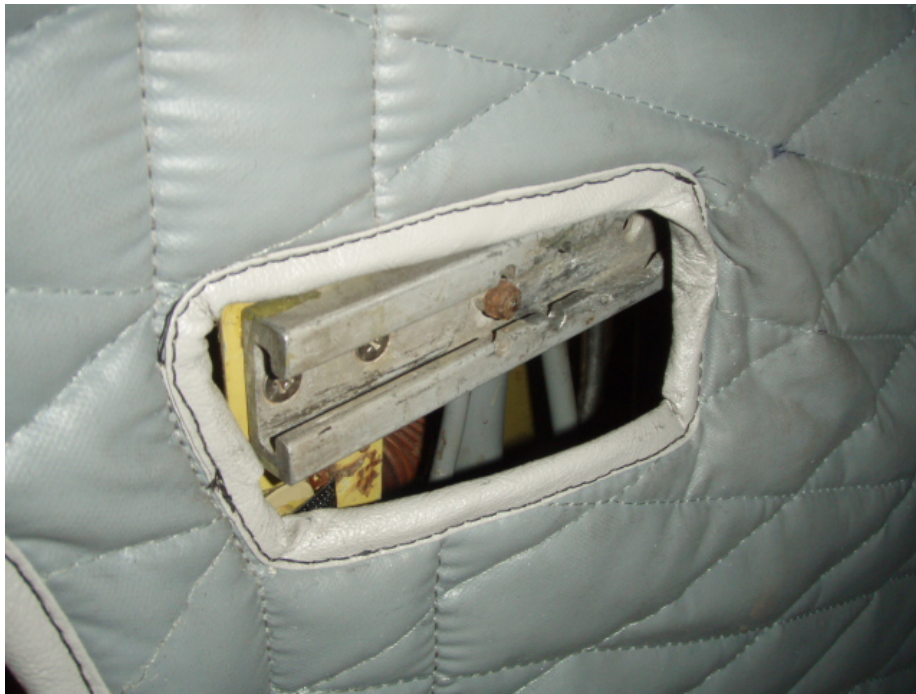
9. View of a section of seat track attached to the cabin sidewall where the single pin hold down fittings lock the side of the seat into the cabin sidewall.

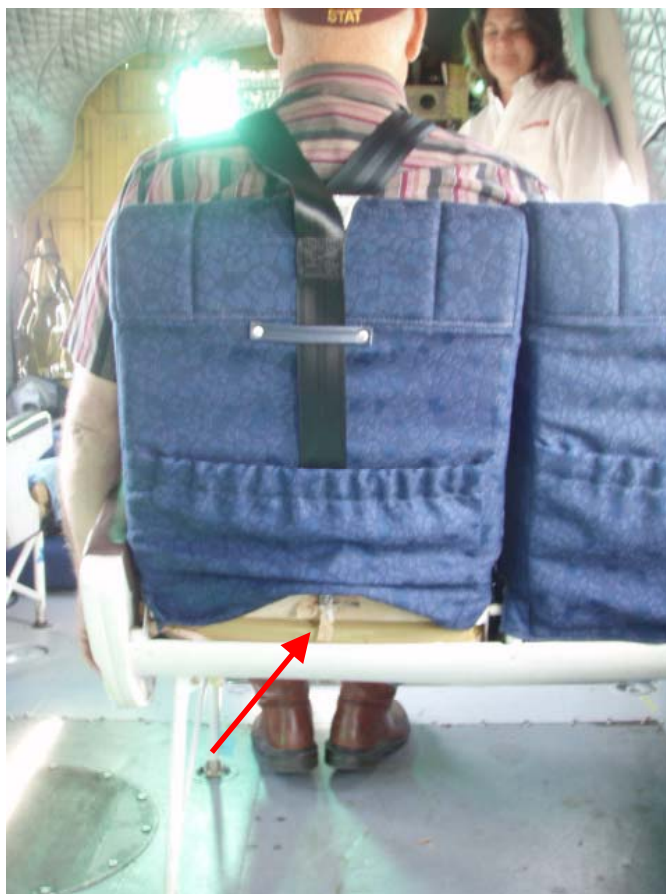
10. View of the rear of an outboard double seat.
Note: Red arrow points to the shoulder restraint attachment to the seat crosstube.

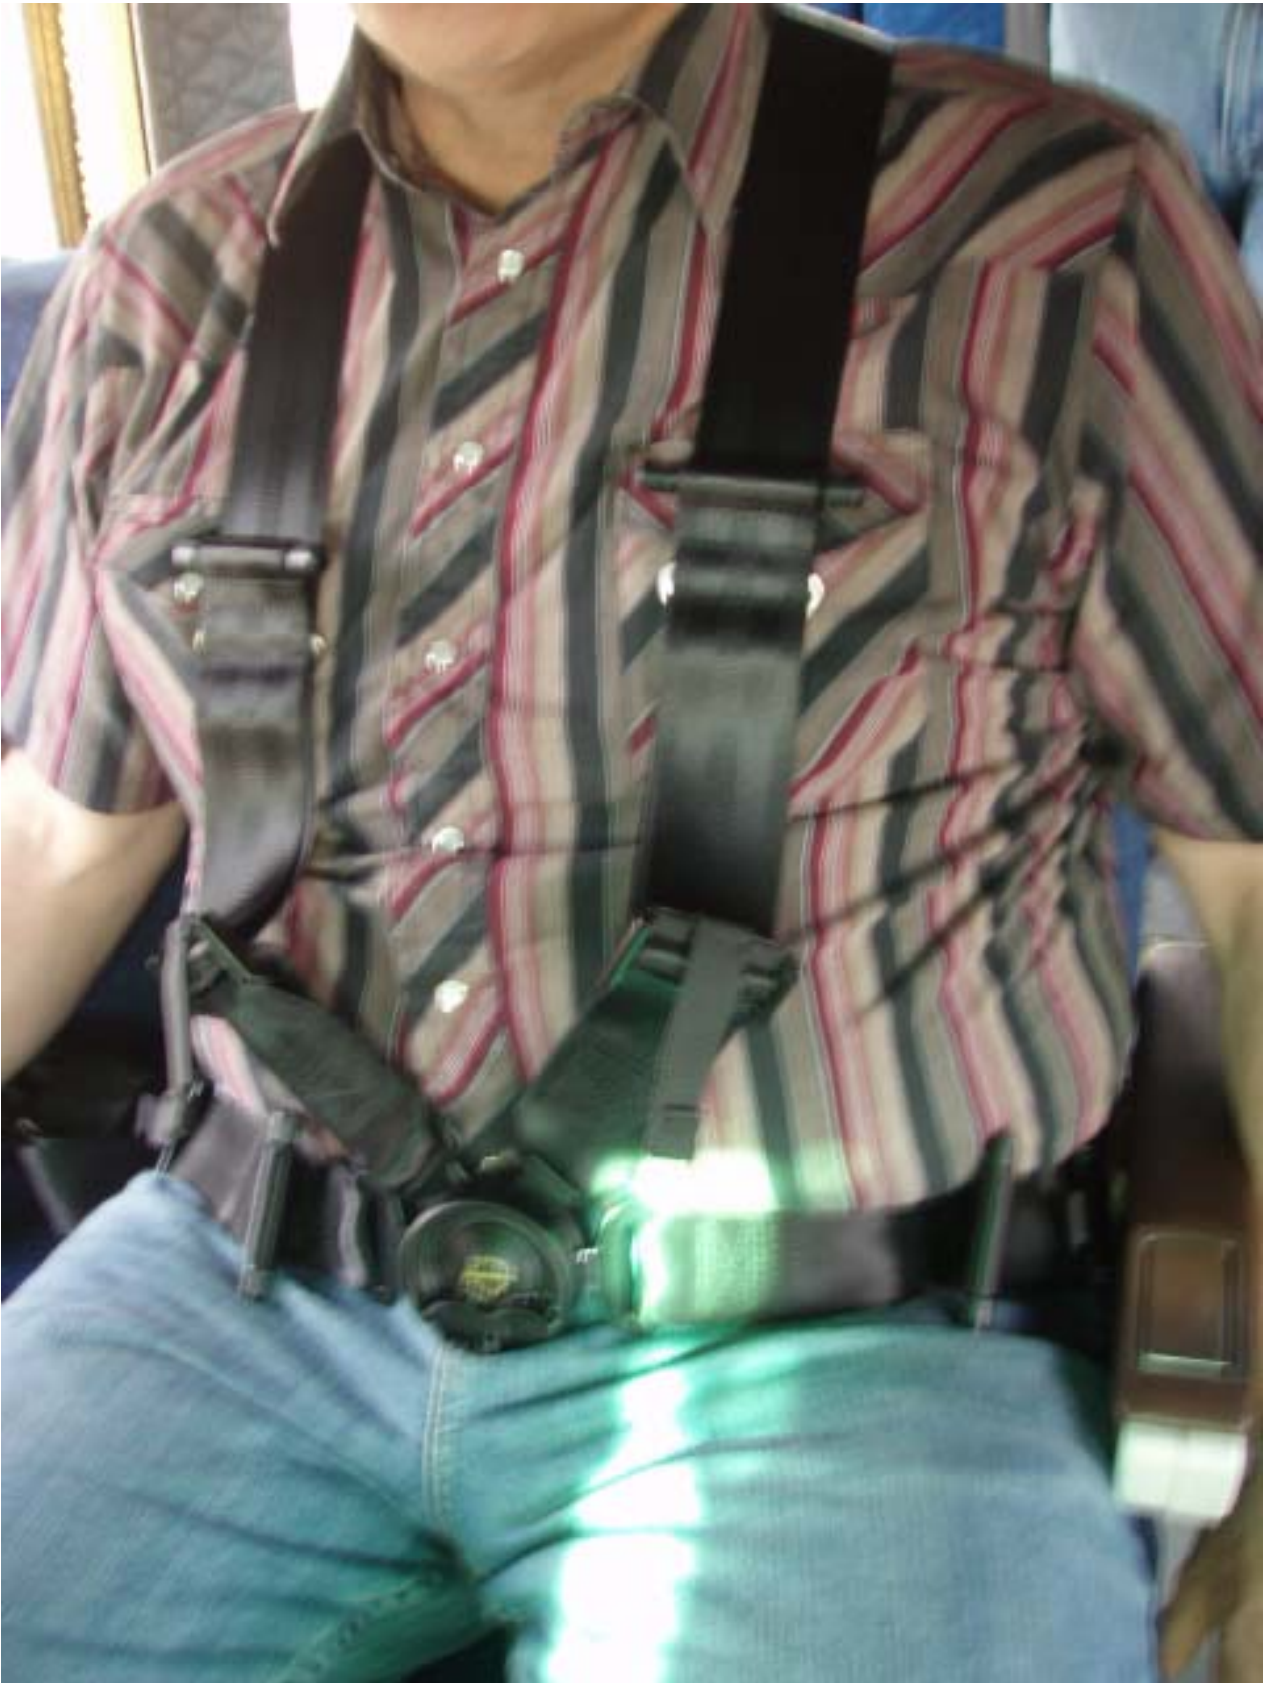
11. View of a buckled 4-point Schroth restraint (like the restraints installed in N612AZ.)

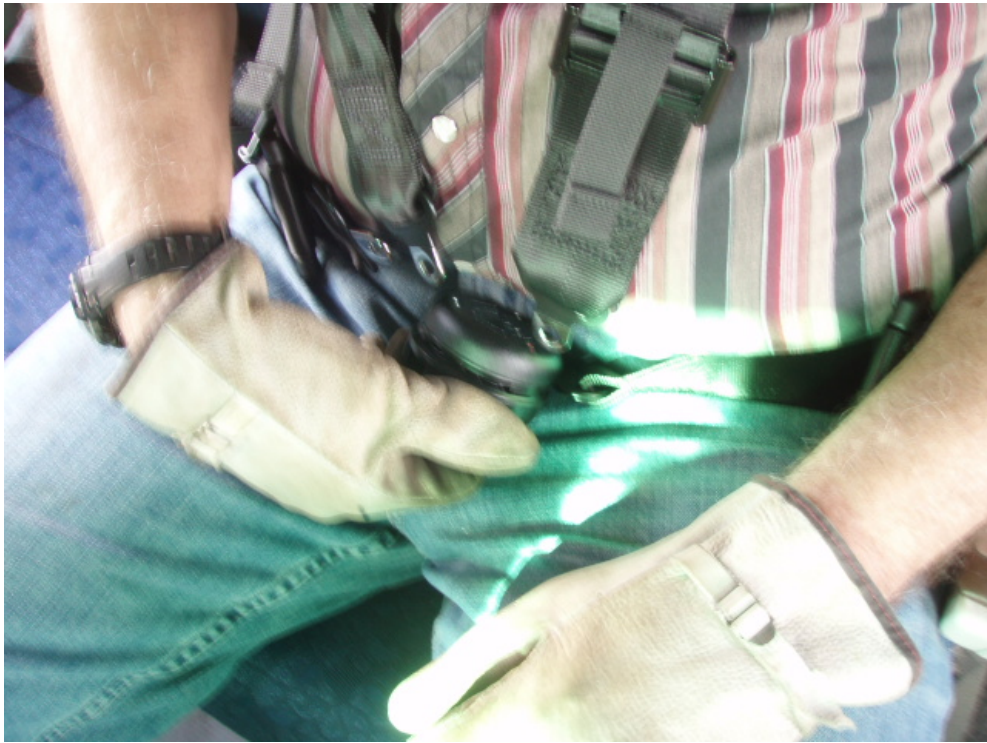
12. View of a Survival Factors Group member wearing Forest Service leather gloves (like those worn by the passengers on board N612AZ) and unbuckling a Schroth 4-point rotary restraint.

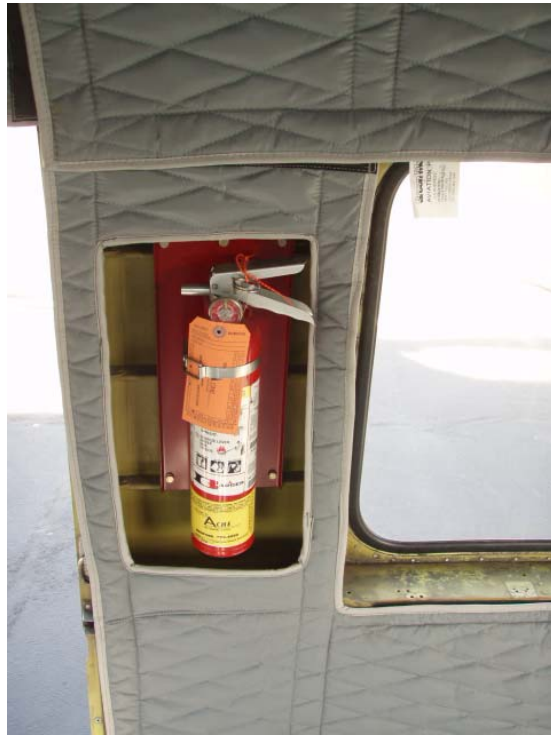
13. View of one of the two fire extinguishers in the S-61N helicopter.
Note: Normally mounted in the aft left cabin next to the emergency exit hatch.
