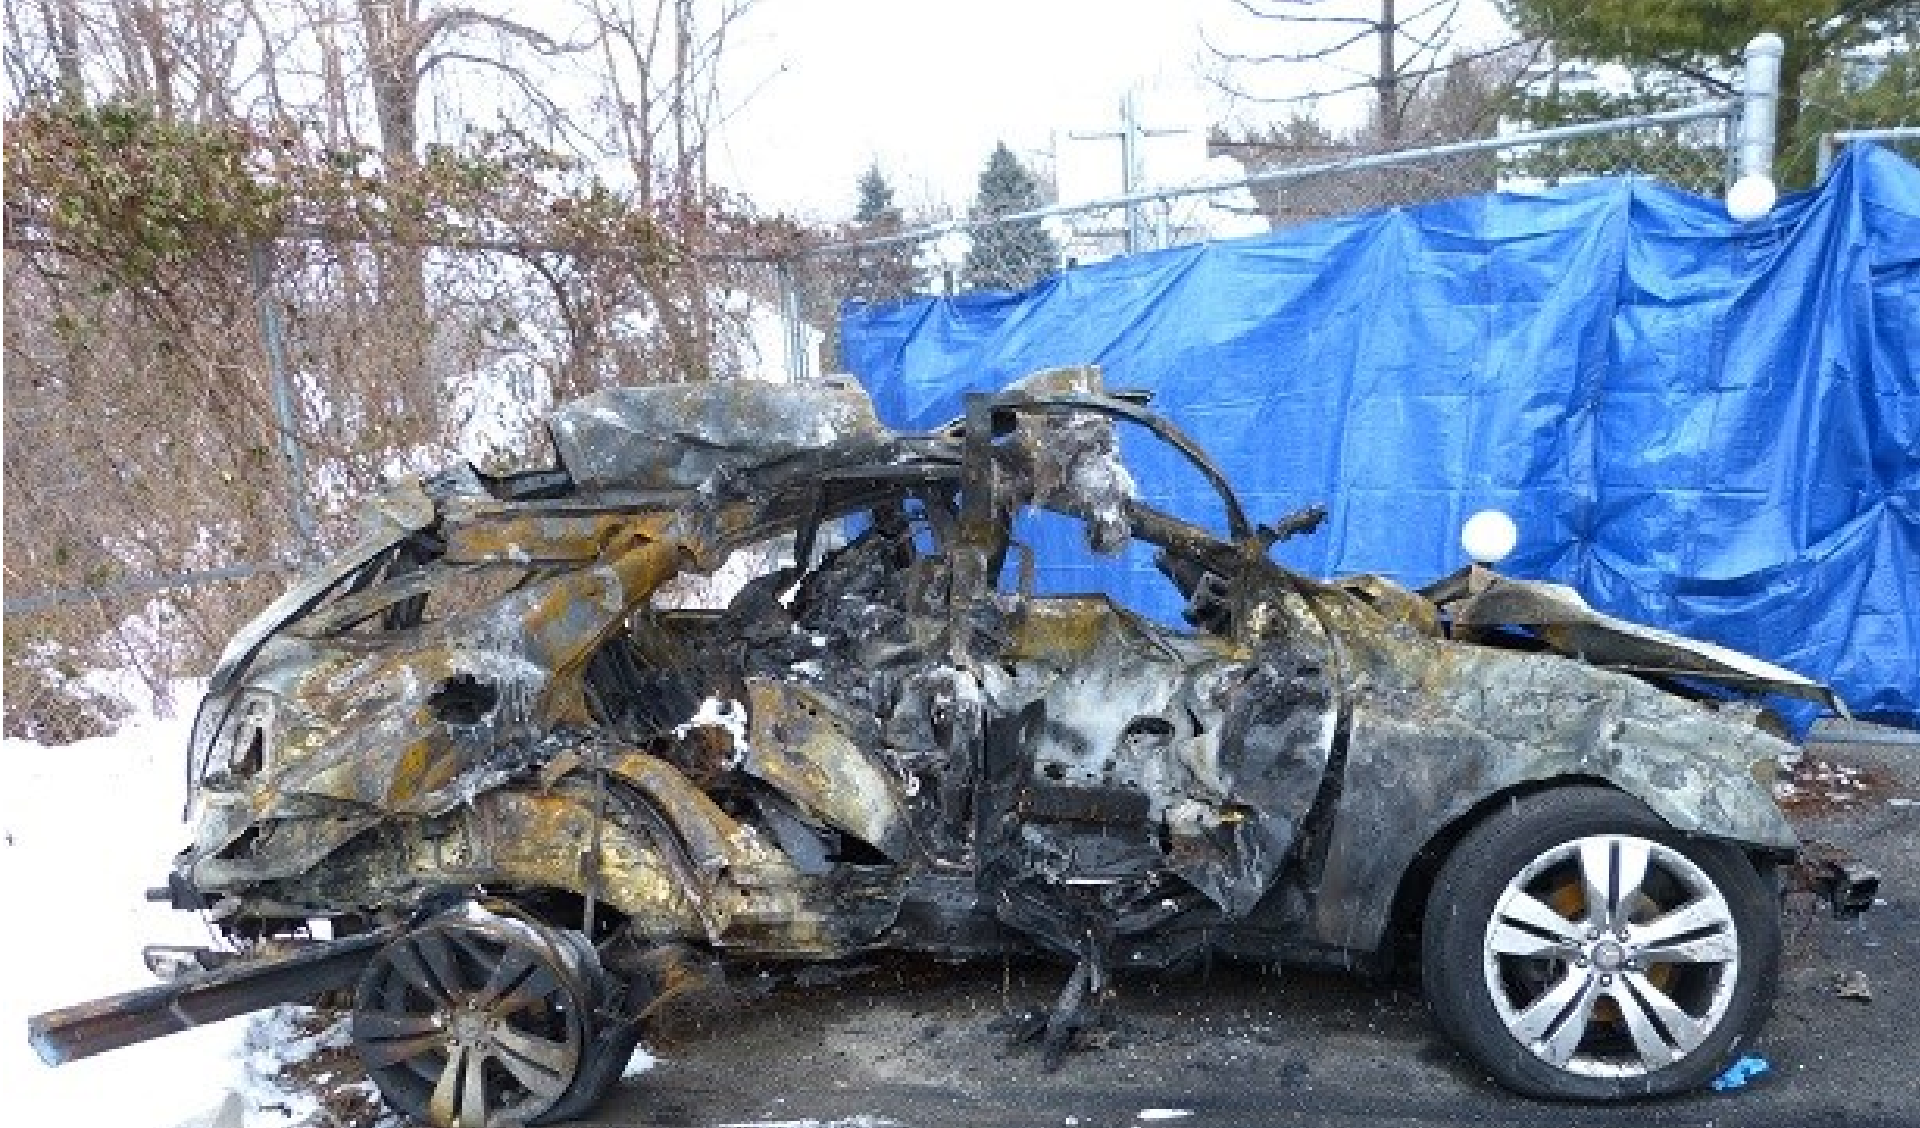
The right side of the SUV is shown. The vehicle is badly fire damaged and the middle portion of the car between the wheels is crushed inward. The fire damage is slightly less severe at the front, with the right front tire and wheel intact, but the tire is deflated. The right rear tire is burned away and the wheel is discolored. At the top left corner of the wheel there is a section of railroad rail visible, protruding from the side of the car.
