Survival Factors Photos

**Penwell, Texas
HWY15FH004**

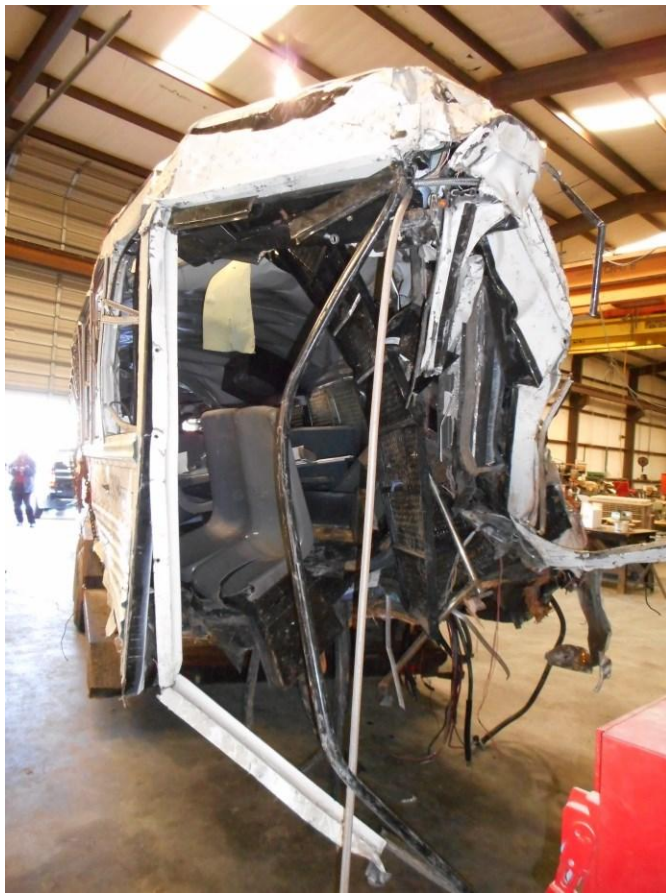
Photo 1 – Frontal view of Bluebird bus showing front end torn away.

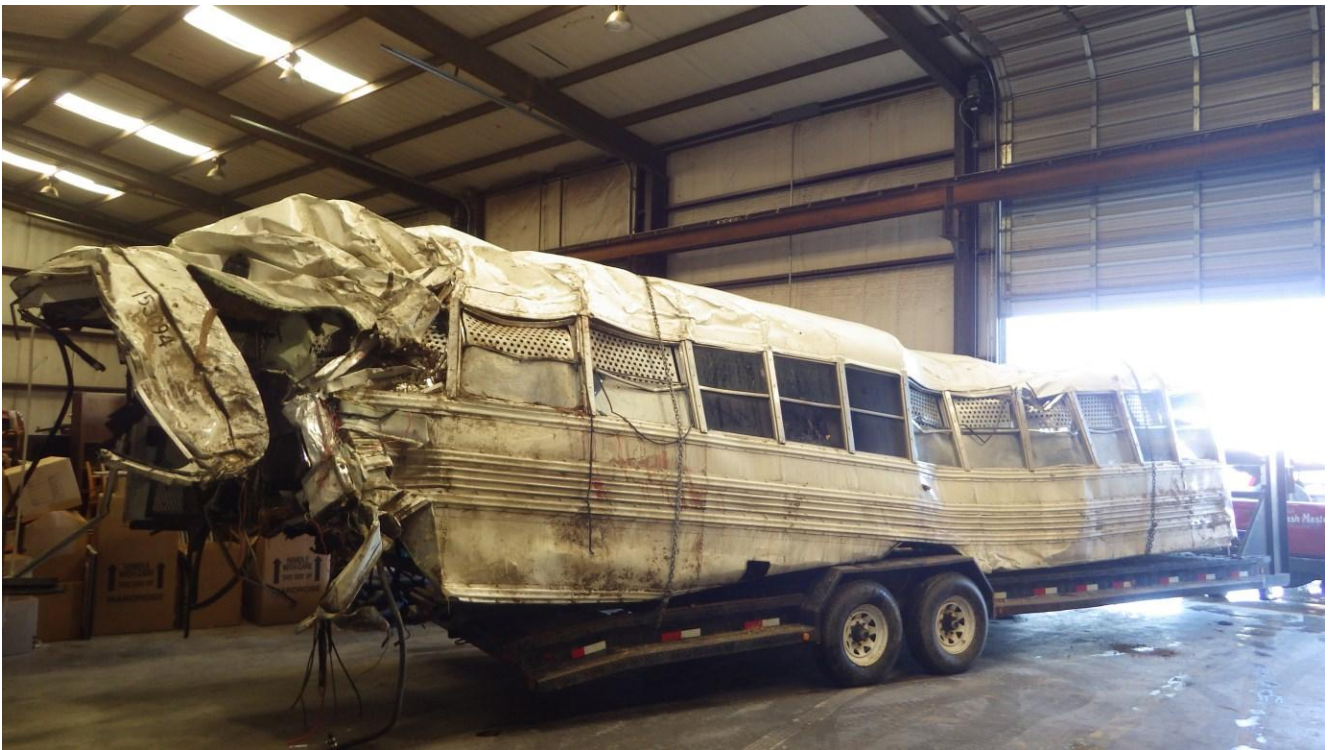
Photo 2 – Left side angle view of Bluebird bus showing missing front end and deformation to side from pillar impacts.

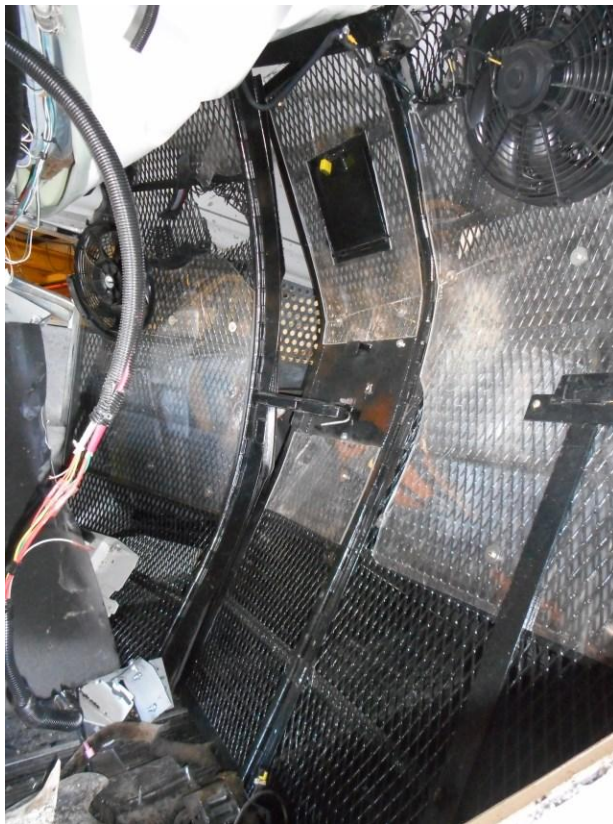
Photo 3 – View of rear caged wall showing bowing to center.

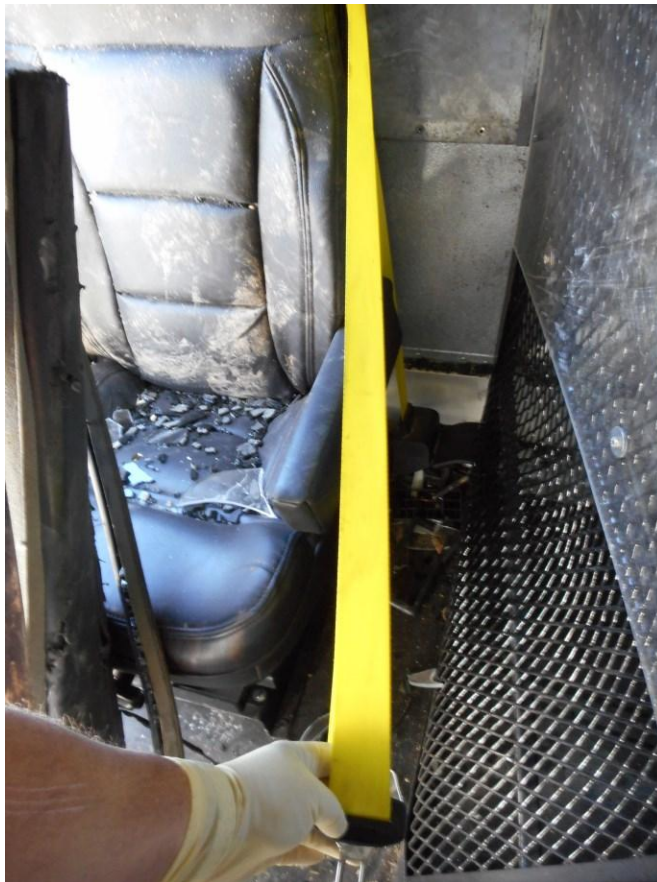
Photo 4 – View of rear jump-seat with seat belt webbing pulled out showing lack of blood.

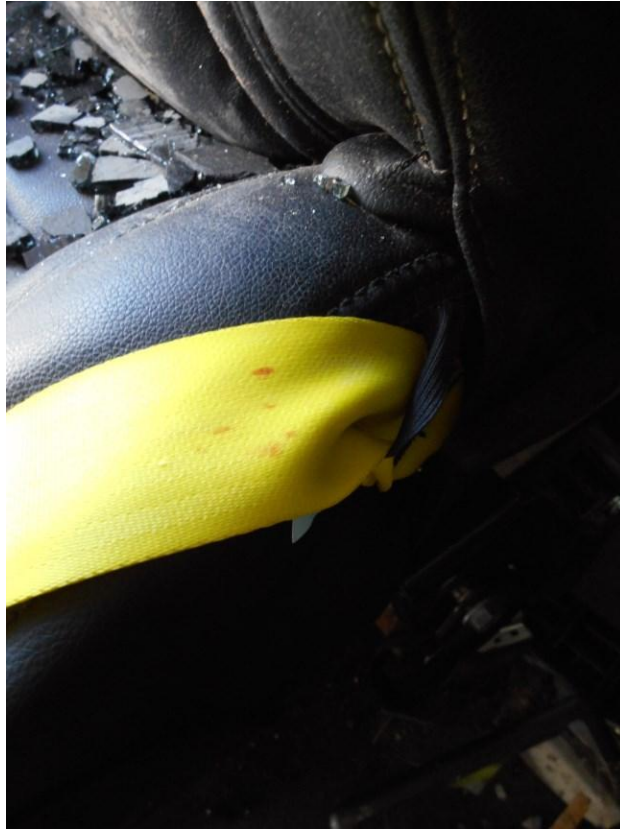
Photo 5 – View of three tiny blood spots on rear jump-seat seat belt webbing.

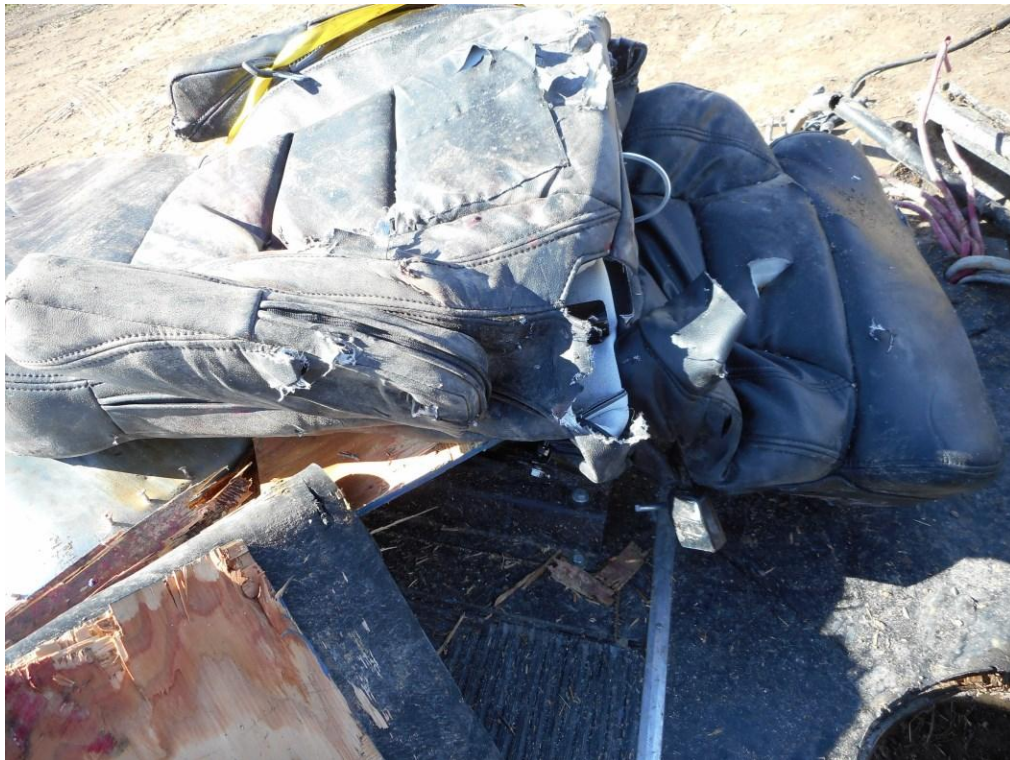
Photo 6 – Overhead view of destroyed driver seat.

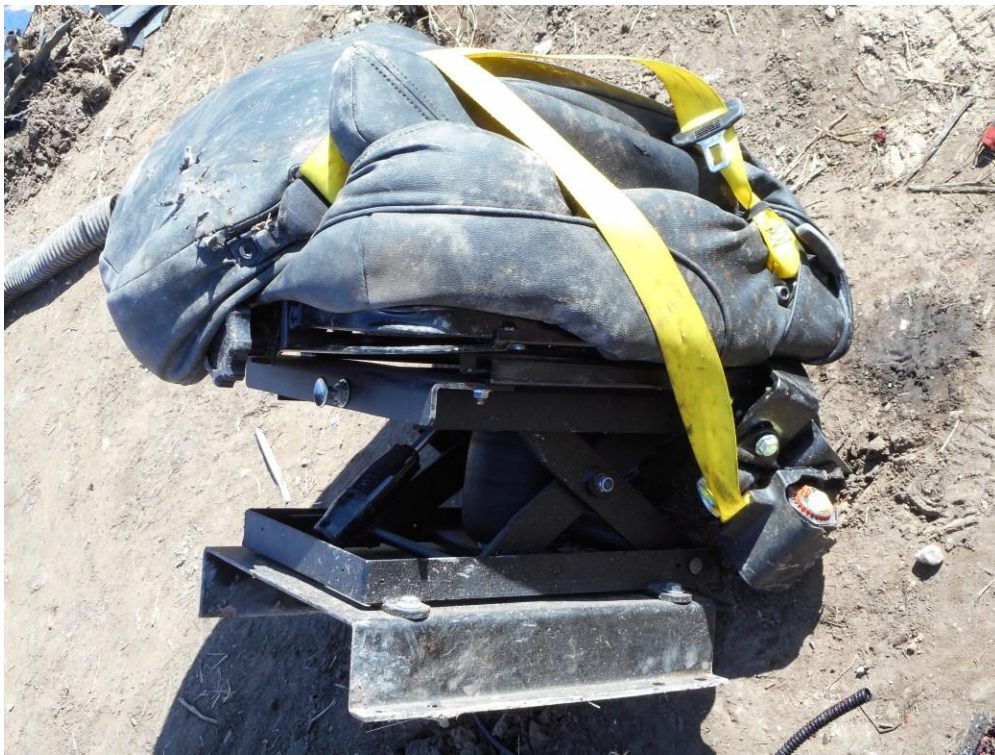
Photo 7 – View of collapsed front jump seat.

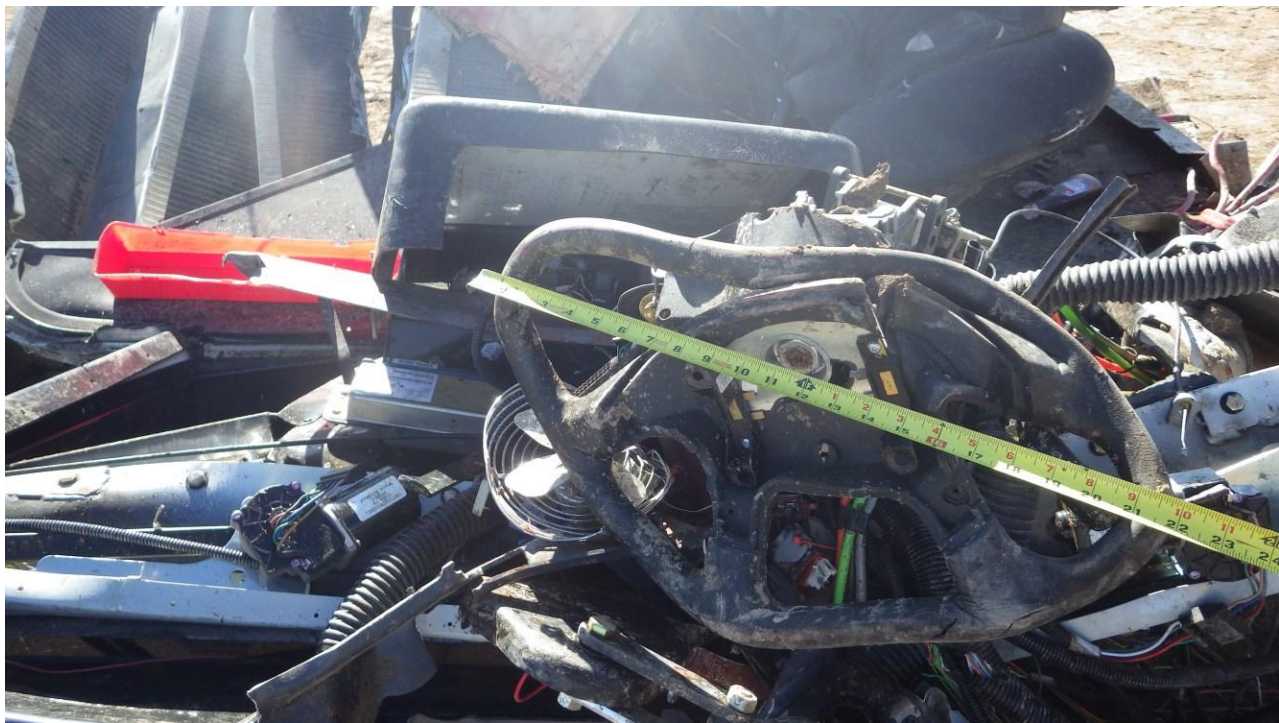
Photo 8 – View of deformation to steering wheel.

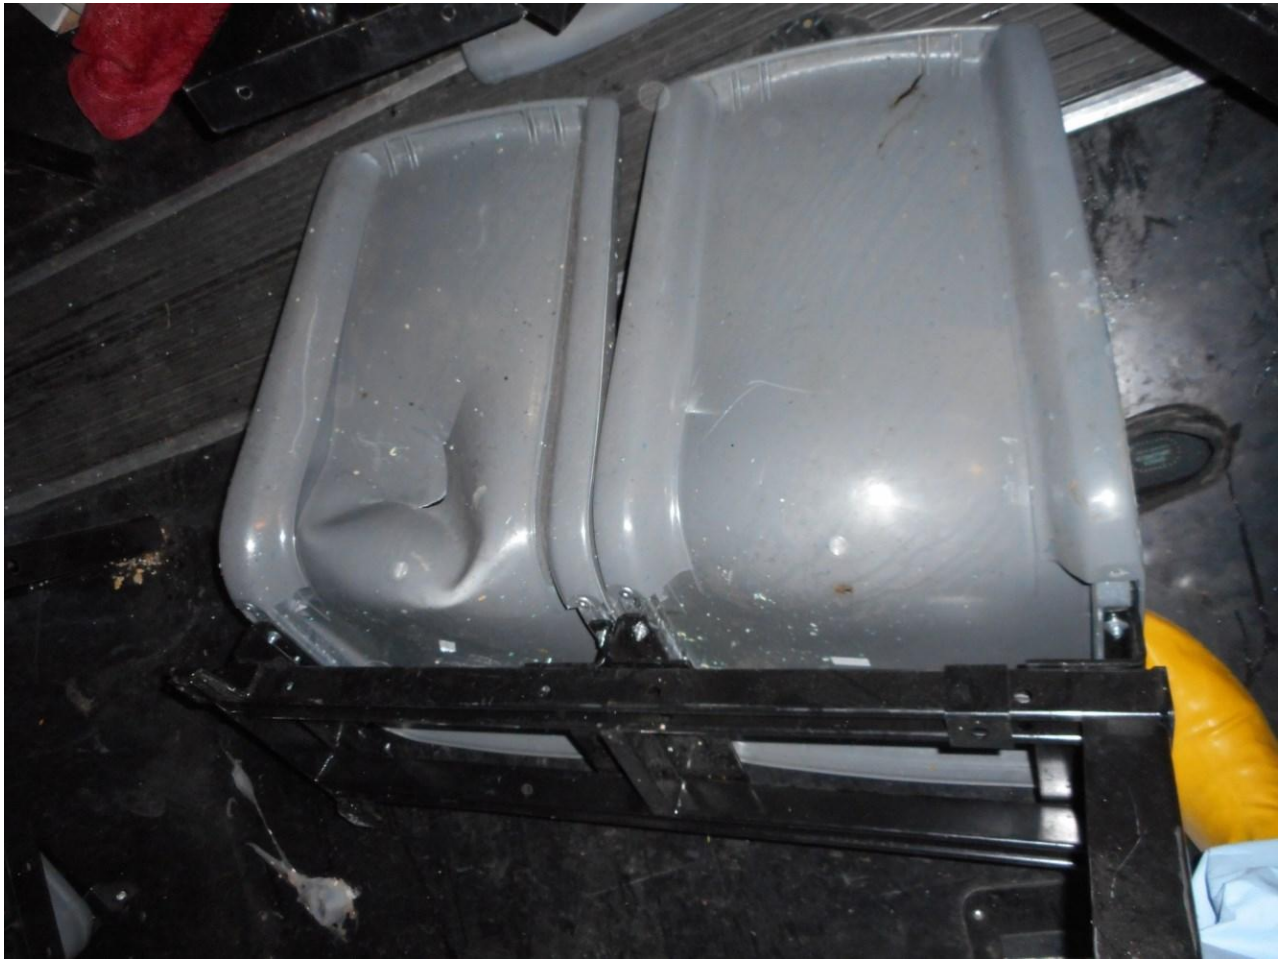
Photo 9 – View of indentation to back of seatback.
