**NATIONAL TRANSPORTATION SAFETY BOARD**

Train 1614 Collision with Bumping Post at Hoboken Terminal

NTSB Accident Number DCA16MR017

System Safety Group Factual Report

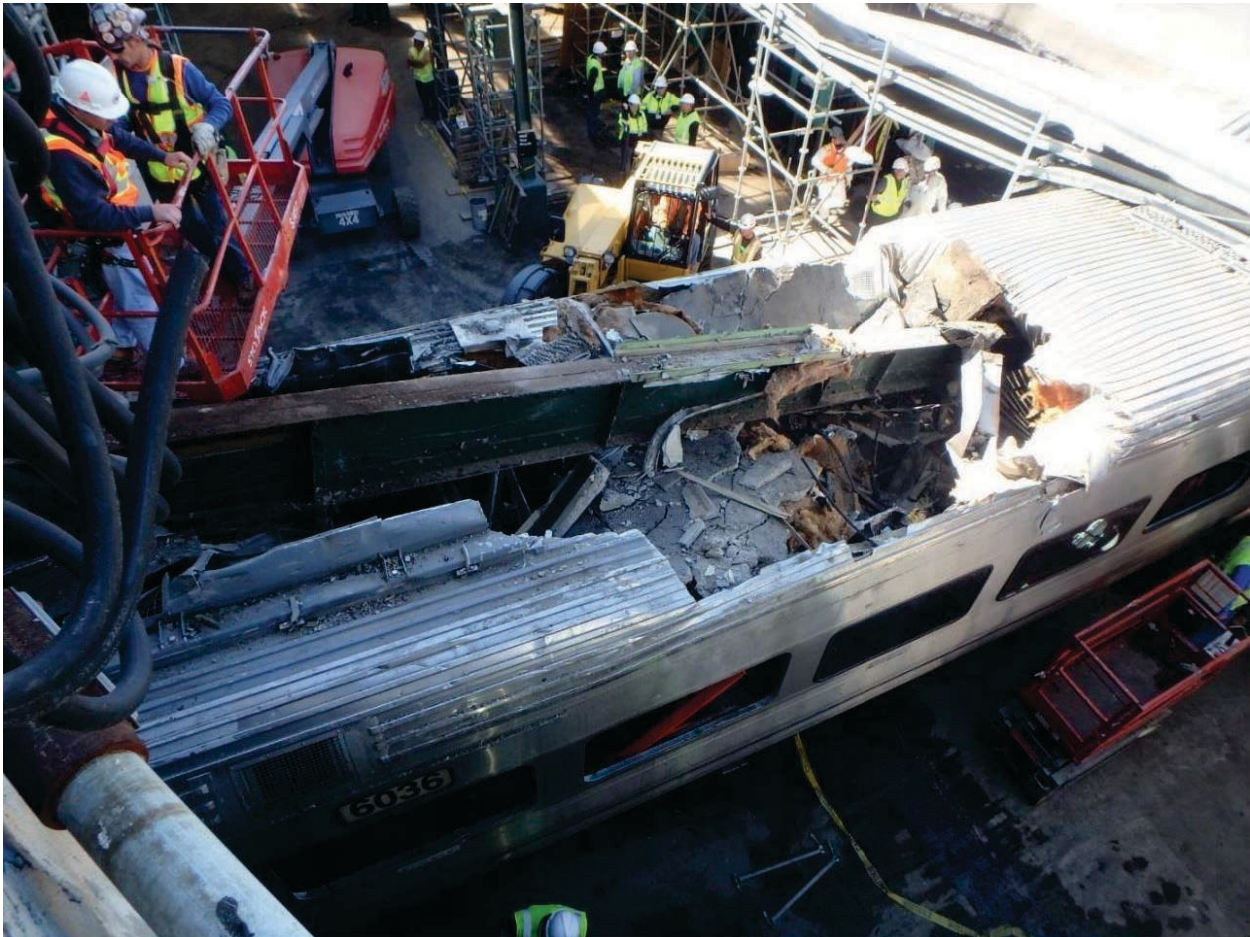
2 **Figure 1.** Damaged Cab Control Car. (Photo: NTSB)

5 On September 29, 2016, about 8:38 a.m. eastern daylight time, New Jersey Transit  
6 (NJT) train 1614 did not stop before reaching the end of terminal track 5, overrode the bumping  
7 post, and struck a wall at the Hoboken Terminal in Hoboken, New Jersey.<sup>1</sup> (See Figure 1.)

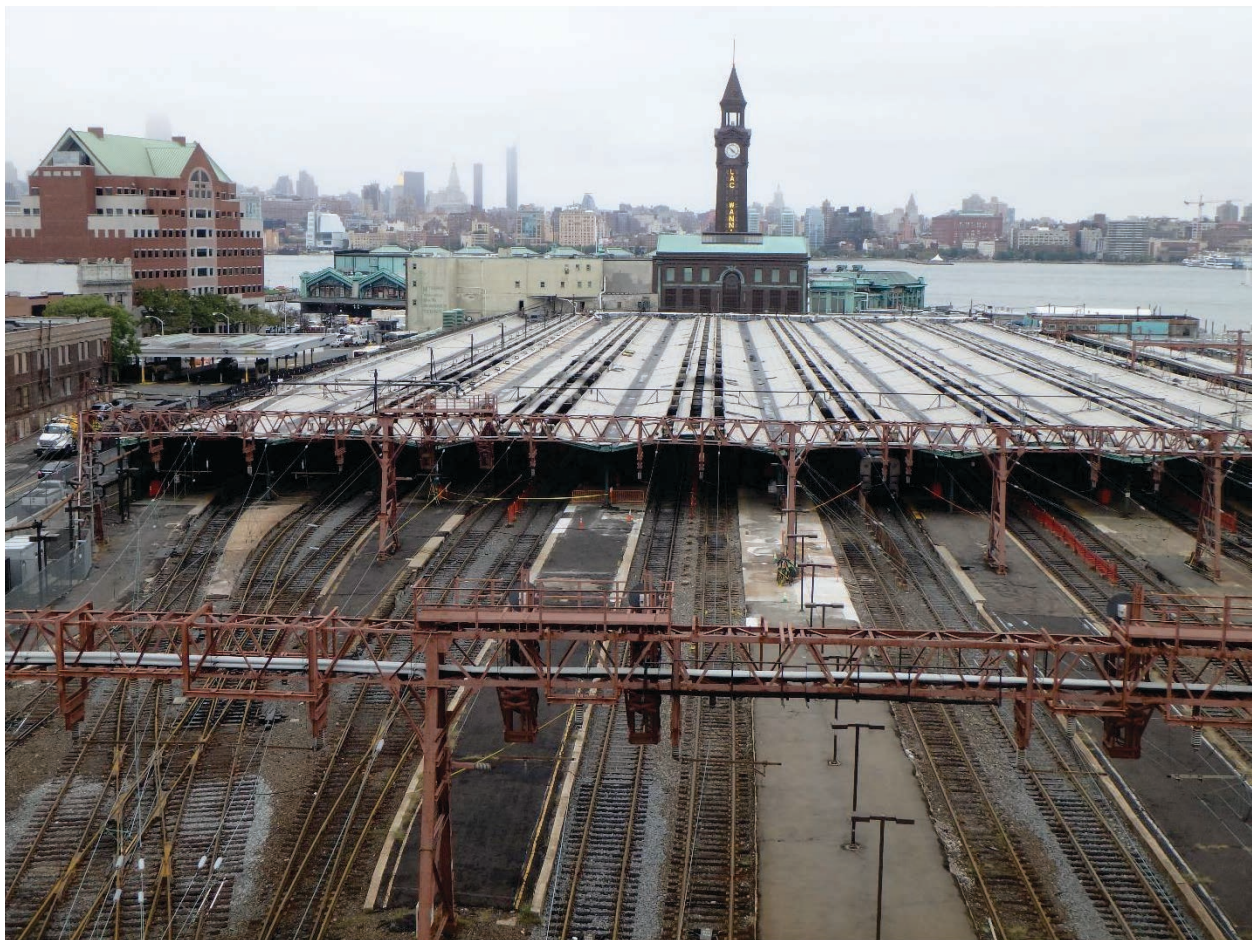
6 **Figure 2.** Track configuration eastward into Hoboken station. (Photo: NTSB)

1 main tracks 1 through 4. There were six main tracks between East End interlocking and Terminal  
2 interlocking on this line, designated as tracks 1, 2, 3, 4-main, 6-main, and 122. Figure 2 illustrates the  
3 track configuration approaching Hoboken station in an eastward direction. (For additional information,  
4 see the *Track & Engineering Group Factual Report* in the public docket for this accident.)

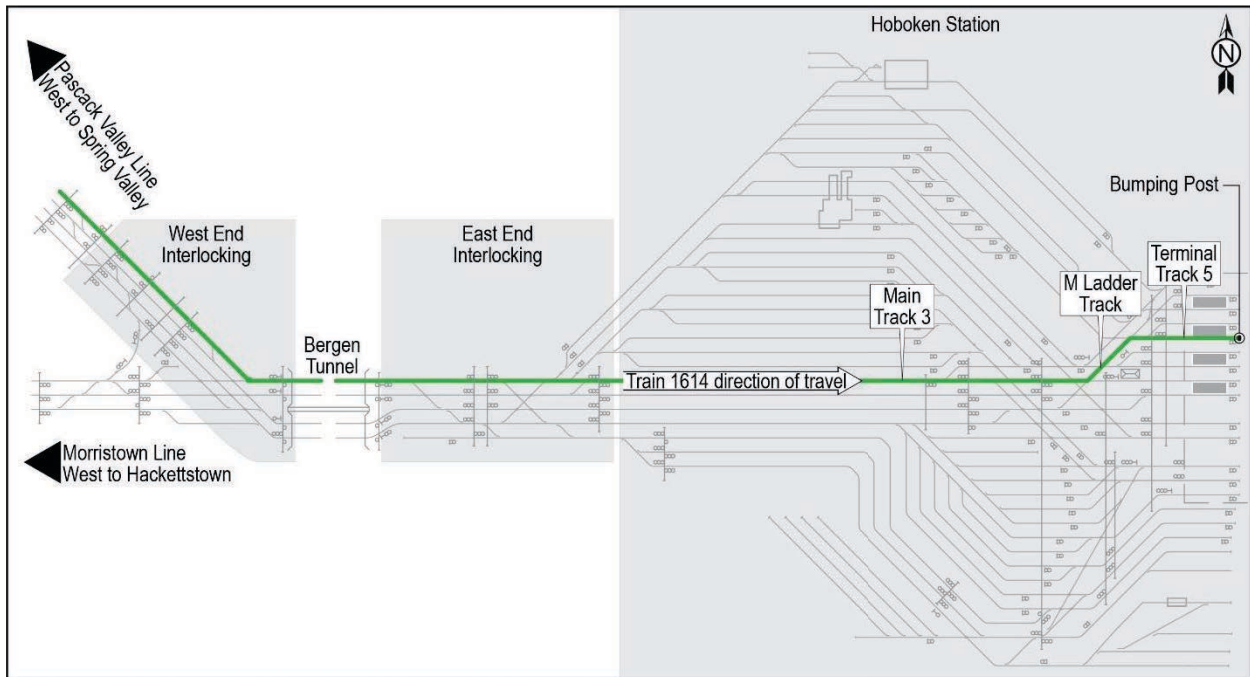
2 **Figure 3.** Train 1614 route into Terminal Track 5.

1           The train was traveling at the speed of 15 miles per hour (MPH) about 100 yards west of the  
2 Hoboken station. Train 1614 crossed over to the “M” ladder track and entered terminal track no. 5.  
3 Train 1614 moved on main track 3 through a series of crossover switches, destined for  
4 terminal track 5 in the station. The train reduced speed to 8 mph, 2 mph below the maximum  
5 authorized speed, as it entered terminal track 5; however, the train speed increased to 21 mph prior to  
6 colliding with the bumping post. (For more information, see the *Cab Car Event Recorder Group*  
7 *Chairman’s Factual Report* in the docket for this accident.) Upon impact with the bumping post, the  
8 lead car of train 1614 rode up and over the bumping post and came to a rest about 40 feet beyond the  
9 end of the track. (See Figure 3.)
