-----SYSTEMS GROUP CHAIRMAN'S FACTUAL REPORT -----

Exemplar Aircraft Examinations

Location: McKinneyville, California
Date: July 29, 2016
Time: About 0105 Pacific Daylight Time
Aircraft: Piper PA-31T
Registration: N661TC

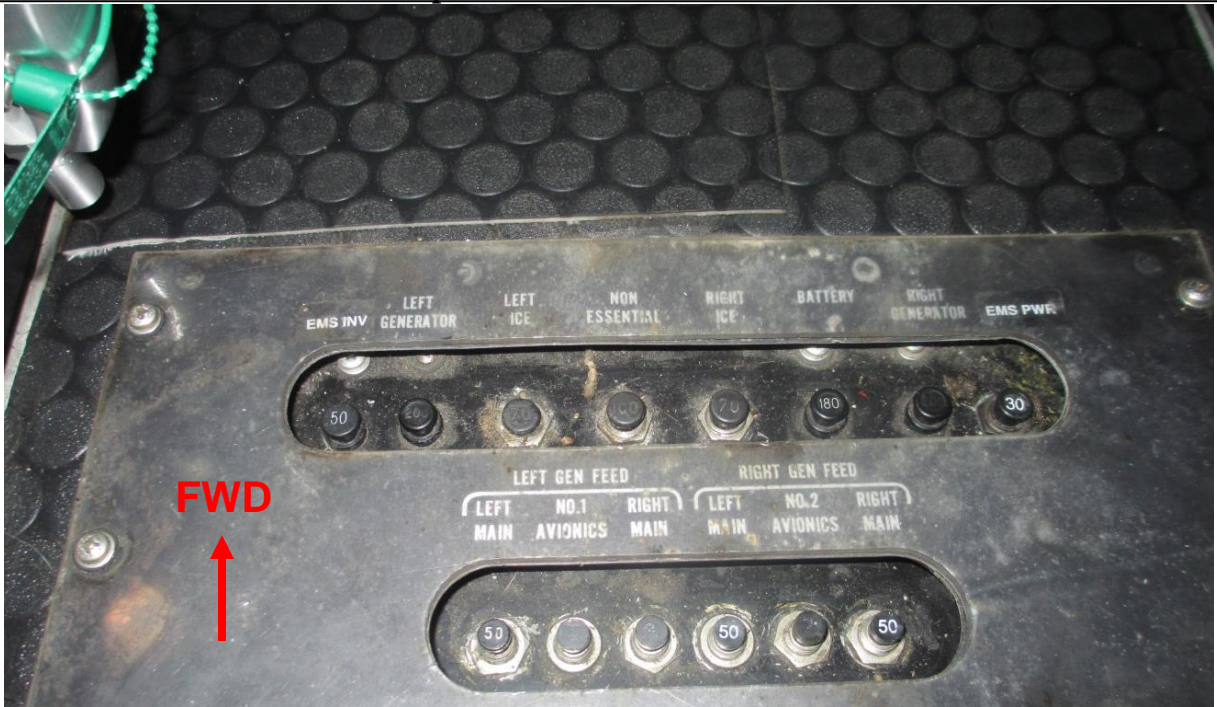
Figure 1 – Main bus tie circuit breaker panel
