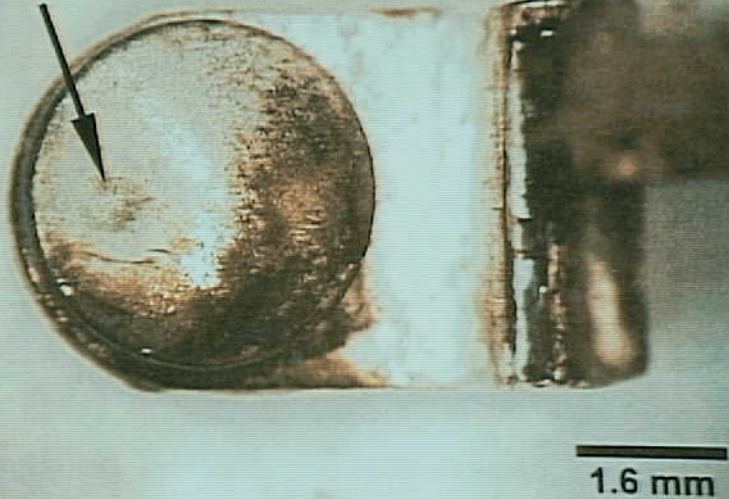
Systems 9 - Exhibit No. 9B - Photo 10. Figure 10c. The stationary load contact of the SPR circuit breaker has a tarnished appearance. Arrow highlights the mechanical wear from the making and breaking of the contacts.
