Systems 9 - Exhibit No. 9B - Photo 12. Figure 12c. EDS spectrum of an area described as being tarnished on the stationary line contact of the SPR circuit breaker. The silver in both spectrums is primarily from the contact material.

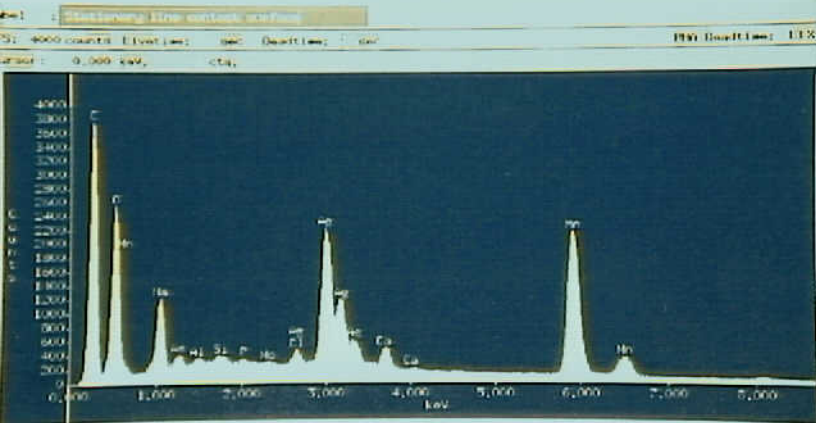
The contact material.

Figure 12. EDS spectrum of a area described as being tarnished on the stationary line contact of the SPR circuit breaker. The silver in both spectrums is primarily from the
