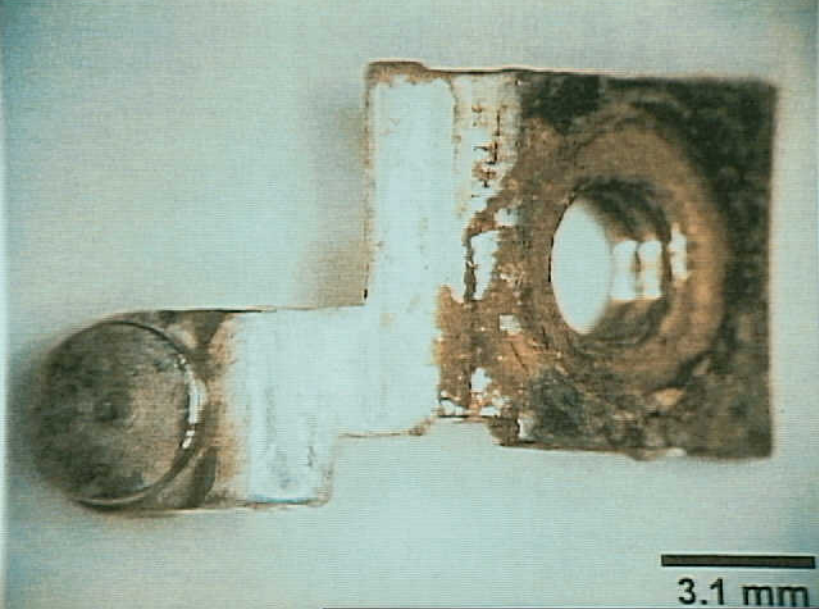
Systems 9 - Exhibit No. 9B - Photo 17. Figure 17c. The stationary line terminal and contact of the RTV circuit breaker have a tarnished appearance.
