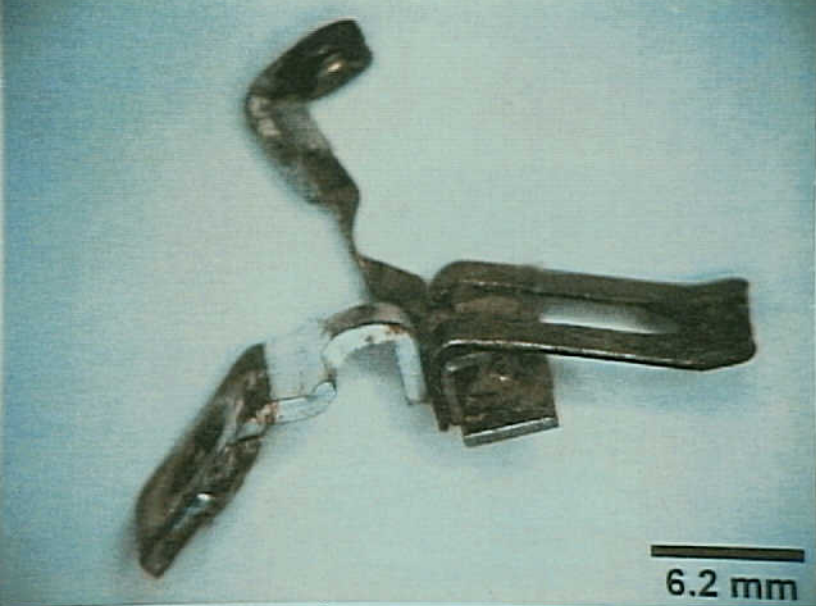
Systems 9 - Exhibit No. 9B - Photo 18. Figure 18c. The stationary load terminal and contact of the RTV circuit breaker have a tarnished appearance.
