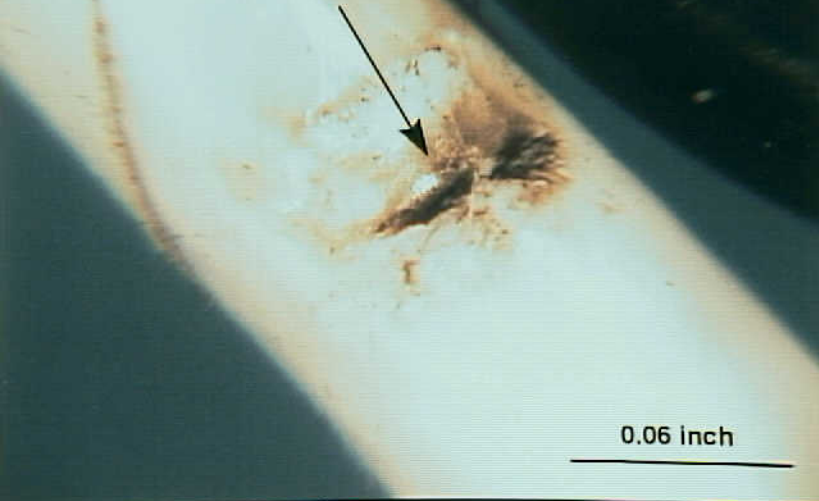
Break in PTFE insulation from contact with terminal  
block serrated surface beneath clamp

Systems 9 - Exhibit No. 9B - Photo 34. Figure 34g. Fuel probe (model no. FG420A12, serial no. A-14) from N93105 with compression damage to PTFE insulation.
