Systems 9 - Exhibit No. 9B - Photo 37. Figure 37g. Compensator (model no. FG6C1, serial no. A-166) from N93105 having apparent compression damage to PTFE insulation.

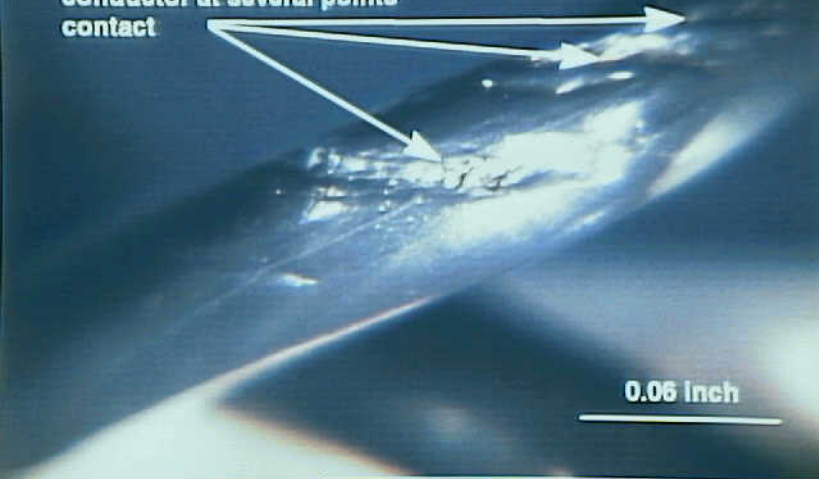
**The same compression
damage seen in Figure 36,
found to have exposed
conductor at several points
contact**

0.06 inch
