Systems 9 - Exhibit No. 9B - Photo 43. Figure 43g. Lo-Z wire from N93105 (model no. FG420A12, serial no. A-21).

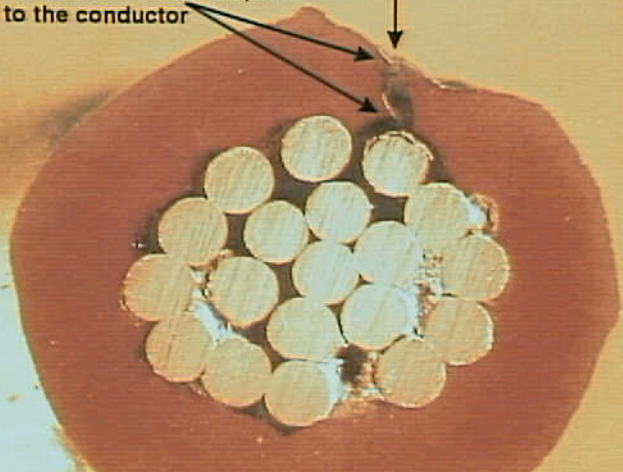
PTFE insulation thinned and split through to the conductor

Cross-sectional view of compression damage. Section was taken where black film can be seen the insulation surface in Figure 42

0.016 inch
