Systems 9 - Exhibit No. 9B - Photo 47. Figure 47g. Cross-sectional view of damaged Hi-Z pigtail lead wire from compensator (model no. FG6C2, serial no. Y-147) out of N93105.

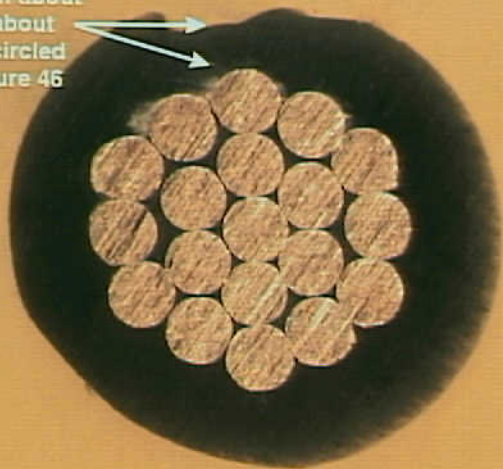
PTFE insulation
thinned from about
8.8 mils to about
3.9 mils in circled
area of Figure 46
