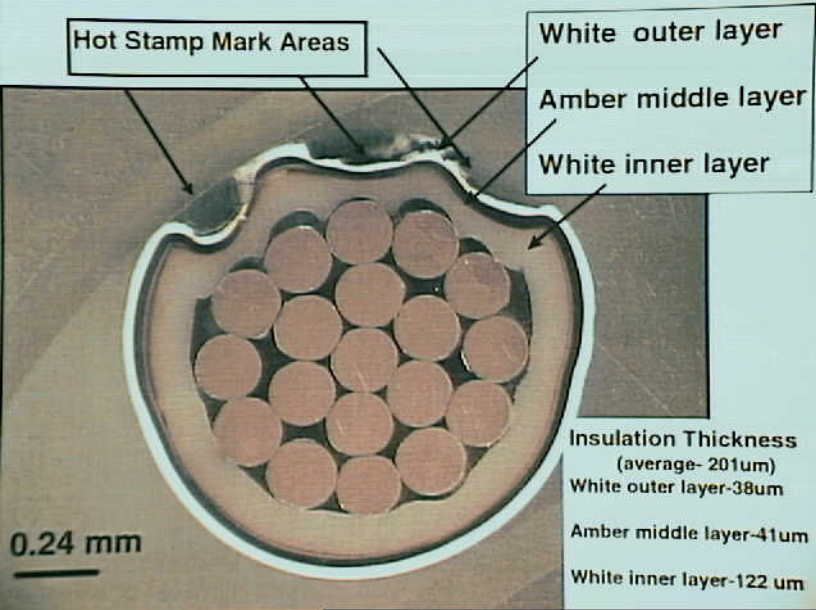
Systems 9 - Exhibit No. 9B - Photo 5. Figure 5f. Cross section of the wire showing three layer construction and depth penetration of the hot stamp mark. Note thickness of layers and total thickness at bottom right. Note deformation in inner layer.
