**Systems 9 - Exhibit No. 9B - Photo 51. Figure 51g. Compensator (model no. FG6C1, serial no. A-166) from N93105 with compression damage to PTFE insulation.**

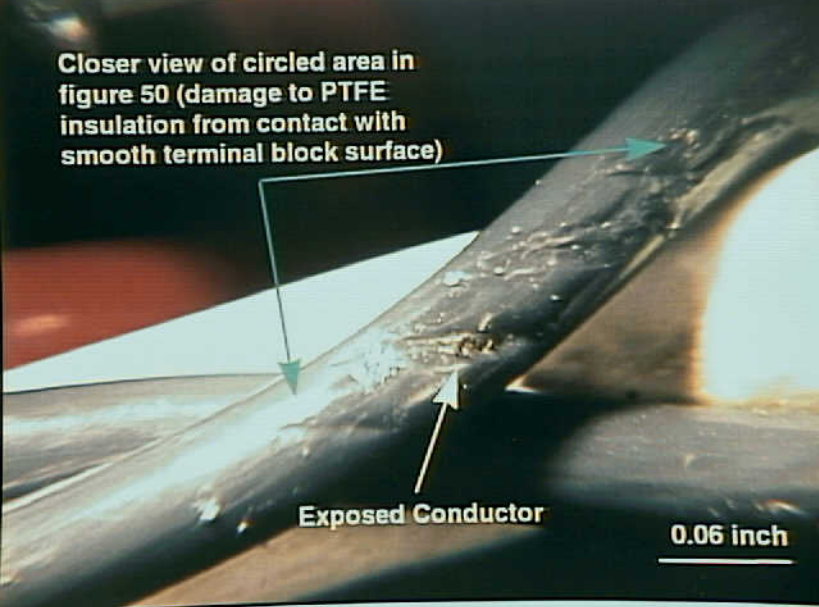
**Closer view of circled area in figure 50 (damage to PTFE insulation from contact with smooth terminal block surface)**

**Exposed Conductor**

**0.06 inch**
