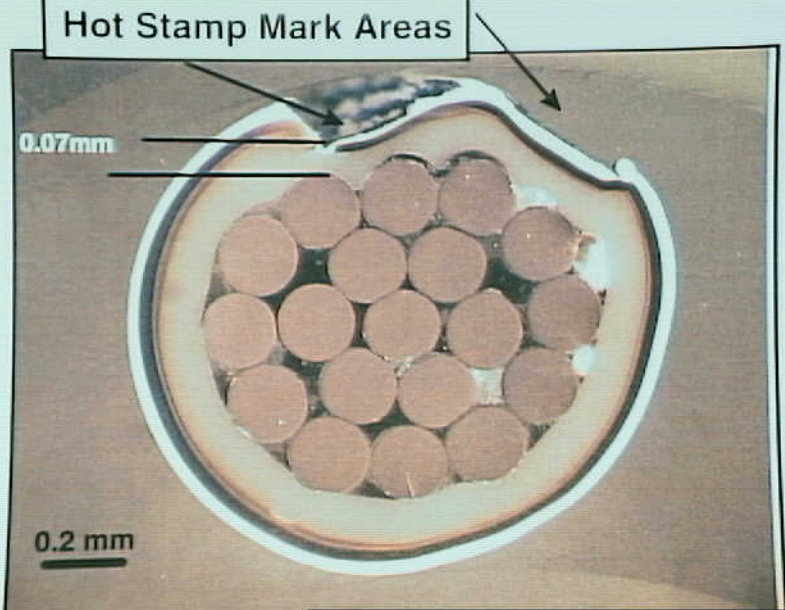
Systems 9 - Exhibit No. 9B - Photo 6. Figure 6f. Perpendicular cross section showing depth penetration of the hot stamp marks. Note that all three insulation layers were penetrated and the inner white layer was deformed by the stamping process.
