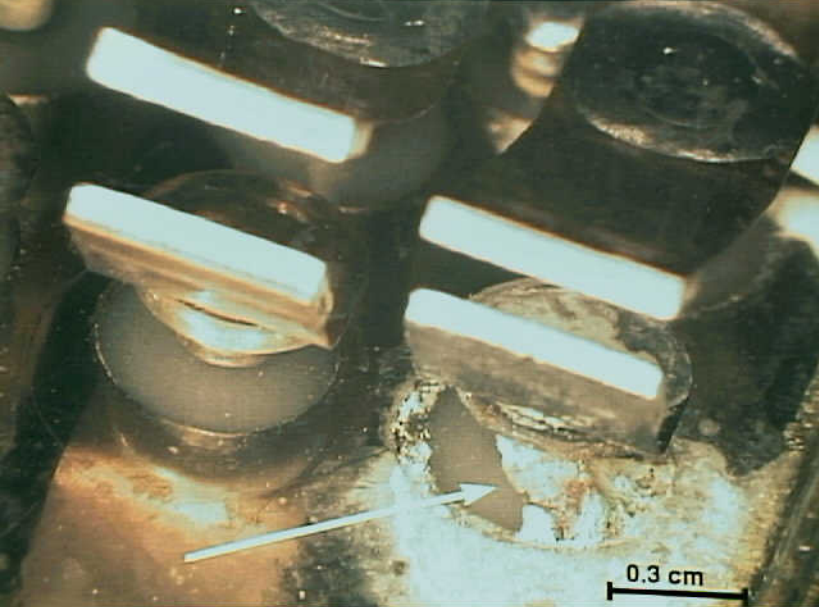
Systems 9 - Exhibit No. 9B - Photo 8. Figure 8b. Residues on and surrounding the glass to metal seal of N.O. contact A1.
