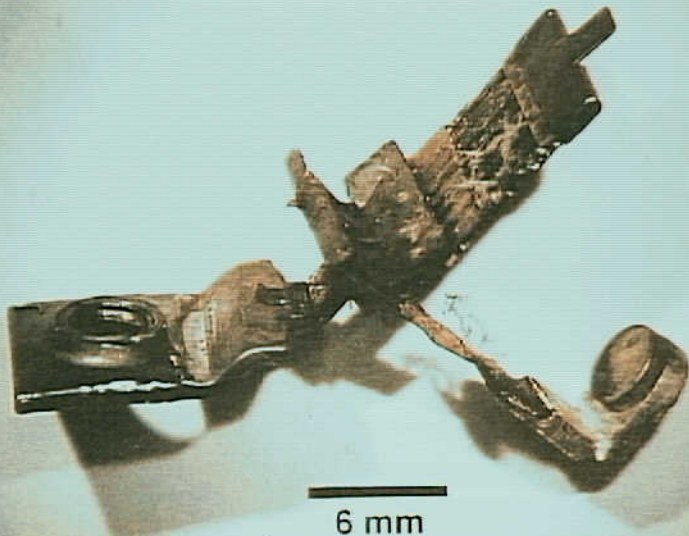
Systems 9 - Exhibit No. 9B - Photo 8. Figure 8c. The stationary load terminal and contact of the SPR circuit breaker have a tarnished appearance.
