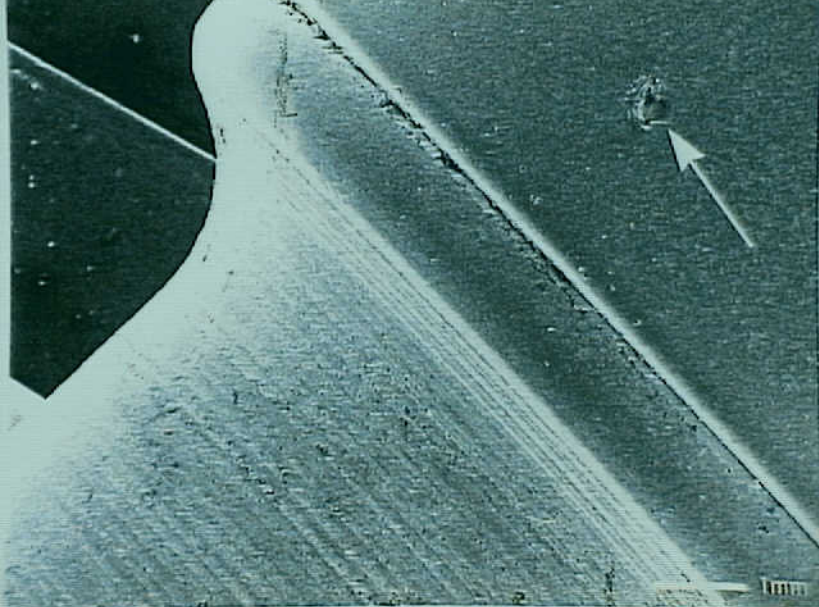
Systems 9 - Exhibit No. 9B - Photo 9. Figure 9a. SEM view of the gouge found on the scavenge pump switch knob (arrow).
