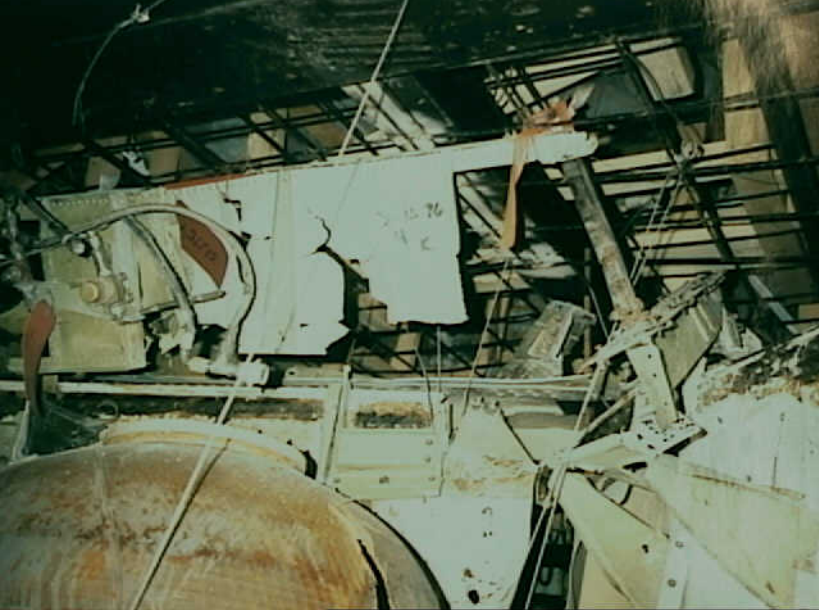
Systems 9 - Fuel Quantity Indication System - Photo 8. View of repaired potable water compressor mount over left potable water tank with green replacement parts, peeled top-coat of whitel paint (on spar) and red fasteners in repaired area.
