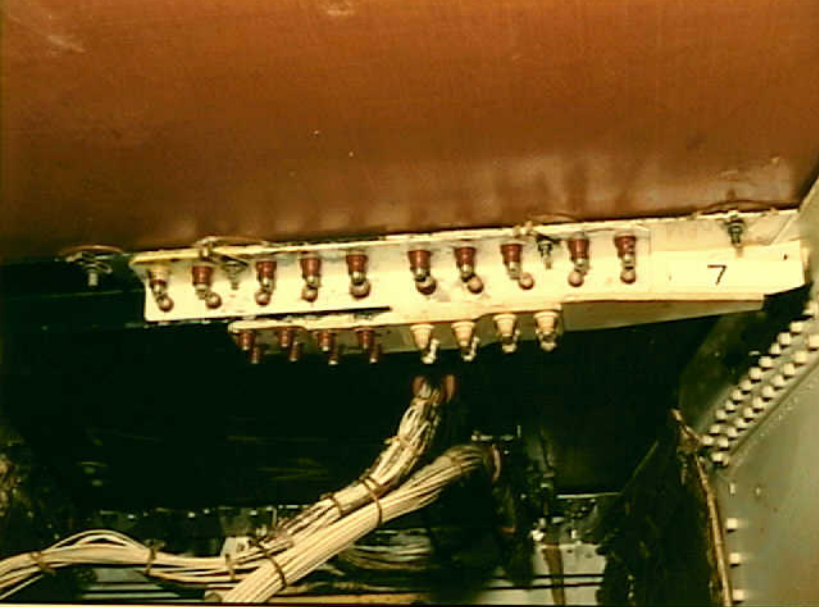
Systems 9 - Photo 11. Airplane 7. B-747 Floor structure repair in electrical equipment center, aft of station 400 (left side). Grouped open splices also visible in bundle.
