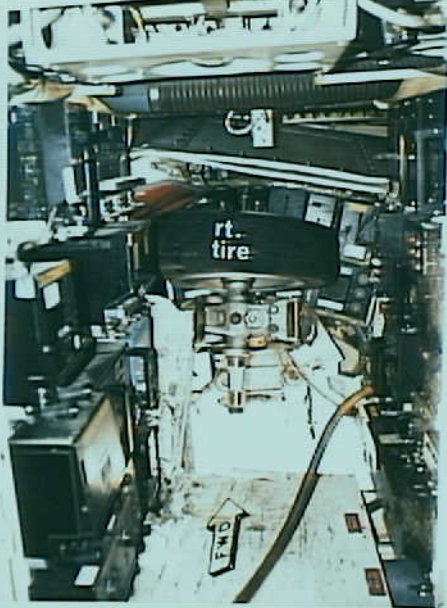
Systems 9 - Photo 11. View of E/E from the forward baggage compartment (looking forward). Note the nose gear folded back into the compartment clocked 90 degrees to the right. The left nose gear tire has been removed to gain access.
