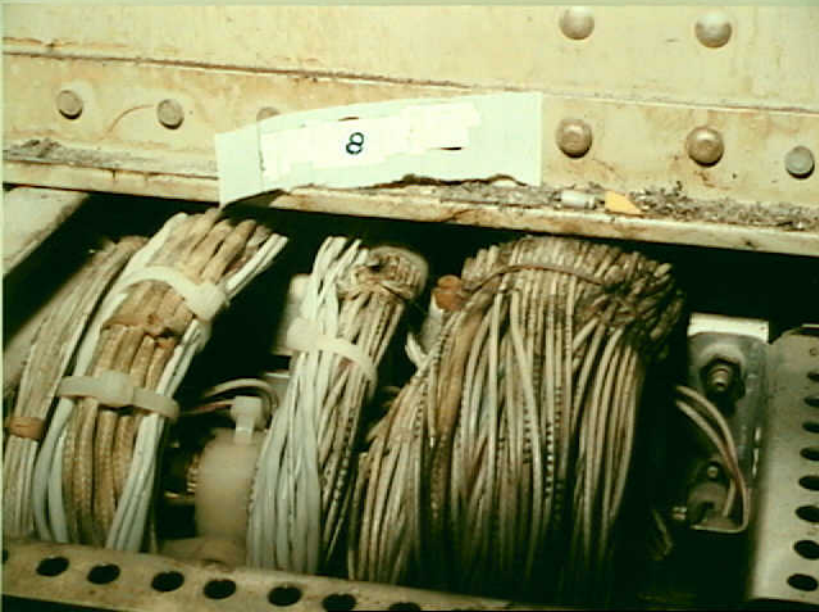
Systems 9 - Photo 14. Airplane 8. DC-9-30 in electrical equipment center at top of left power distribution panel. Visible are drill shavings and rivet fragments. Mixture of wire types is visible. Location is covered by floor boards.
