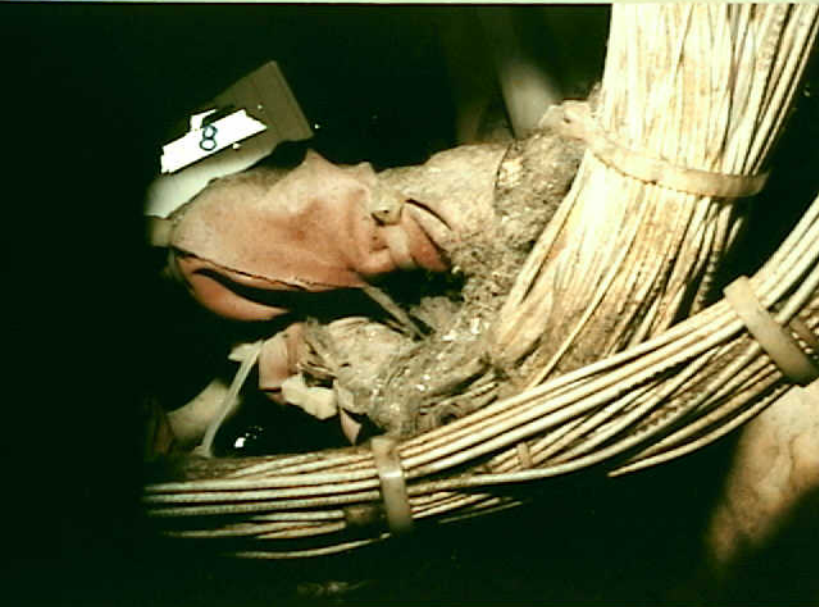
Systems 9 - Photo 15. Airplane 8. DC-9-30 Lint and metal shavings in electrical equipment center, behind left avionics racks.
