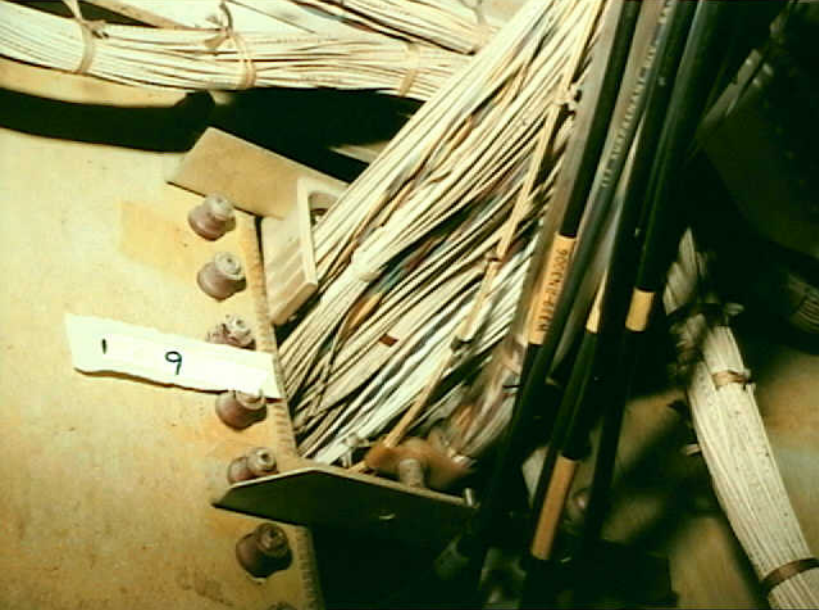
Systems 9 - Photo 17. Airplane 9. B-747 Raceway clamp at STAT 400 opening has no retainer. Pressing upward on wires revealed that the quantity of wires prevented installation of a retainer. Mixed wire types and fresh white wire insulation is visible.
