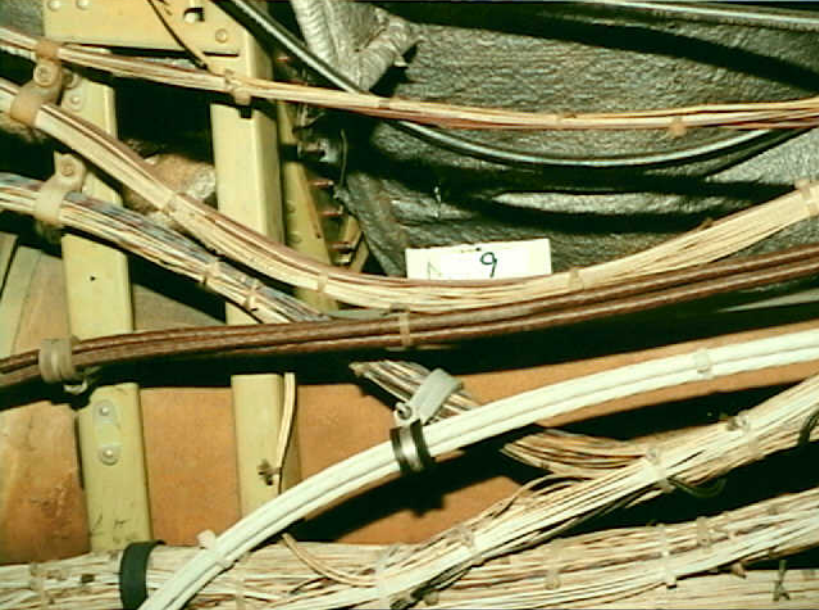
Systems 9 - Photo 19. Airplane 9. B-747 upper deck. CWT FQIS wires in bundle W480 sag and rub on galley power cable. Also visible are mixture of clamp types, mixture of wire types, broken clamp retainer at lower left and sags in upper bundles.
