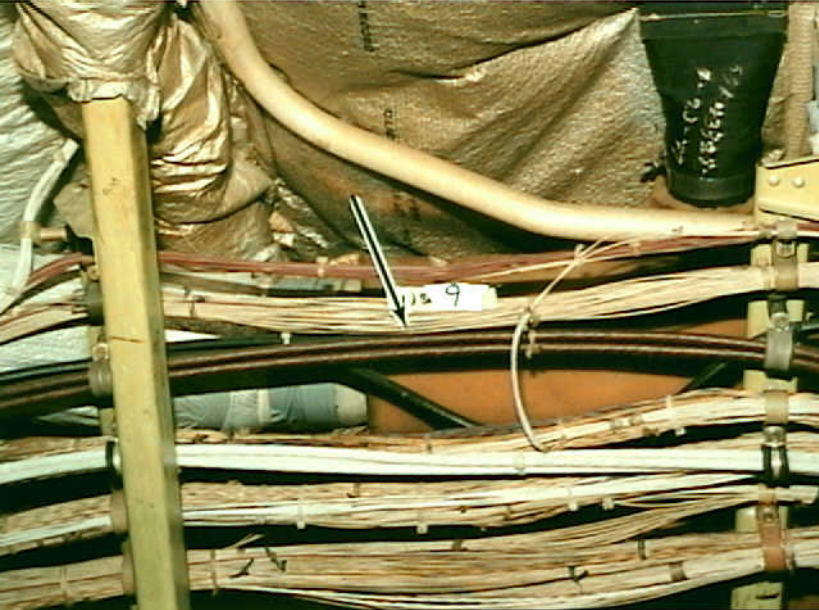
Systems 9 - Photo 20. Airplane 9. B-747 wire installation forward of photo 19 shows CWT FQIS wires in W480 sag and rub galley power cable. Splices are half exposed in clamp at upper left, behind structure (beneath red wires). Capped wire is at right.
