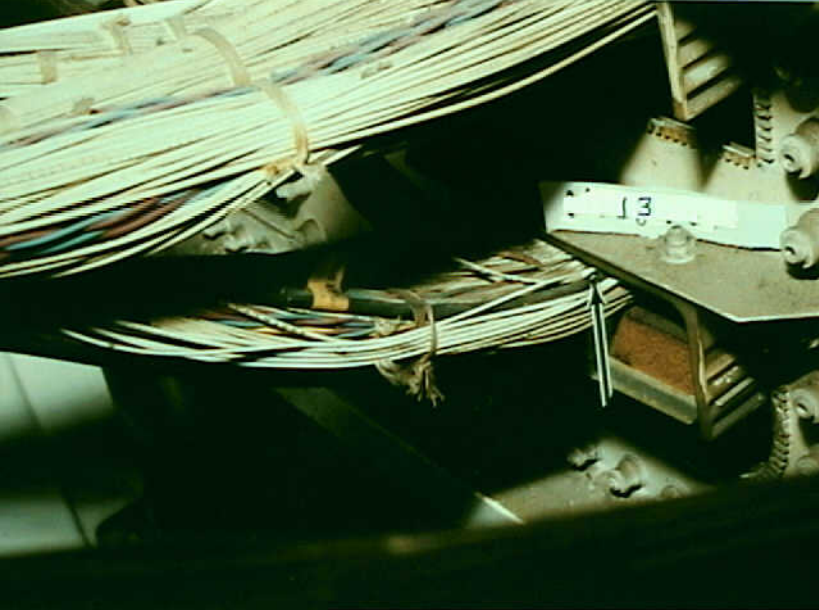
Systems 9 - Photo 29. Airplane 13. B-747 station 400 (left) opening with clamp loosened for photo. Arrow points to hole worn through black woven sleeve on wires. Wire in sleeve was damaged. Loose string ties visible. Clamp above is missing retainer.
