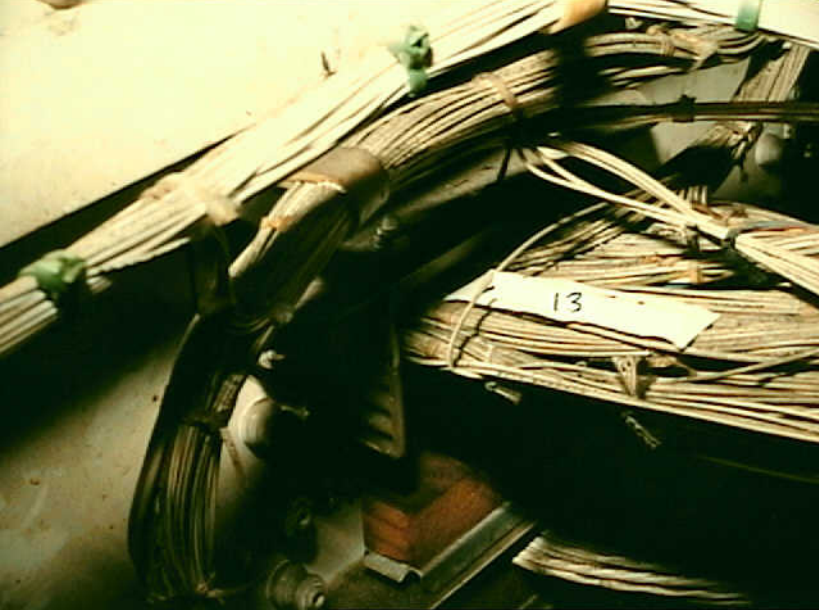
Systems 9 - Photo 30. Airplane 13. B-747 station 400 (right) opening with clamp loosened for photo. Insulation of adjacent wire chafed off at nylon edge of clamp. Also visible are a mixture of new and old wire and drill shavings.
