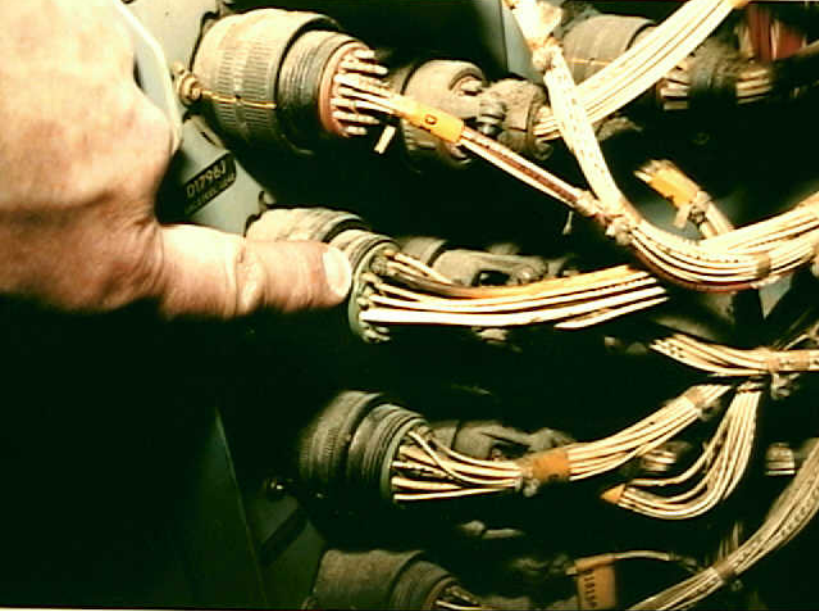
Systems 9 - Photo 36. Airplane 16. B-747 wire insulation outboard of (P6) circuit breaker panel is split and dark brown where it comes from the connector. Copper conductor is visible. Note plug missing two holes
