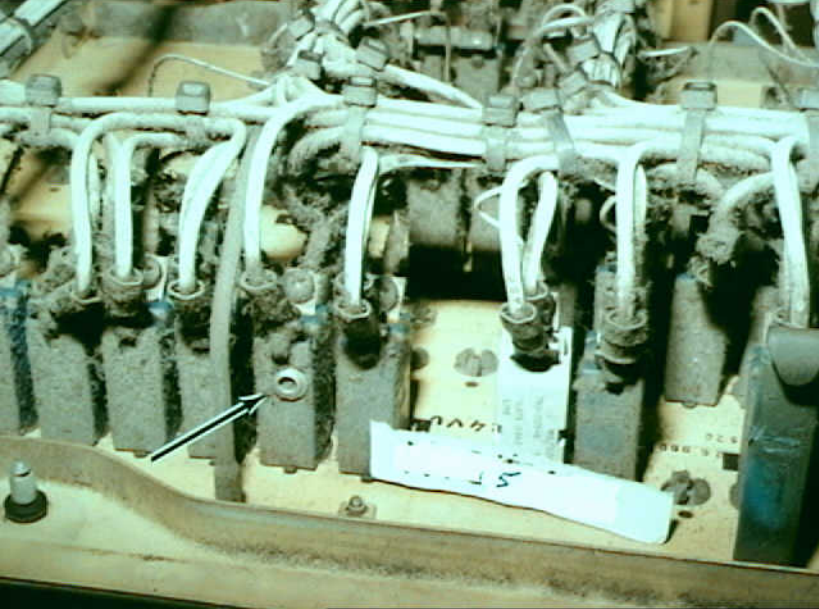
Systems 9 - Photo 4. Airplane 5. Hardware (washer) on circuit breaker and lint accumulation. Location is inside of opened circuit breaker panel in Airbus A-300 cockpit.
