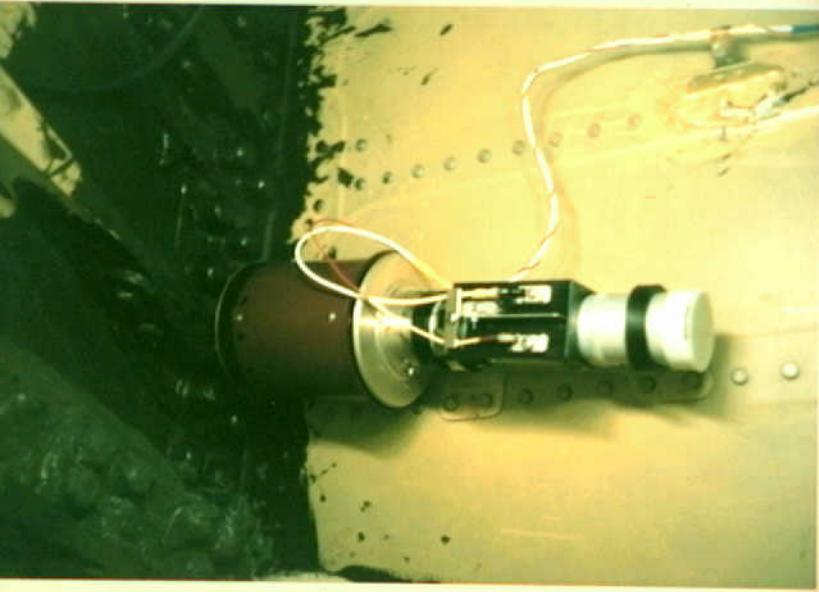
Systems 9 - Photo 47. Airplane 19. B-757 Compensator and wire insulation. Roughened wire insulation was found where wires contacted the corners of the can shaped lower portion and near the row of rivets. (Top of compensator shown to right).
