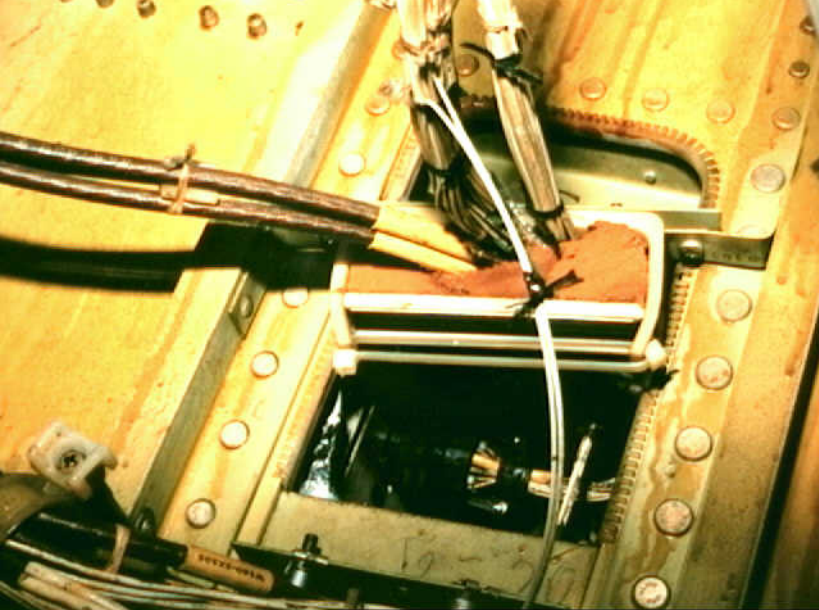
Systems 9 - Photo 51. (Feb. 21-25, 1998) B-747 opening and wire behind bundle at left of photo 50. Clamp sprung open when plastic panduit (ty-wrap) was removed. Visible are degraded foam, brown on wires, and power cables routed with system wires.
