NATIONAL TRANSPORTATION SAFETY BOARD

737 Rudder Power Control Unit  
Particulate Contamination Test  
January 12-20, 1995

### **737 Rudder PCU Particulate Contamination Test**

January 12 through 20, 1995

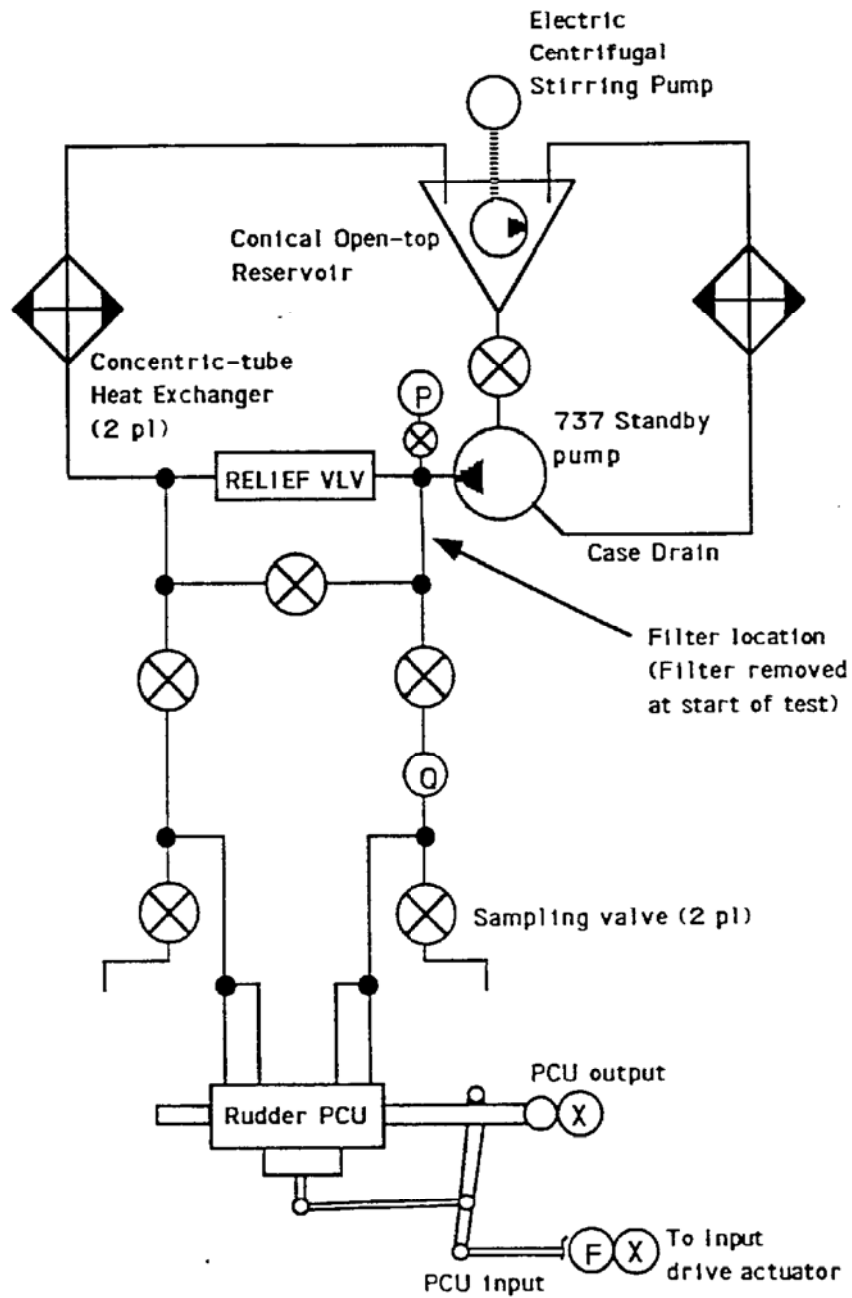
**Figure 1**  
**Test Rig Schematic**

The test rig schematic is given as Figure 1.

A test circuit will be fabricated per the schematic given in Figure 1. Pump will be part number 10-61292-4 (737 Standby pump). Rudder PCU will be p/n 65-44861-11 with inlet filters removed. A crank mechanism, driven by a hydraulic or electric motor, will be required in order to provide the correct input to the PCU.

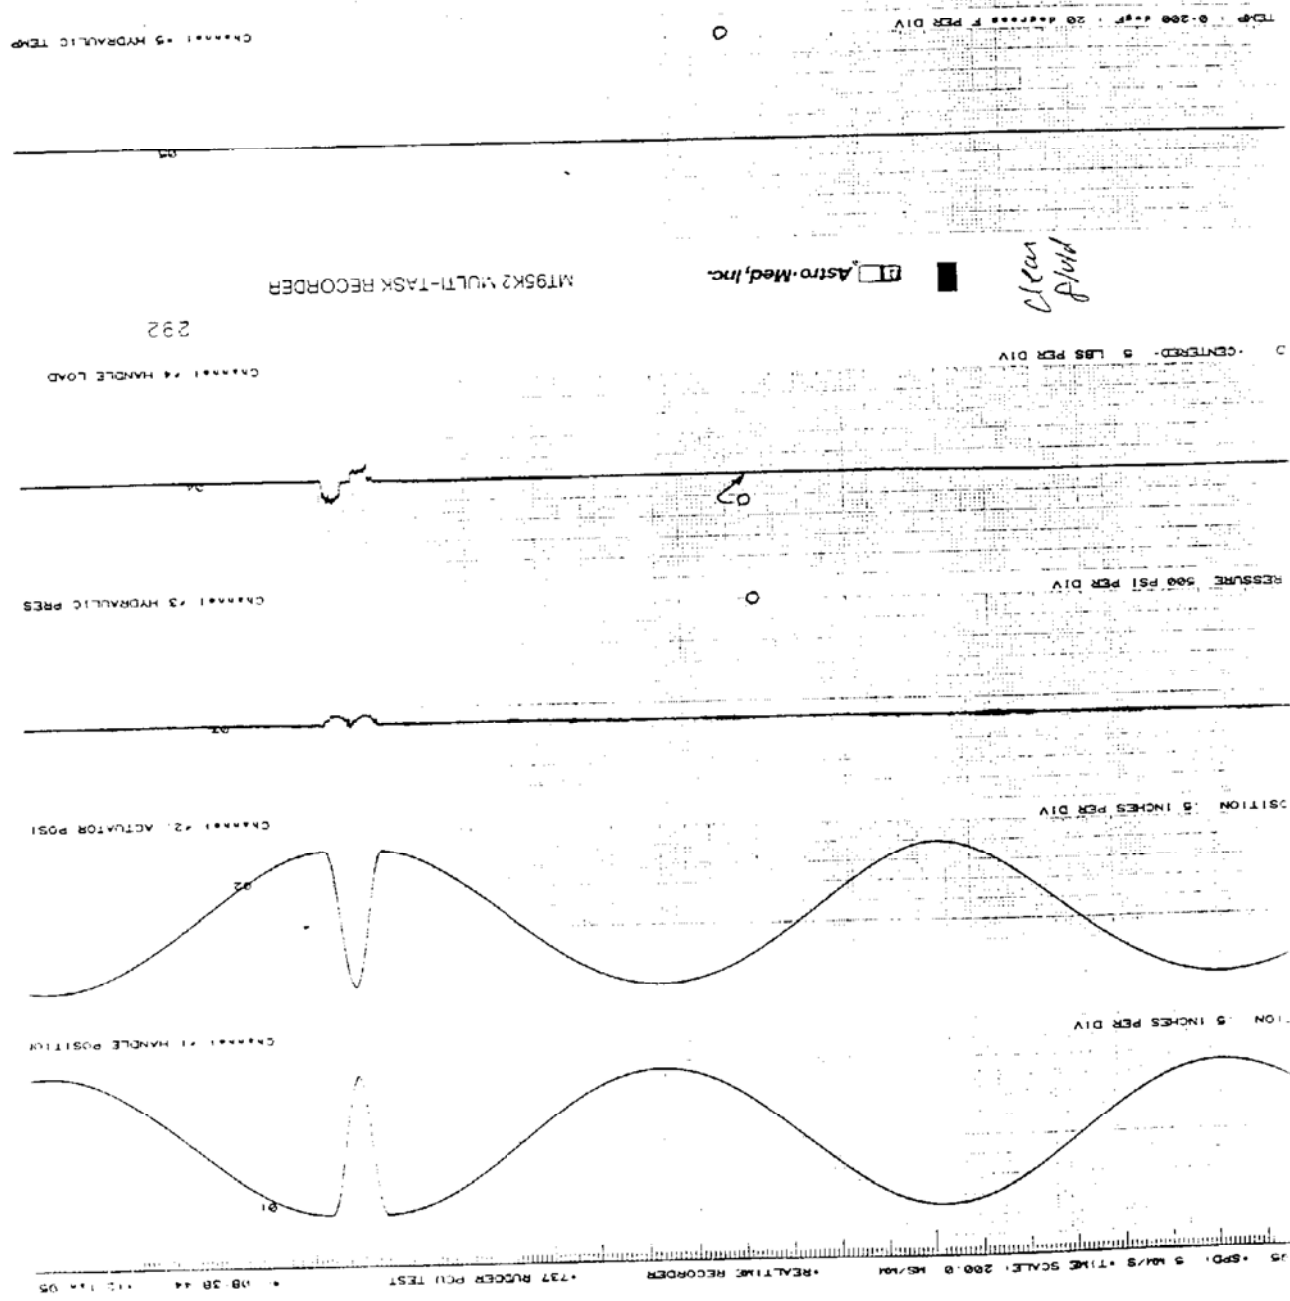
Removed filter, ran about twenty minutes, checking out input mechanism, etc. Samples 2P & 2R taken. (Figure D1)

FIGURE D1  
12 JAN 8:38 AM  
START OF TEST  
CLASS 12 PRESSURE  
CLASS 8 RETURN

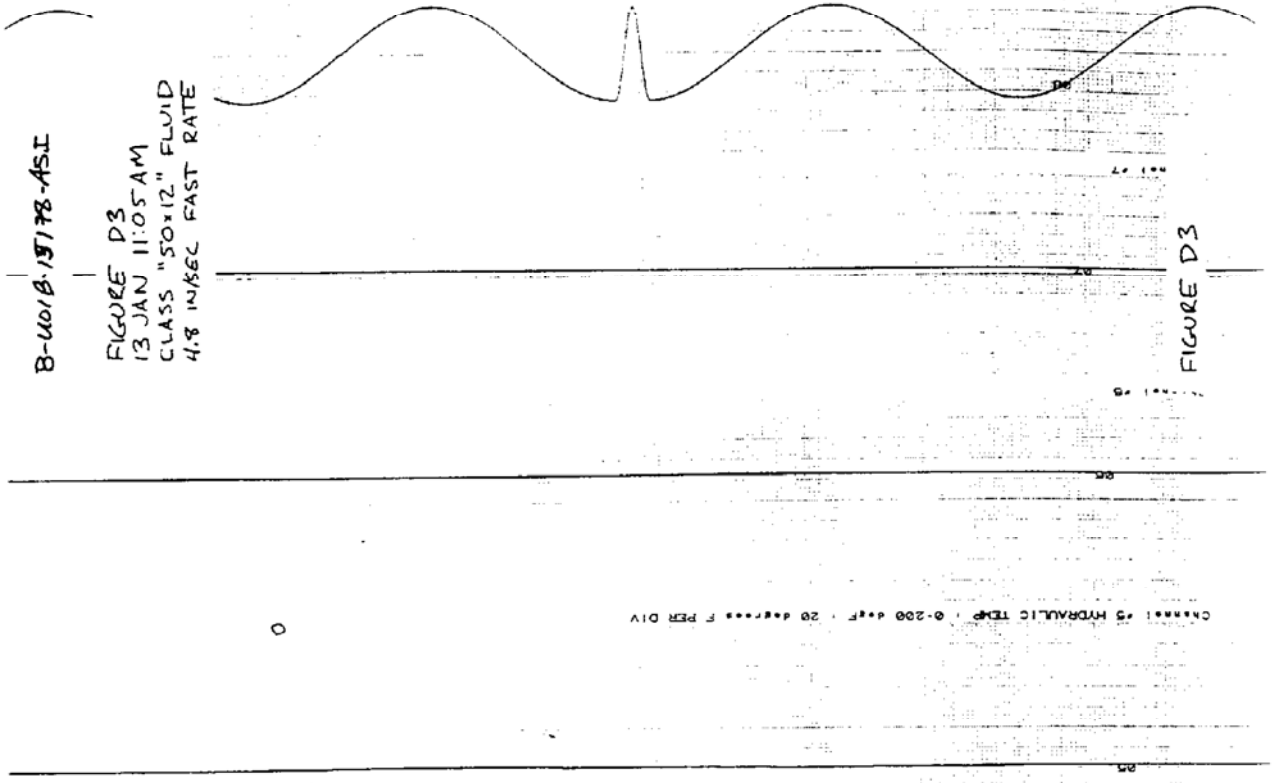
Input force during fast cycles gradually increased, causing numerous high-input-force shutdowns. High-force protection was disabled. Saw input forces as high as 135 lb. (Figure D3)

FIGURE D3  
13 JAN 11:05 AM  
CLASS "50x12" FLUID  
4.8 IN/SEC FAST RATE

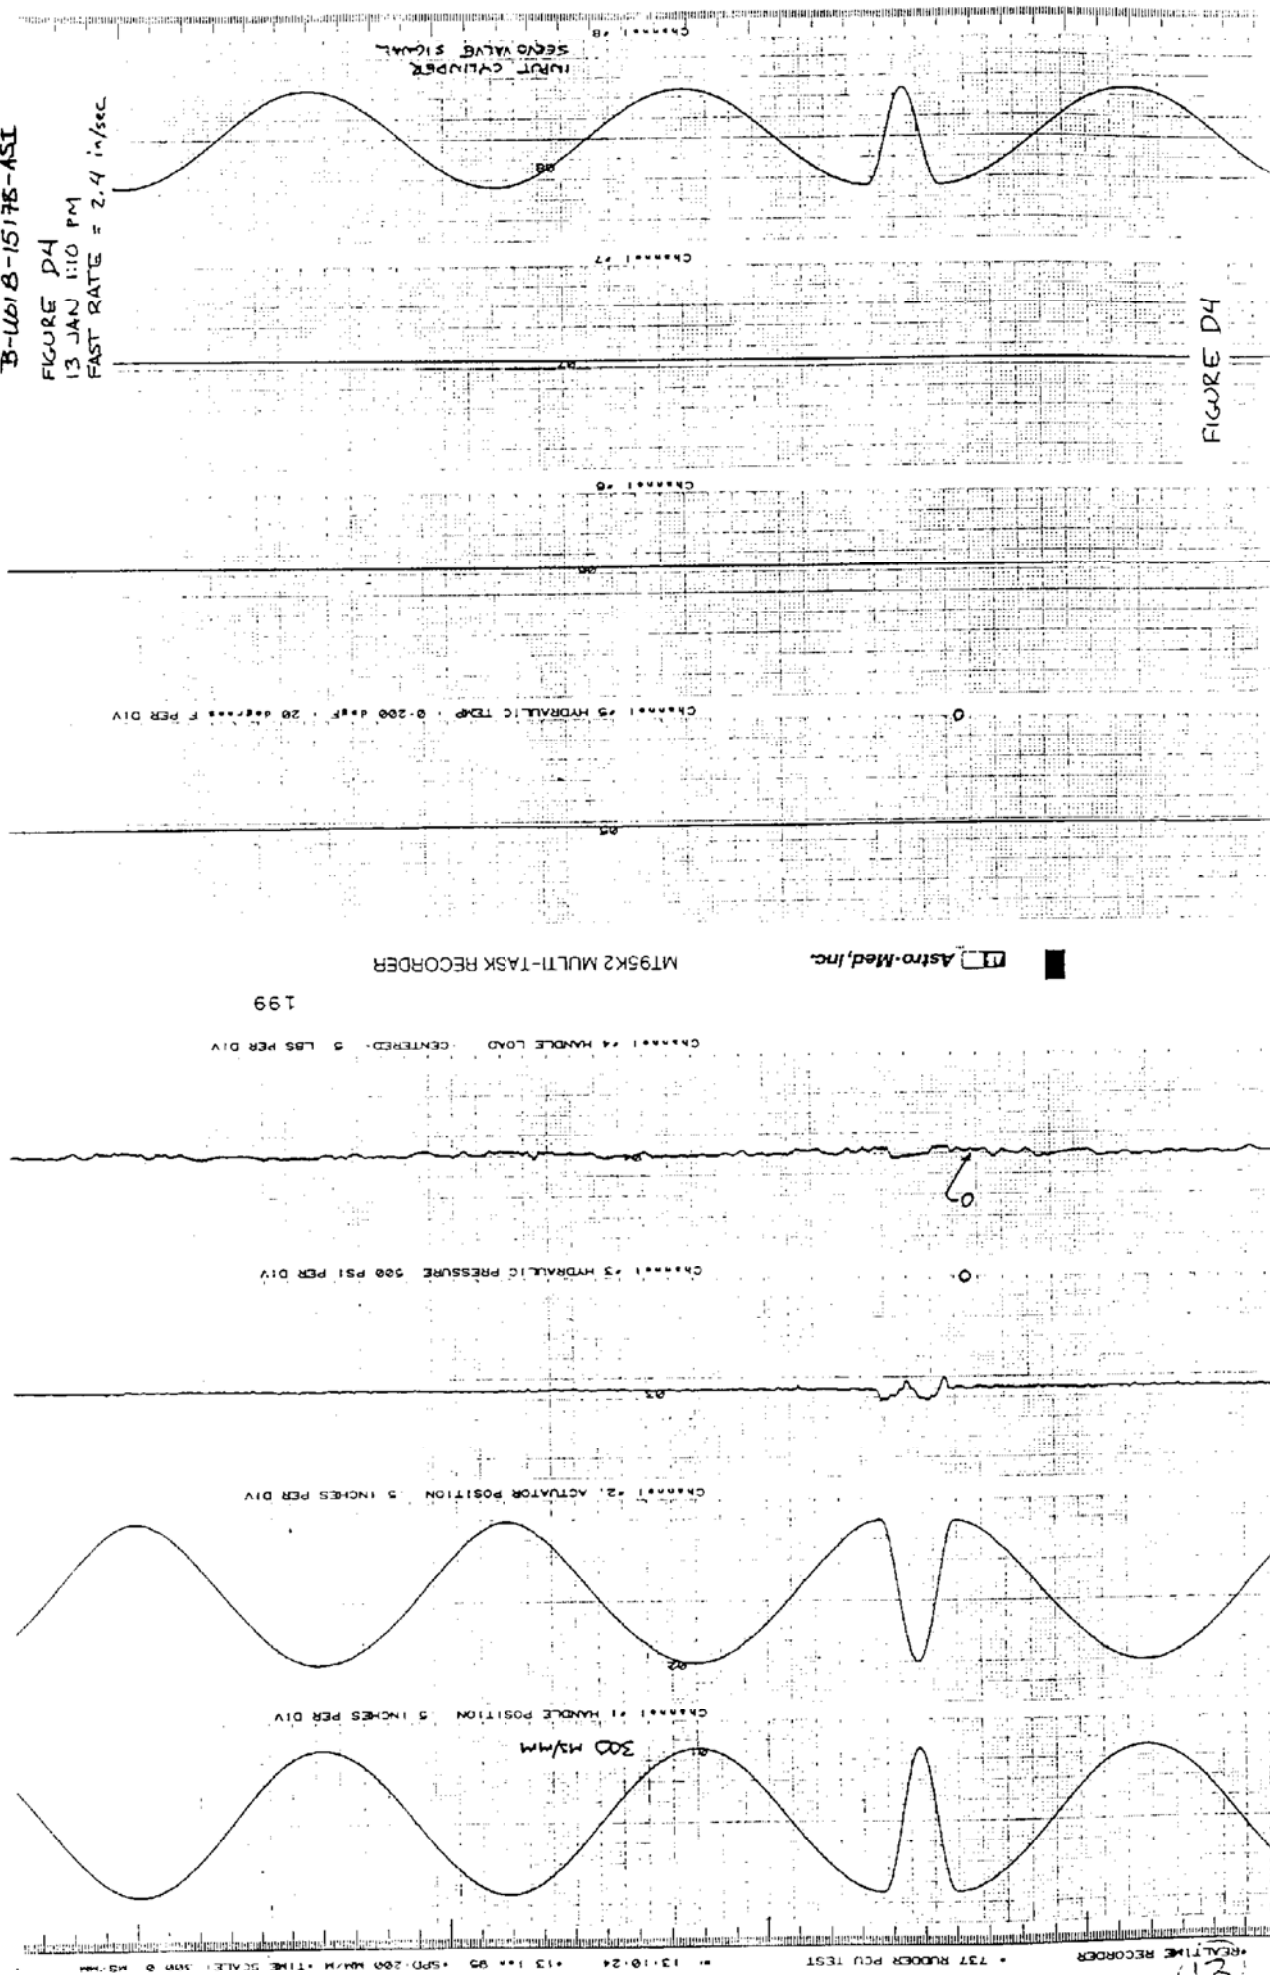
Reduced fast rate to 2.4 in/sec. (Figure D4)

FAST RATE = 2.4 in/sec

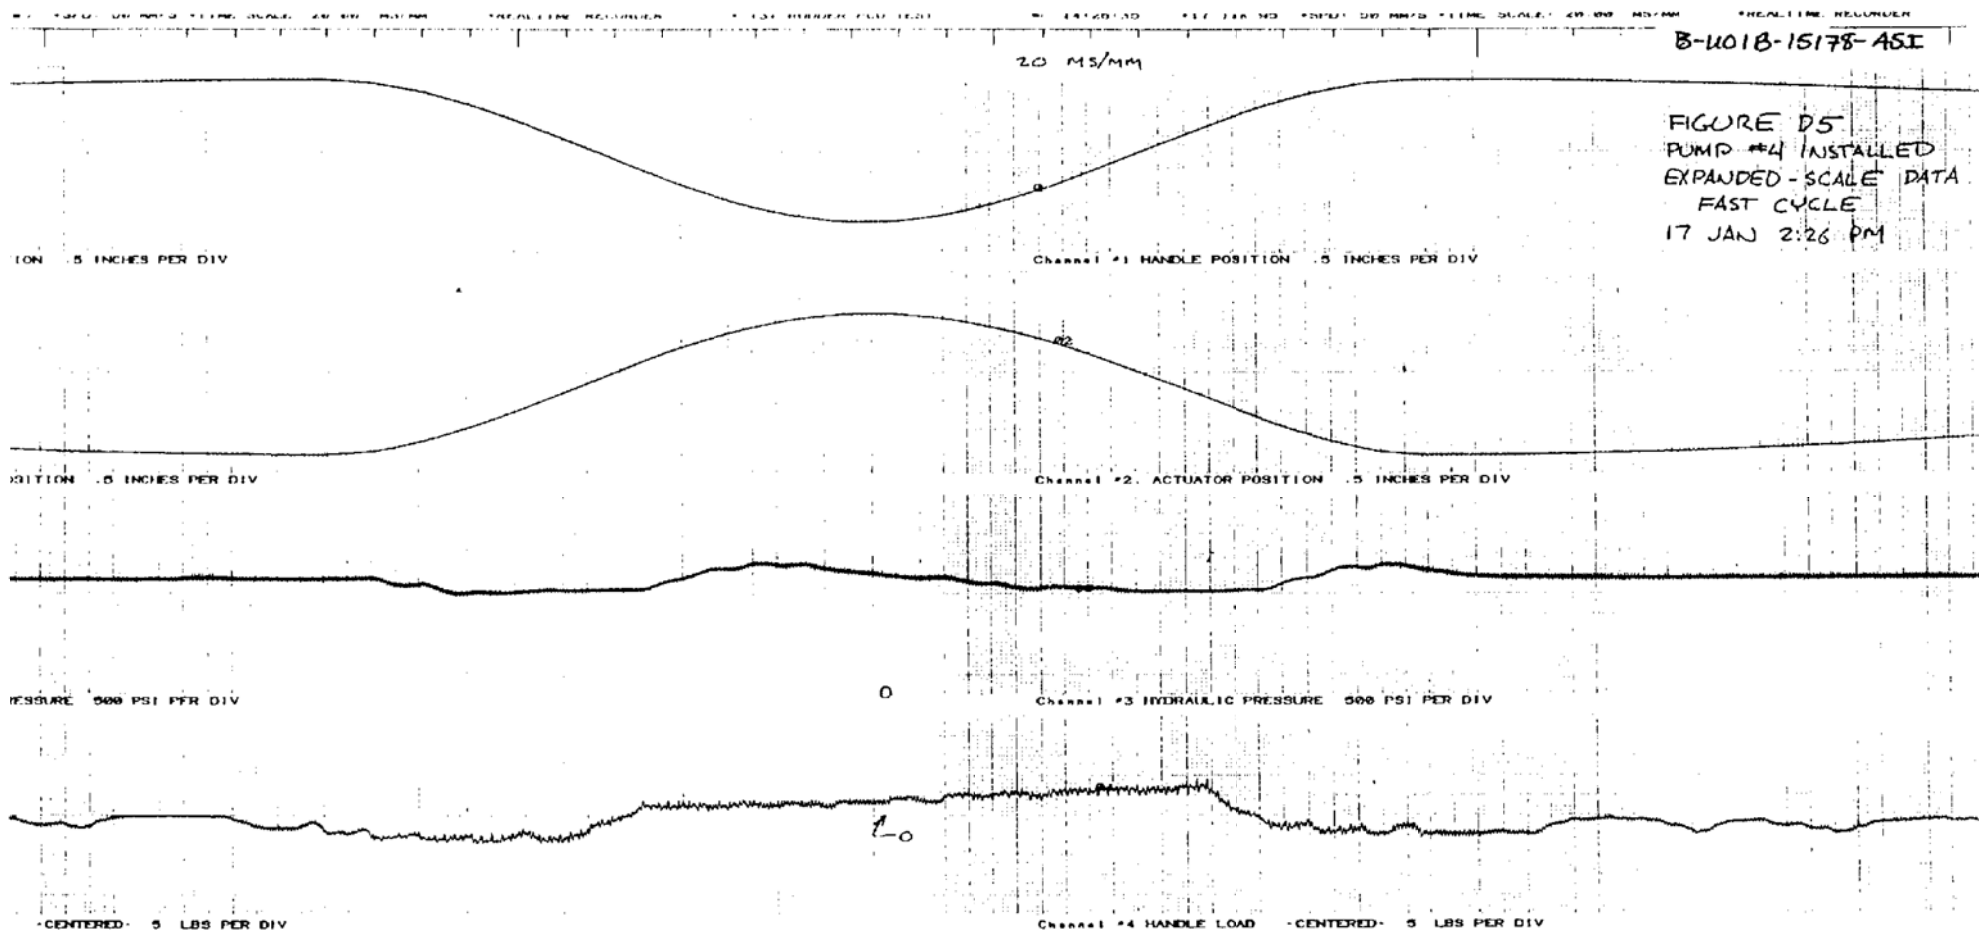
FIGURE D5

Produced expanded-scale data for fast (2.4 in/sec) cycle. (Figure D5)

Input force about 8 lb (slow cycle force was about 4 lb)

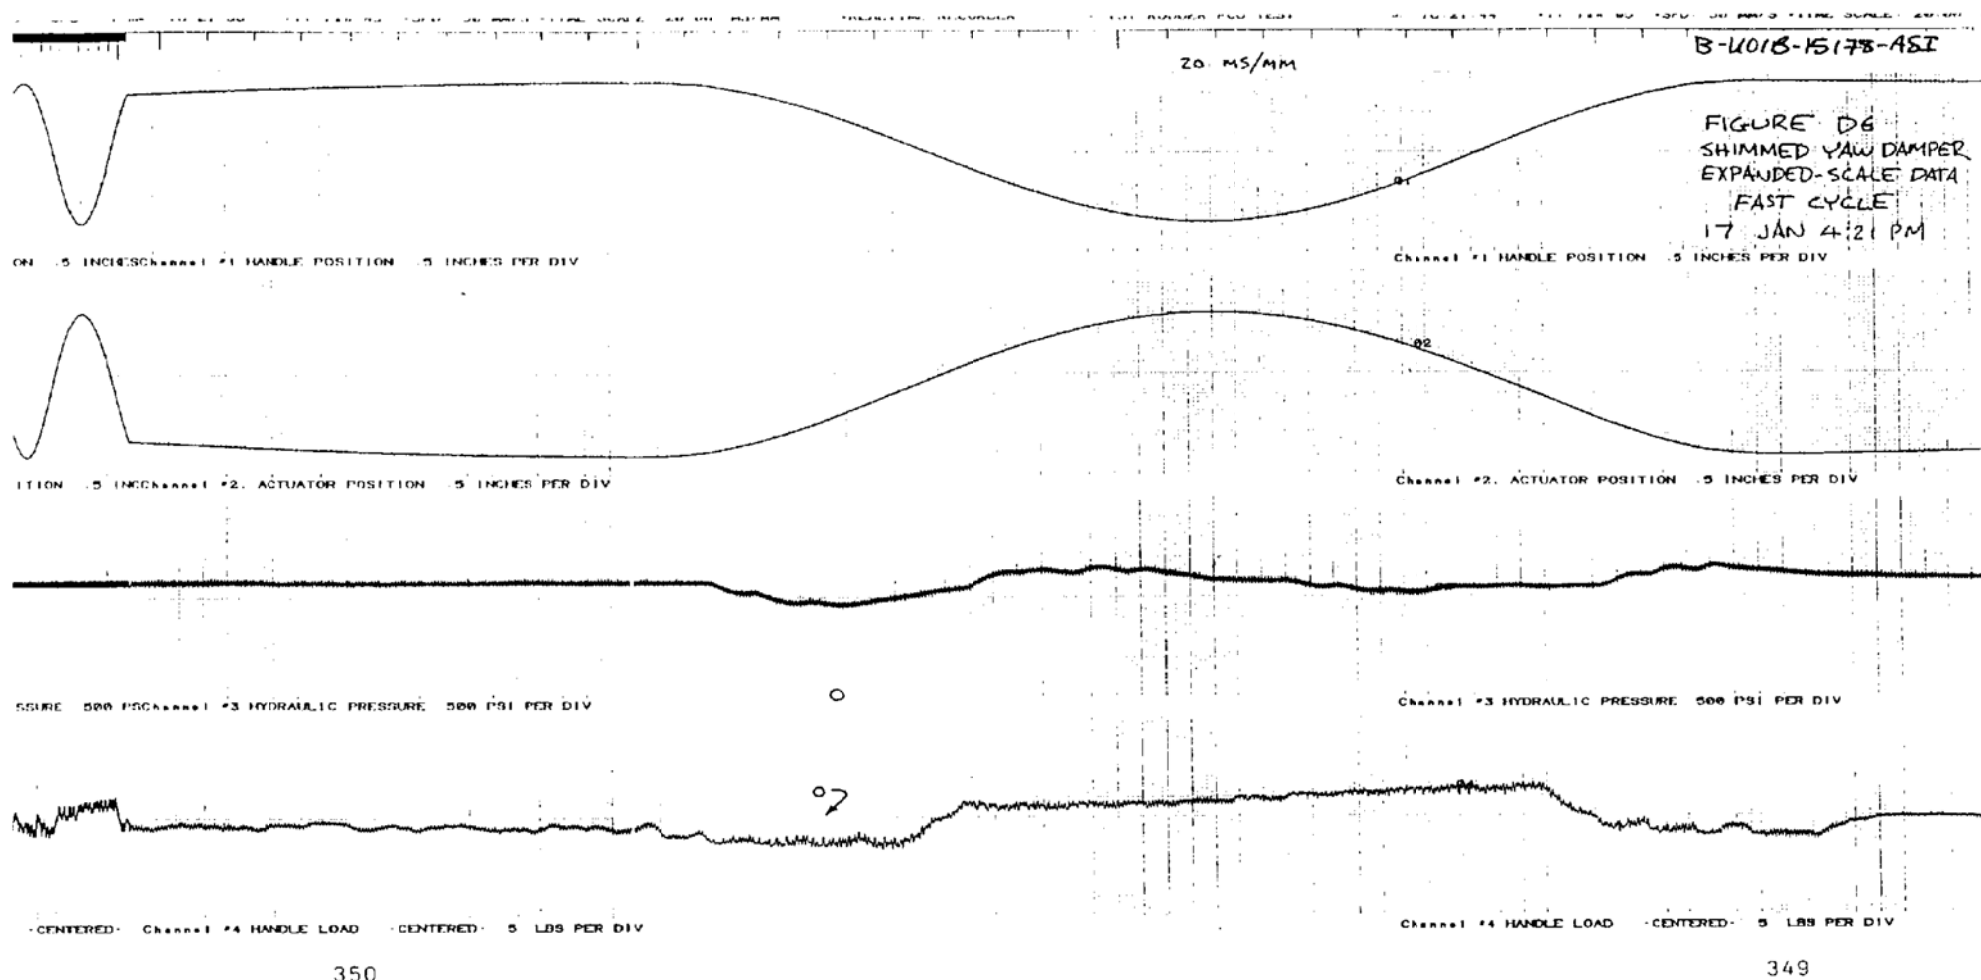
FIGURE D6

Produced expanded-scale data for fast cycle (Figure D6)

Input force same as before shims

8 lb during high-rate, approx 5 lb during slow cycles

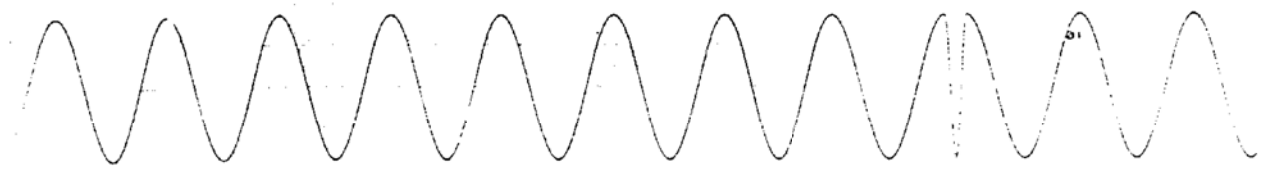
1/2 95 SPD MM/S TIME SCALE 1.000 SEC/MM REALTIME RECORDER 737 RUDDER PCU TEST 09 59 51 18 1

POSITION .5 INCHES PER DIV

Channel 1 HANDLE POS

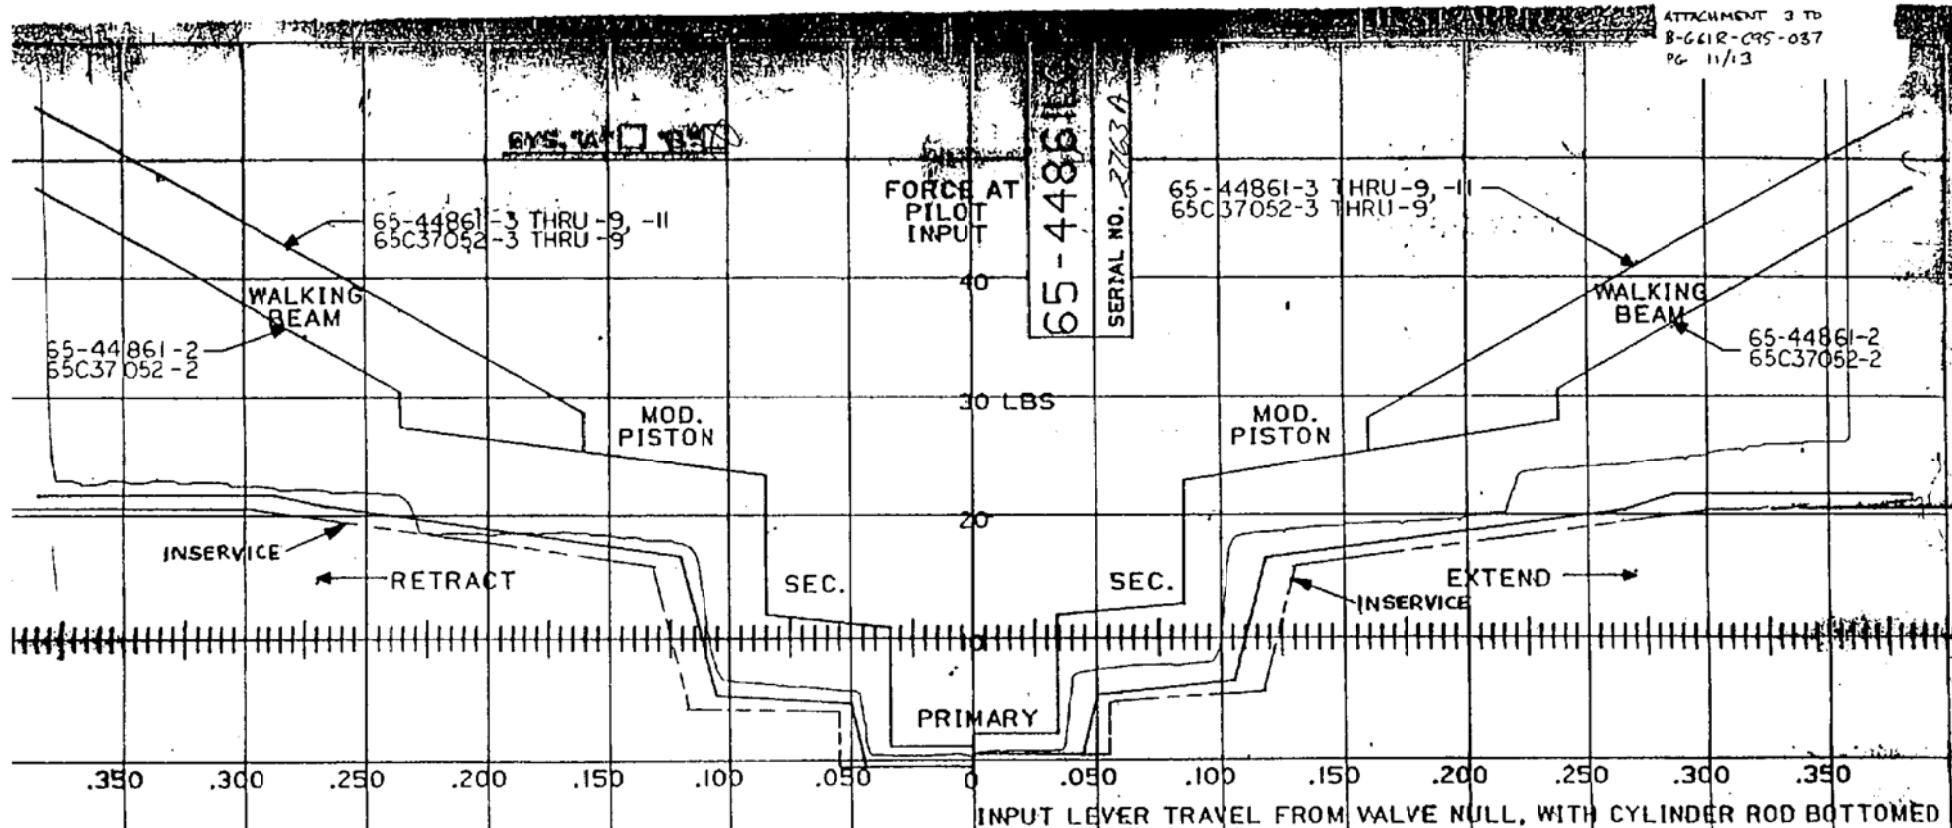
INPUT FORCE VS INPUT TRAVEL  
TEST 12G

12.G. Input Force vs. Input Travel	Force plot must fall within limits shown on Fig. 723.	<u>✓</u> OK		
12.H. Cylinder Rod Leakage	1 drop/25 cycles max at each End Gland (In-Service 1 drop/5 cycles)  2 drops/25 cycles max. at Center Gland (In-Service 2 drops/5 cycles)  1 drop/100 cycles max at Input Shaft (In-Service 1 drop/25 cycles)	Rod Gland <u>0</u> drops Aft Gland <u>0</u> drops  Center <u>0</u> drops Gland  Input Shaft <u>0</u> drops

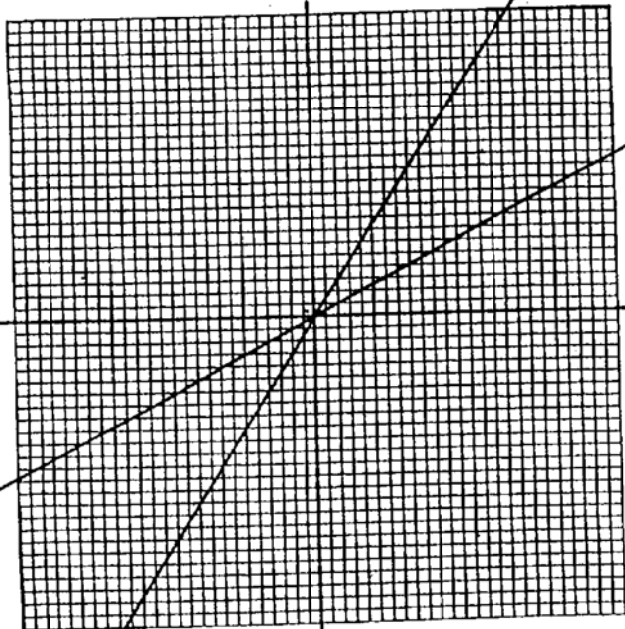
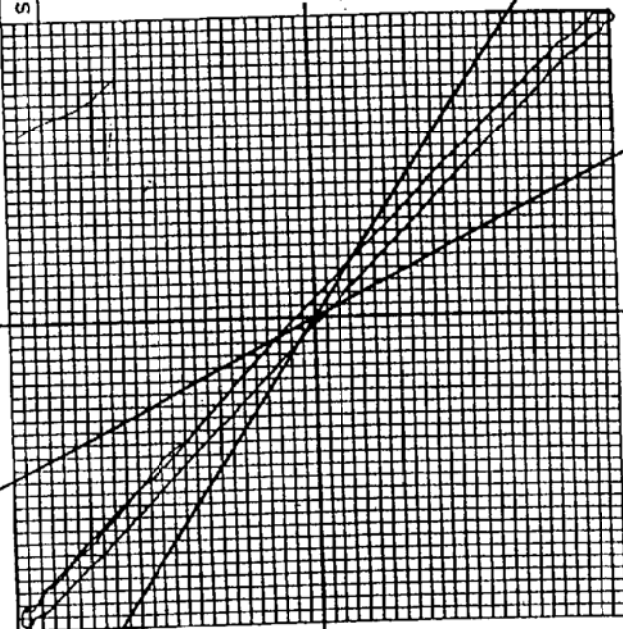
TEST 12R  
REPEATABILITY AND LINEARITY  
(-5 ASSY, 1 SYSTEM ONLY)

65-4486ILG  
SERIAL NO. 2763A
