## ENGINE ANALYSIS REPORT

**ENGINE MODEL** IO-470-U (Left)

**AIRCRAFT MODEL** Cessna 310I

**REGISTRATION NUMBER** N8145M

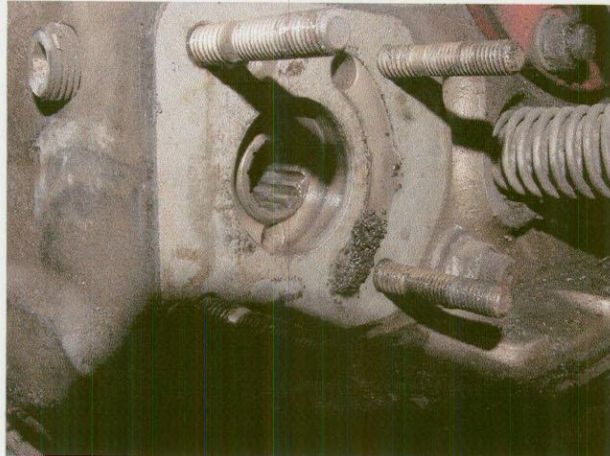
1. The induction balance tube was crushed.
2. No band clamp was on the rubber coupling below number 1 cylinder.
3. Debris, which appeared to carbon chunks, was found on the propeller governor oil screen.

**17. DEBRIS FOUND IN GOVERNOR  
SCREEN**

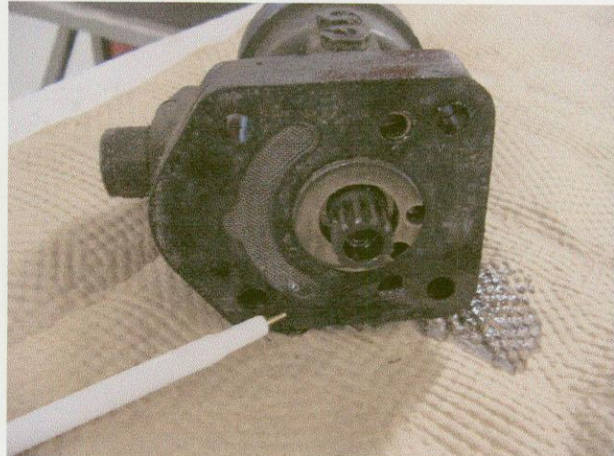
**18. DEBRIS FOUND IN SCREEN AT  
POINTER**

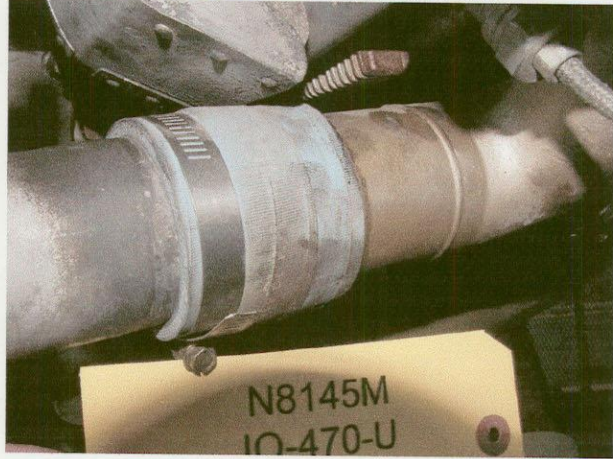
Induction balance tube was crushed and replaced for engine run. A band clamp was missing from the induction coupling below number 1 cylinder.

20. MISSING BAND CLAMP

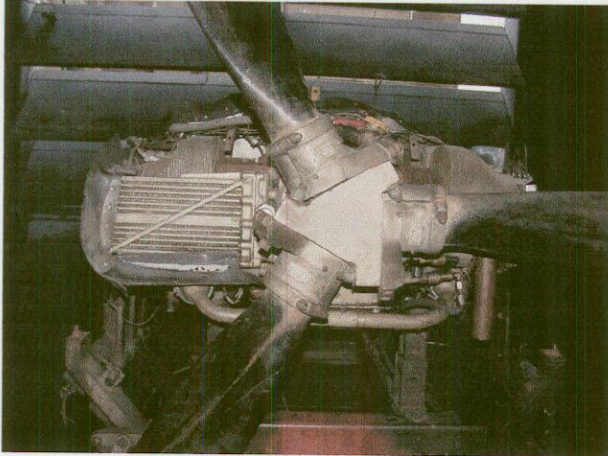
The engine was tested on TCM production test cell number 43. The engine ran normally and was capable of developing rated power. See copy of Aircraft Engine Test Log for data taken during engine run.

21. FRONT ON TEST STAND

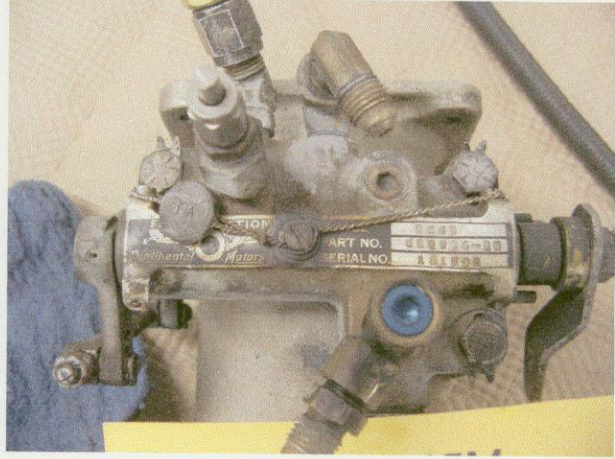
**26. FUEL METERING UNIT**

A fuel stain was observed at the center plug retainer screw. The fuel metering unit was functional tested on the engine run.

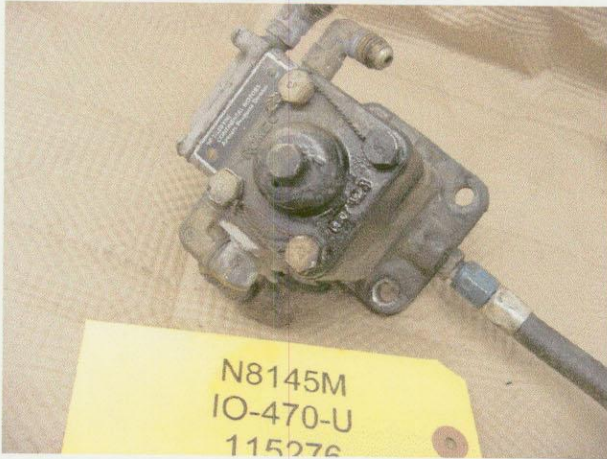
**27. FUEL PUMP**

The fuel pump exhibited a fuel stain on the rear relief valve cover. Pump was functional tested on the engine run.
