**Head-on Collision of
Metrolink Commuter Train No. 111
and UP Freight Train No. LOF65-12**

**Track & Engineering Group
Factual Report**

**HEAD ON COLLISION/DERAILMENT OF METROLINK TRAIN No. 111 &
UNION PACIFIC TRAIN No. LOF65-12**

TRACK & ENGINEERING GROUP FACTUAL REPORT

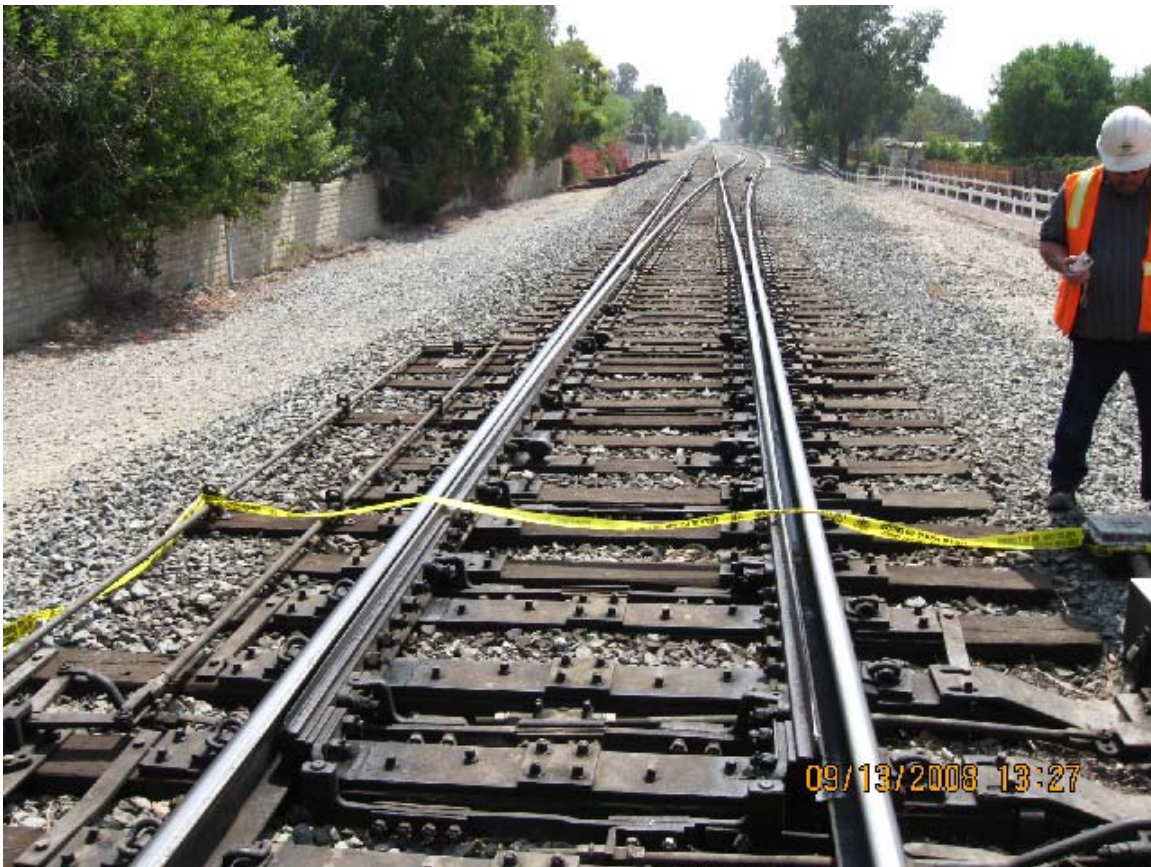
Photo No. 1

View of Topanga turnout looking east

As the above photograph shows, both switch points are “open” or not firmly against either stock rail. There is a chip out of the right hand switch point. The switch rods are bent.

On September 14, 2008, investigators inspected the No. 20 turnout (a right hand switch) located at MP 444.4 on the main track that provides access to the Chatsworth siding, which begins at Topanga. During that inspection, the investigators observed contact marks on the field side of the turnout's left hand switch point about 31 feet from the end of the switch point. These marks extended for several feet along the switch point's length in a west direction toward the end of the switch point. Before the switch was disturbed or repaired, investigators noted the switch appeared to be in a reverse position; however the switch points were not up against either stock rail. Investigators observed the operating rod that controls the throw of the switch was severely bent. The right hand switch point's tip showed fresh signs of damage. The switch point was in the reverse position (lined against main track movement) at the time the Metrolink passenger train traversed through it.

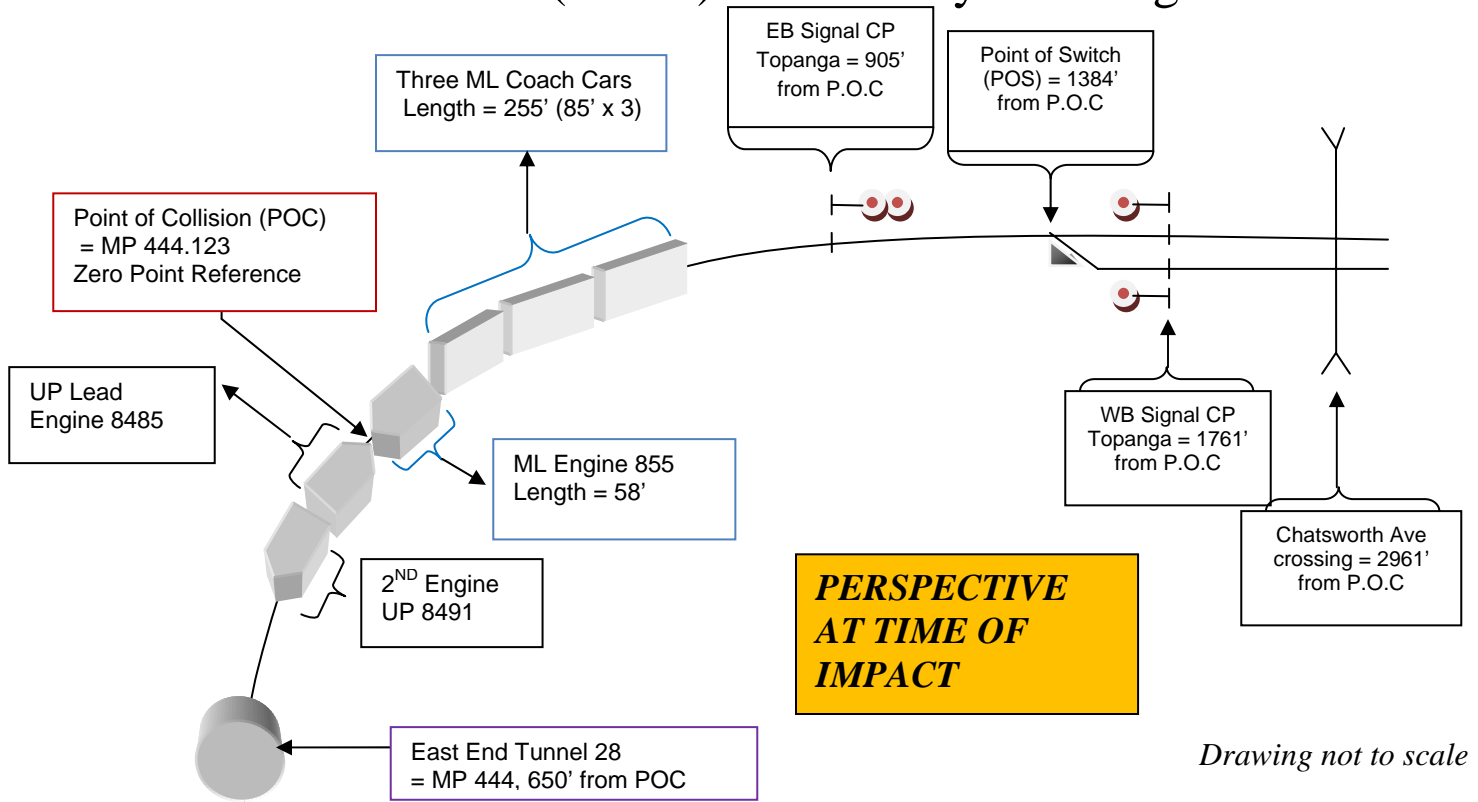
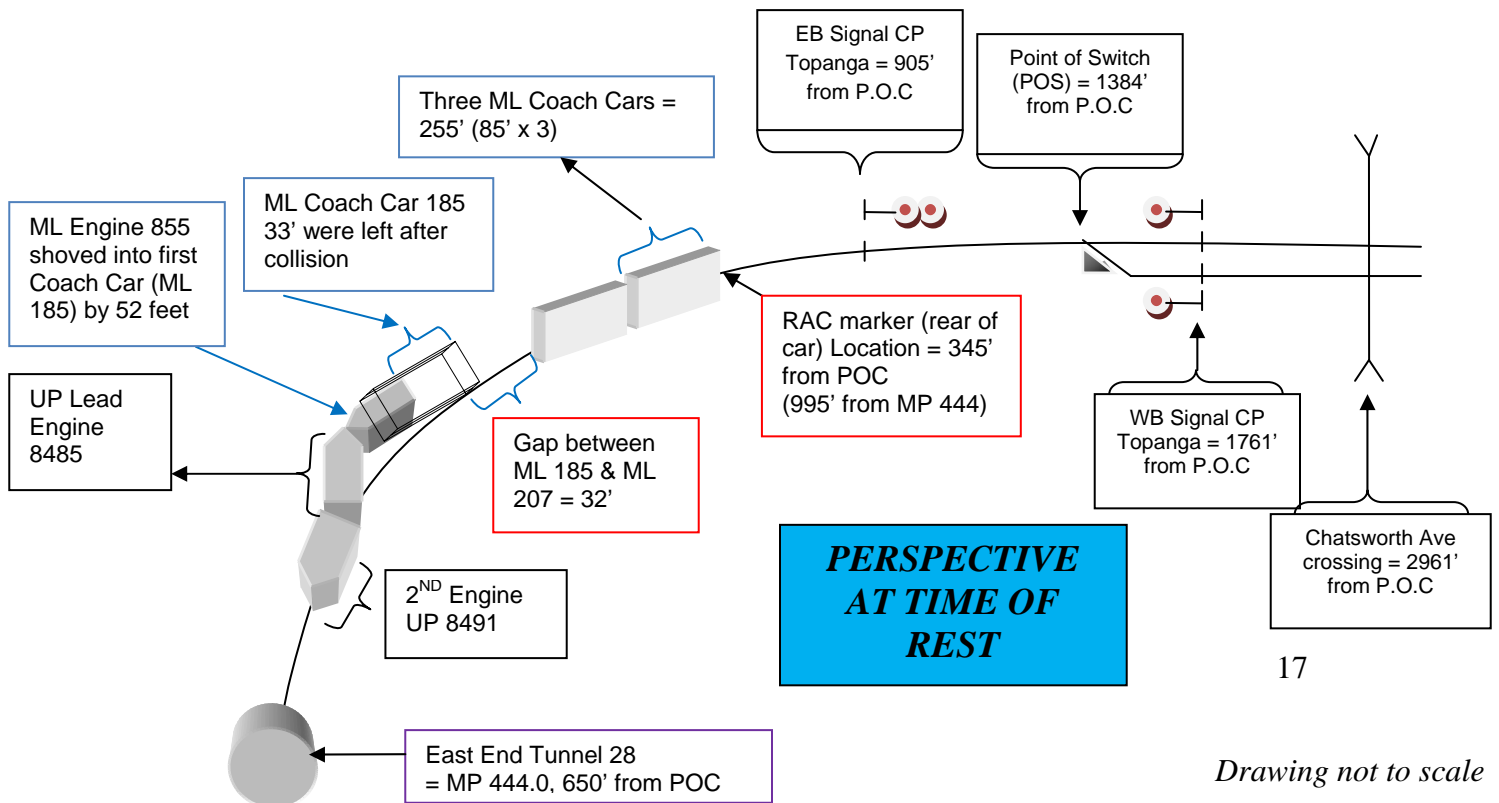
Point of Collision (P.O.C) Preliminary Drawings

Metrolink engineering department personnel surveyed the collision site and produced an engineering drawing detailing the POC and other related locations relative to the accident investigation. The drawing includes the pertinent landmarks and sight distance tests data points. See Appendix A for a list of engineering station measurements associated with the POC and various landmarks and pertinent accident investigation data points. Appendix B shows a graphic of the POC detailing Metrolink train equipment lengths and immediate area.
